GEOLOGIC REPORT ON A LANDSLIDE
ALONG THE RAM RIVER
ROCKY MOUNTAIN HOUSE AREA, ALBERTA

C. P. Kathol¹ and R. A. McPherson²

1973

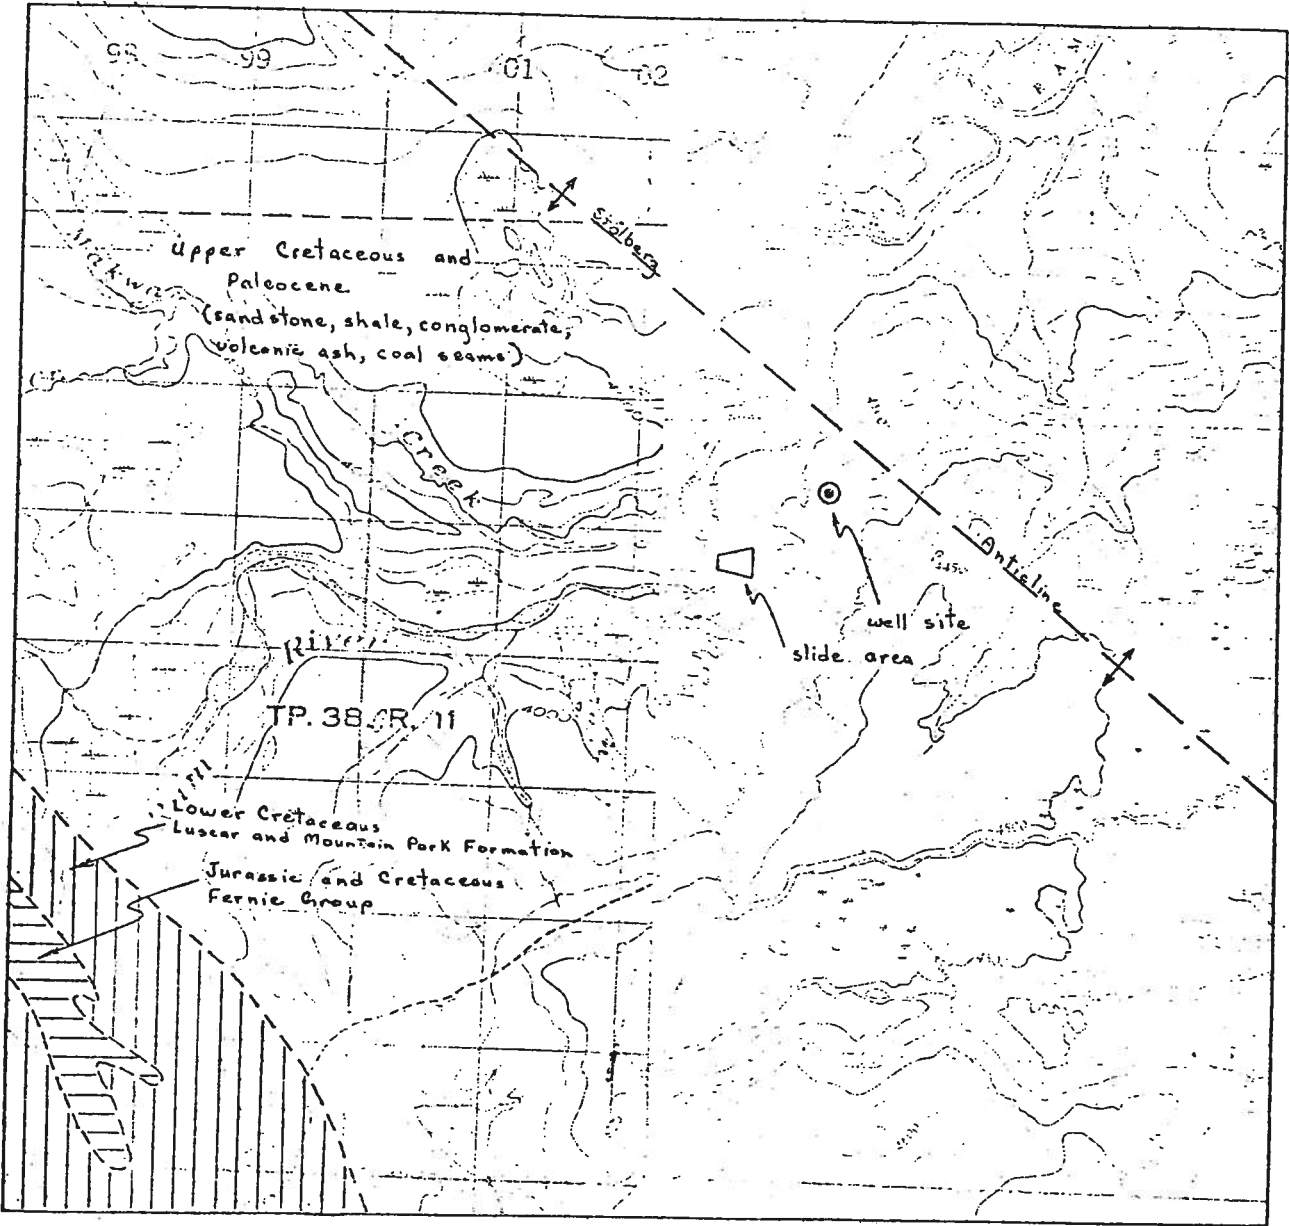
Figure 2. Bedrock geology in the vicinity of the landslide after Erdman (1950)

Based on mapping by Erdman (1950), the large northwest-southeast trending Stolberg Anticline occurs in the area. Both the landslide and the exploration well are located on the southwest limb of this anticline (Fig. 2). Data from the exploration well (see Appendix), indicates that carbonate rocks occur well below 10,000 feet.

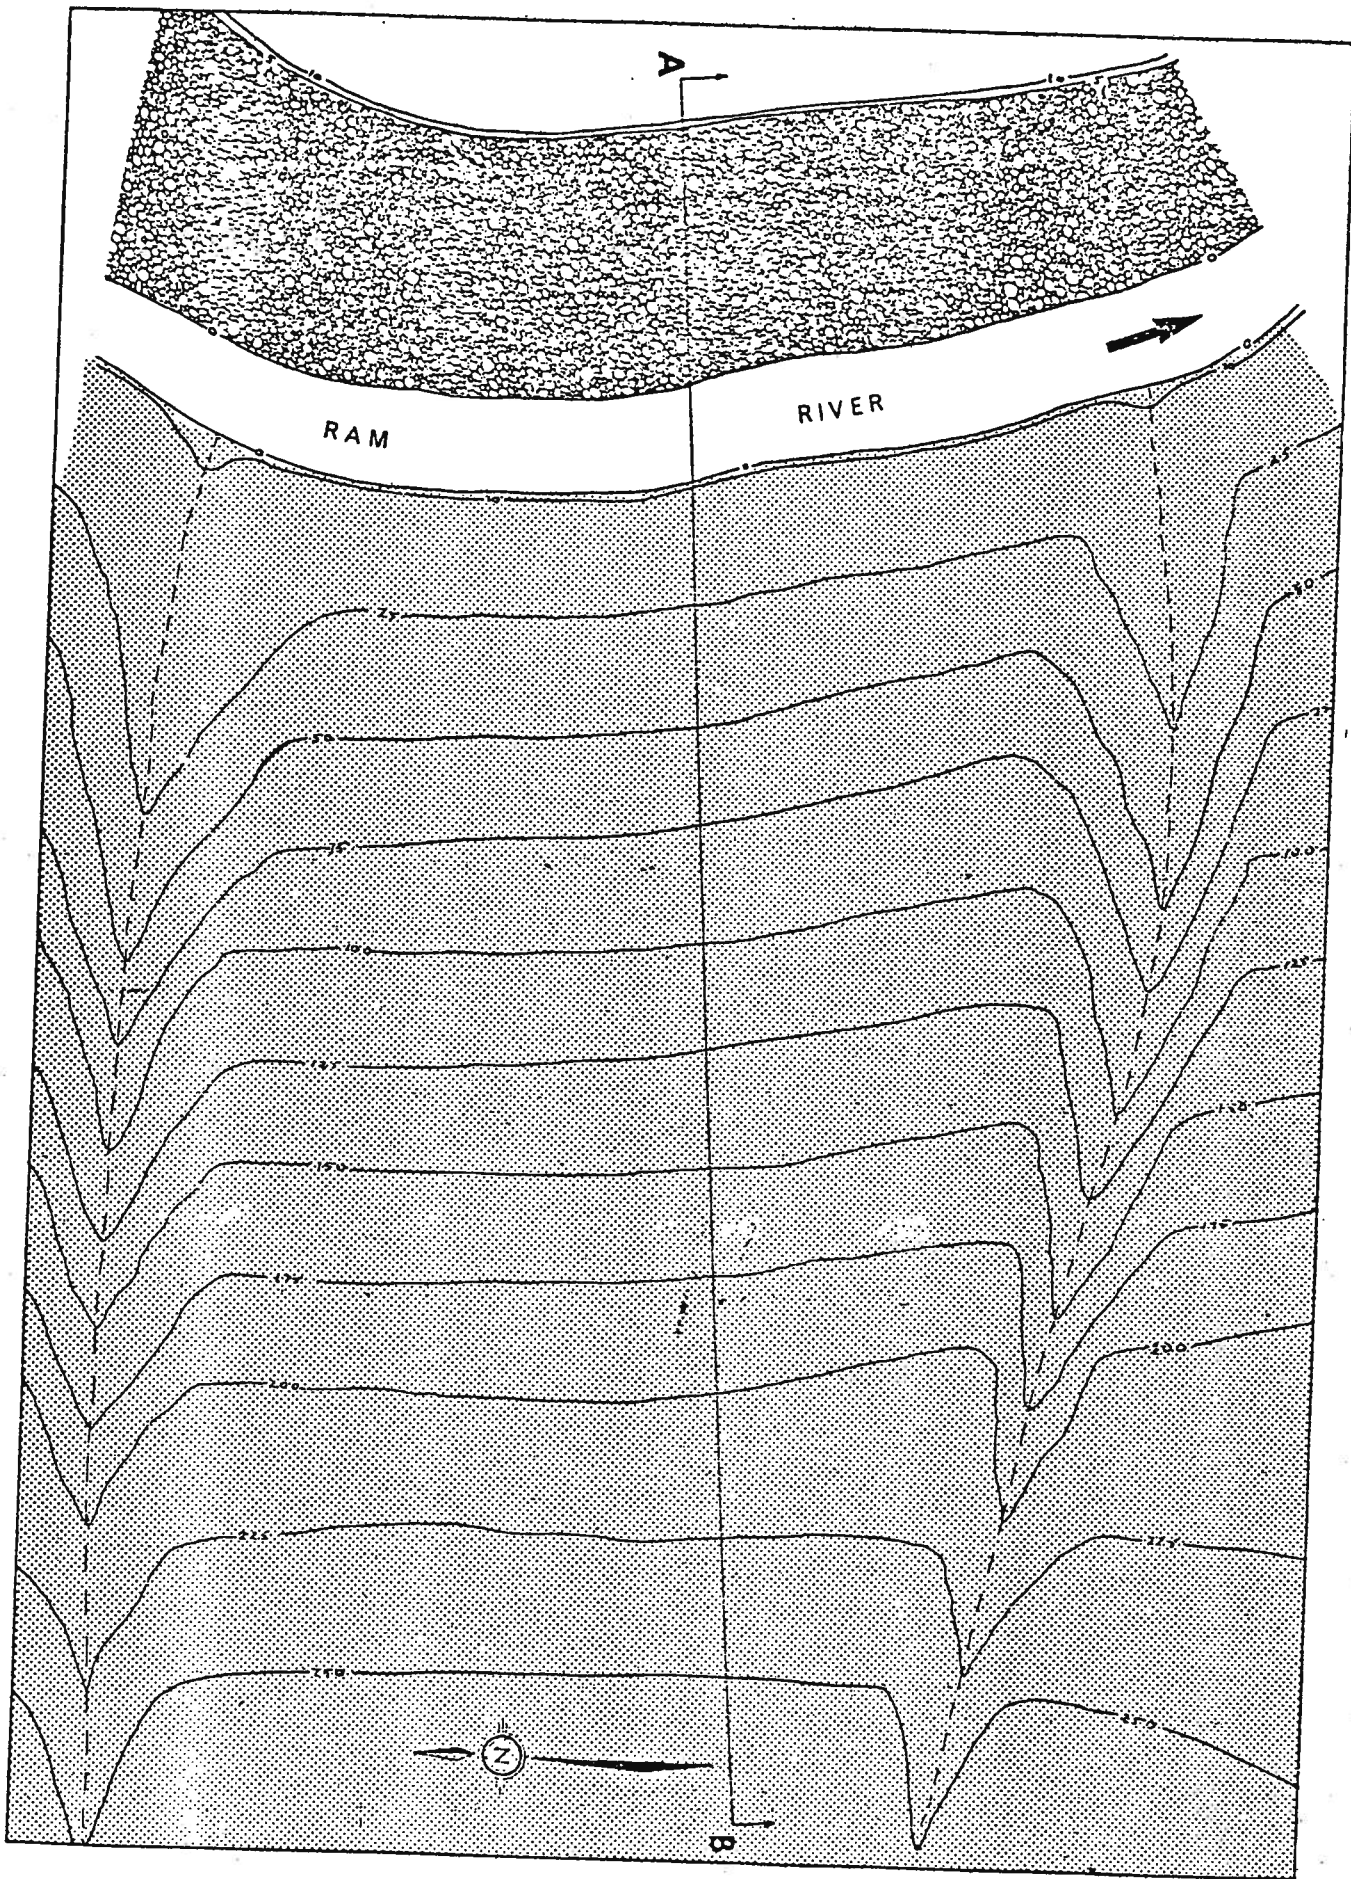
Figure 3. Schematic diagram of topograph of the area prior to the landslide

The geomorphology of the area, as interpreted from topographic maps and air photographs is schematically shown on figure 3. A vegetated slope in which two gullies were cut by surface water runoff was being undercut by the Ram River (Fig. 3).

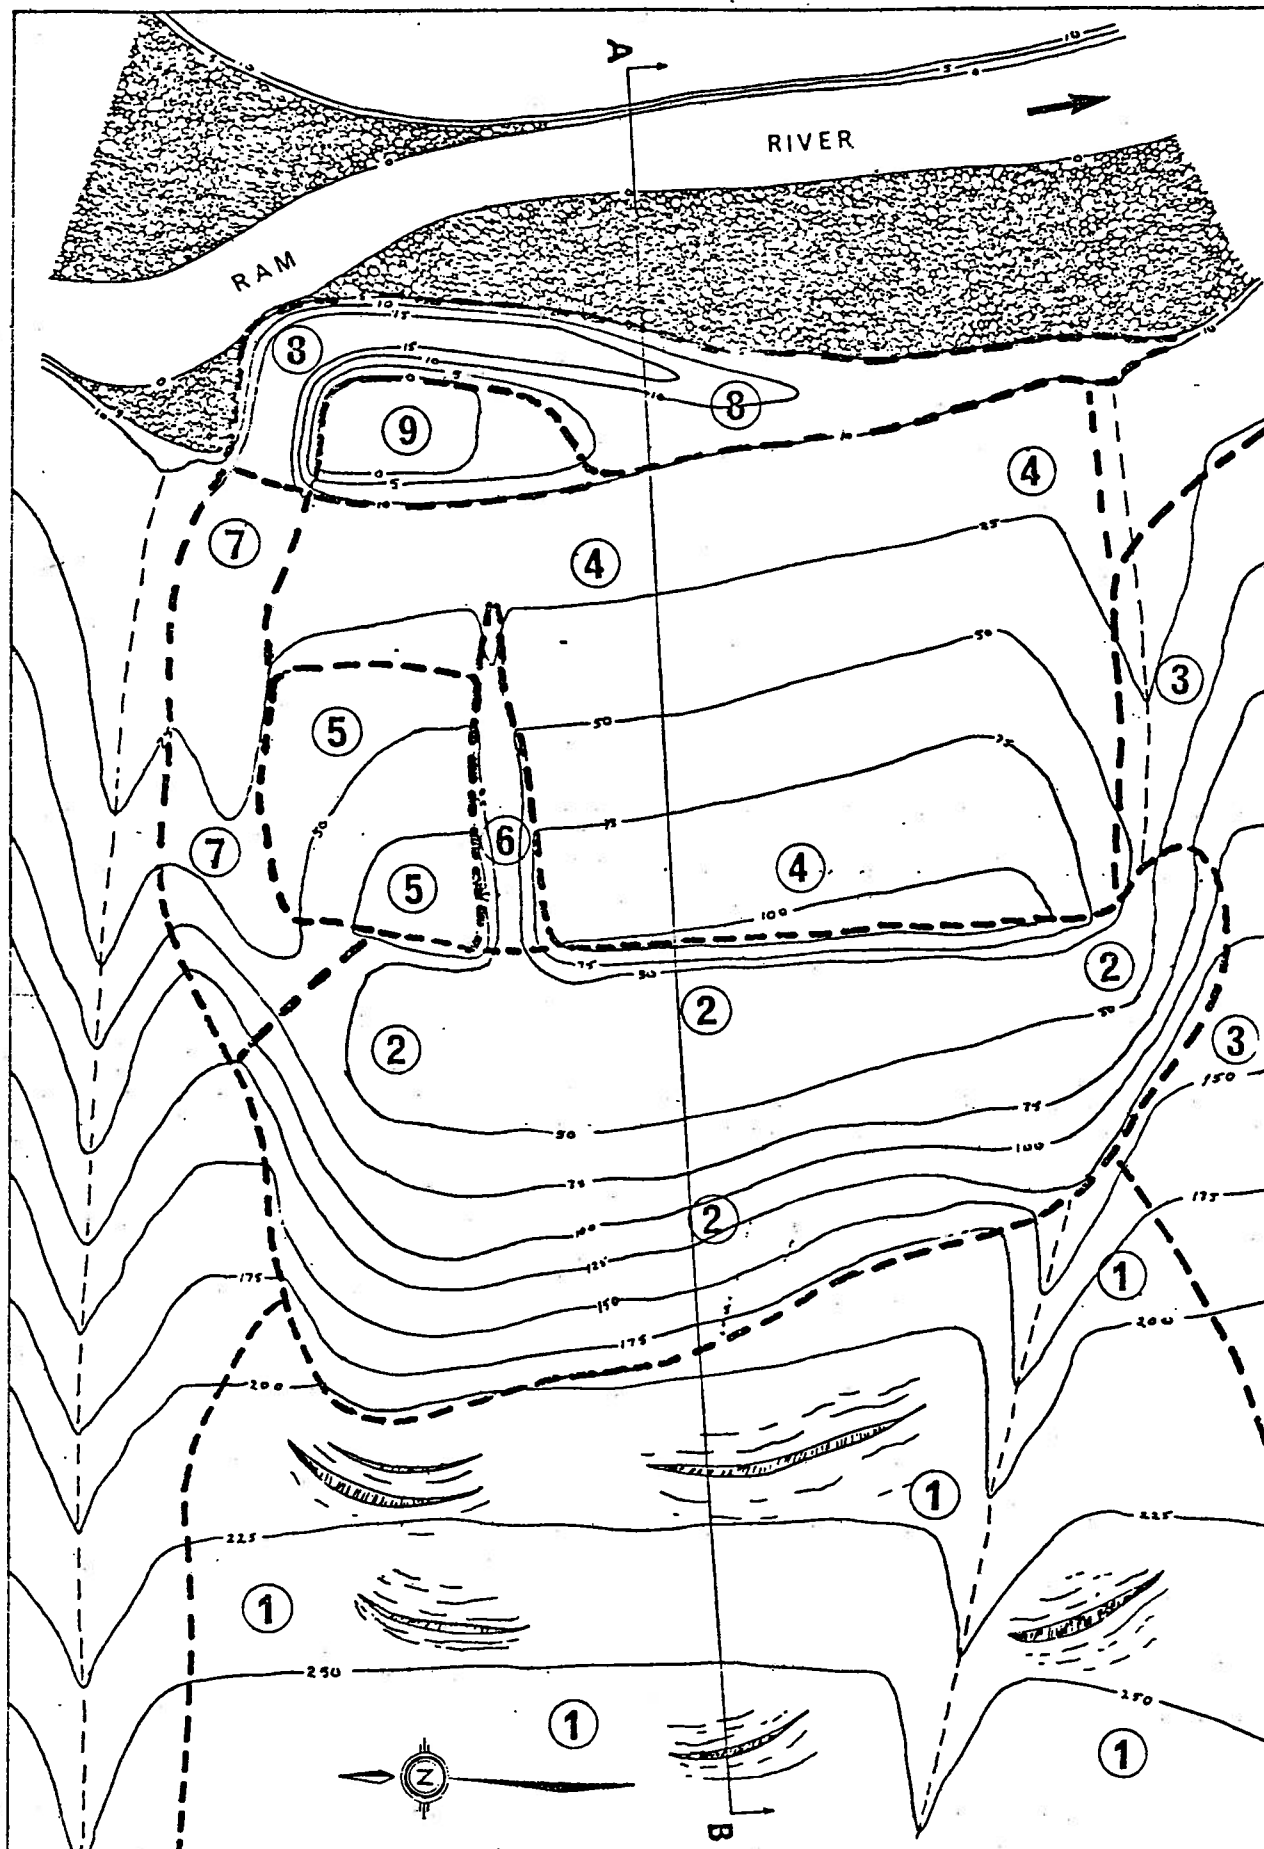
Figure 4. Schematic diagram of slide area

The configuration of the area subsequent to the slide (based on field observations) is schematically shown on figure 4. The area has been subdivided into sections 1 to 9 and each of the sections is described separately. Photographs of the slide area are included in the Appendix and a geologic cross section is included on figure 5.

The upper portion of the slope consists of colluvium underlain by hummocky lacustrine silts and clays. Till and bedrock are present below these surface deposits. Much evidence of slope instability is present in terms of bent and overturned trees as well as numerous apparently recent slump scars. Surface water is ponded in many of the slump scars and depressions.

Section 2 is a major depression separated from sections 1 and 4 by relatively steep banks. The banks consist of highly jointed and fractured sandstone with minor shale and conglomerate. The bedrock is overlain by till, lacustrine sediments and colluvium. No slickensides were observed on the banks surrounding the depression. The base of the depression consists of bedrock overlain by large slabs of bedrock that have broken off the banks and alluvium deposited by surface water running off the slopes. Many chunks of the broken bedrock had well developed slickensides indicating movement along failure planes. Water is present in many of the lows in this area.

The gully that existed prior to the slide has been somewhat disrupted but no evidence exists for a significant slide in this area as most of the trees are still in place.

Section 4 has a near vertical east bank and the surface slopes gradually to the river as shown in the geologic cross section. Tree cover occurs over most of the slope and appears relatively undisturbed.

Section 5 consists of a slump block that has broken away from section 4 leaving a crevasse like opening (labelled section 6).

Section 7 is a major elongate low that slopes downward to the Ram River. Large slabs of bedrock with well developed slickensides are present in this low as well as crumpled shale, and glacial deposits. Where present, the trees are broken and bent indicative of downslope movement.

Section 8 consists of an elongate ridge of slickensided slabs of sandstone, crumpled shale, and surficial deposits. Driftwood has been incorporated within the rubble. The top of the ridge is estimated to be 10 to 15 feet above present river level. The ridge trends approximately east-west and then turns almost at right angles and trends north-south.

Section 9 is a depression behind the elongate ridge (section 8) which used to be the old river channel. The slide blocked this channel and caused the Ram River to incise a new channel as shown on figure 5.

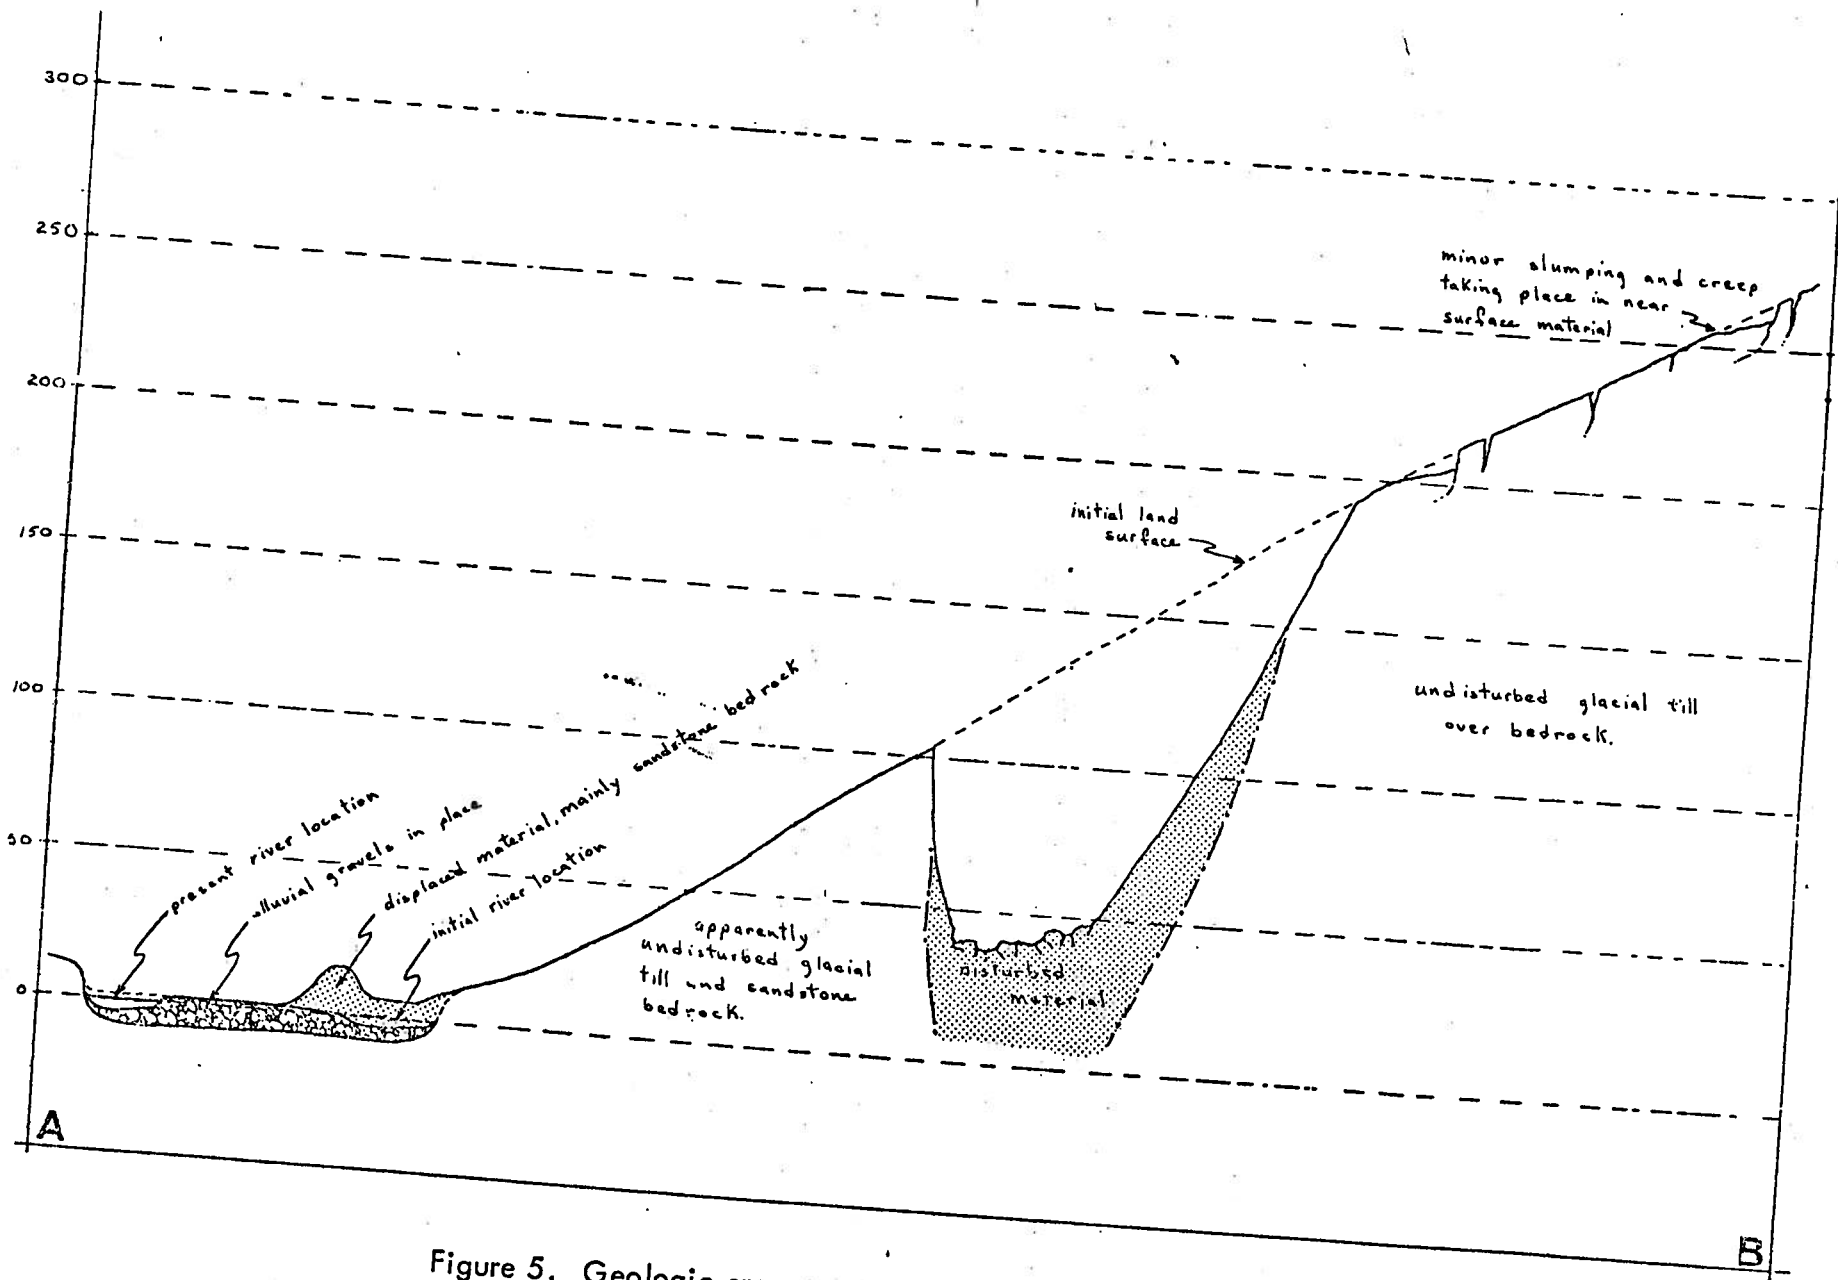
Figure 5. Geologic cross section of slide area. Location of cross section shown on figure 4.

(a) A landslide occurred along section 7 depositing the elongate ridge labelled 8 and diverting the Ram River. Since that time the river has cut a new channel as shown on figure 5. Nearly horizontal slickensides on the sides of section 7 indicate that the movement was downslope towards 8.
