# **Turtle Mountain Field Laboratory, Alberta (NTS 82G): 2012 Data and Activity Summary**

J. Warren<sup>1</sup>, A.J. Morgan<sup>2</sup>, D.K. Chao<sup>1</sup>, C.R. Froese<sup>1</sup> and D.E. Wood<sup>1</sup>

December 2014

Warren, J., Morgan, A.J., Chao, D.K., Froese, C.R. and Wood, D.E. (2014): Turtle Mountain field laboratory, Alberta (NTS 82G): 2012 data and activity summary; Alberta Energy Regulator, AER/AGS Open File Report 2014-09, 16 p.

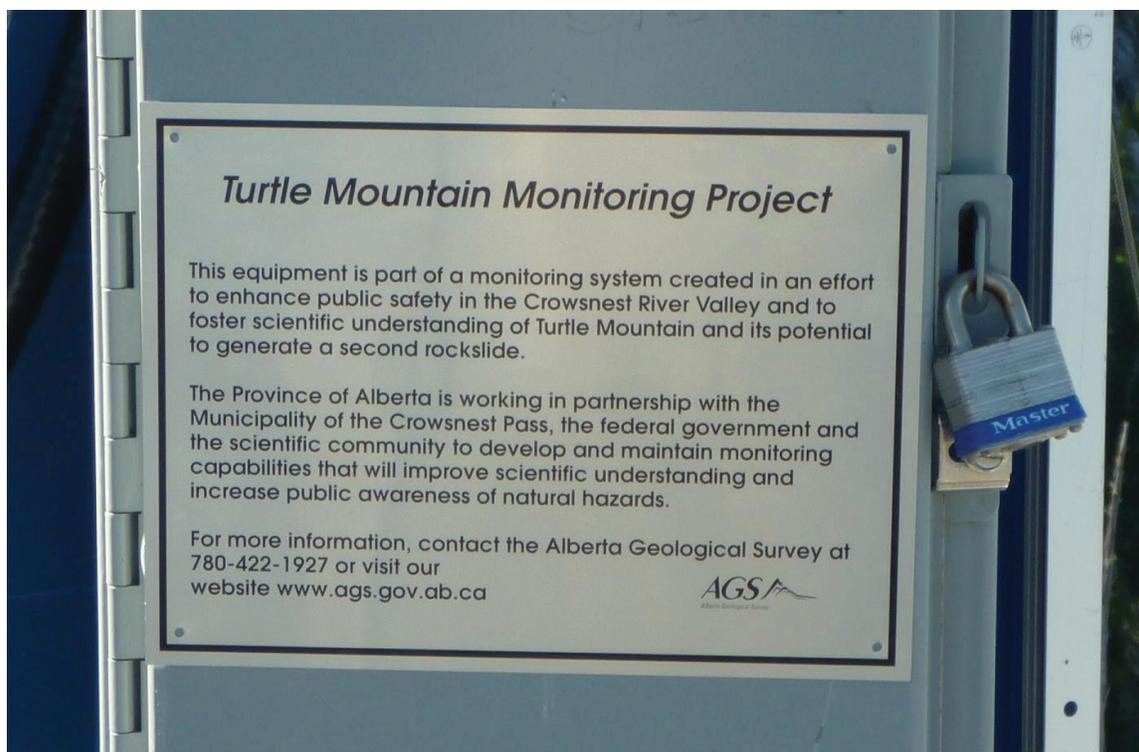
New signs were added to each sensor on Turtle Mountain this year. The signs describe the project and give the contact information for the AGS, including our website address (Figure 2).

**Figure 2. New Turtle Mountain Monitoring Project signage placed on the mountaintop equipment and on the IBIS station located at the pump house in Bellevue, Alberta.**

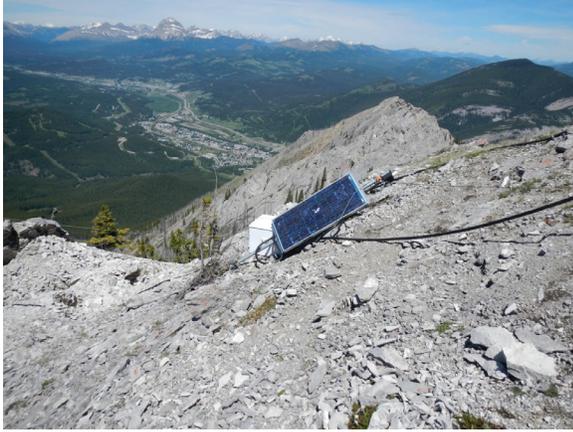
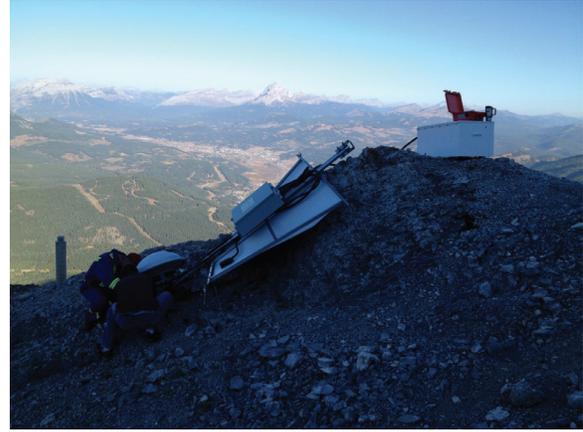
During the June reconnaissance trip, the Upper West dGPS station was found to have fallen due to the turnbuckles having been removed (Figure 4), likely because of vandalism or wind vibration. To reduce the chances of this happening again, all dGPS stations were equipped with safety cables.

In September, a heavy wind event caused a guy wire of the dGPS radio station to fail, causing the mast to fall. There was damage to the solar panels, weather station mounting bracket, and WiFi access point antenna, and they needed to be replaced. Solar panels were taken from the pit station, since a replacement panel was not in stock.

Figure 4. a) Fallen Upper West station b) fallen radio station.

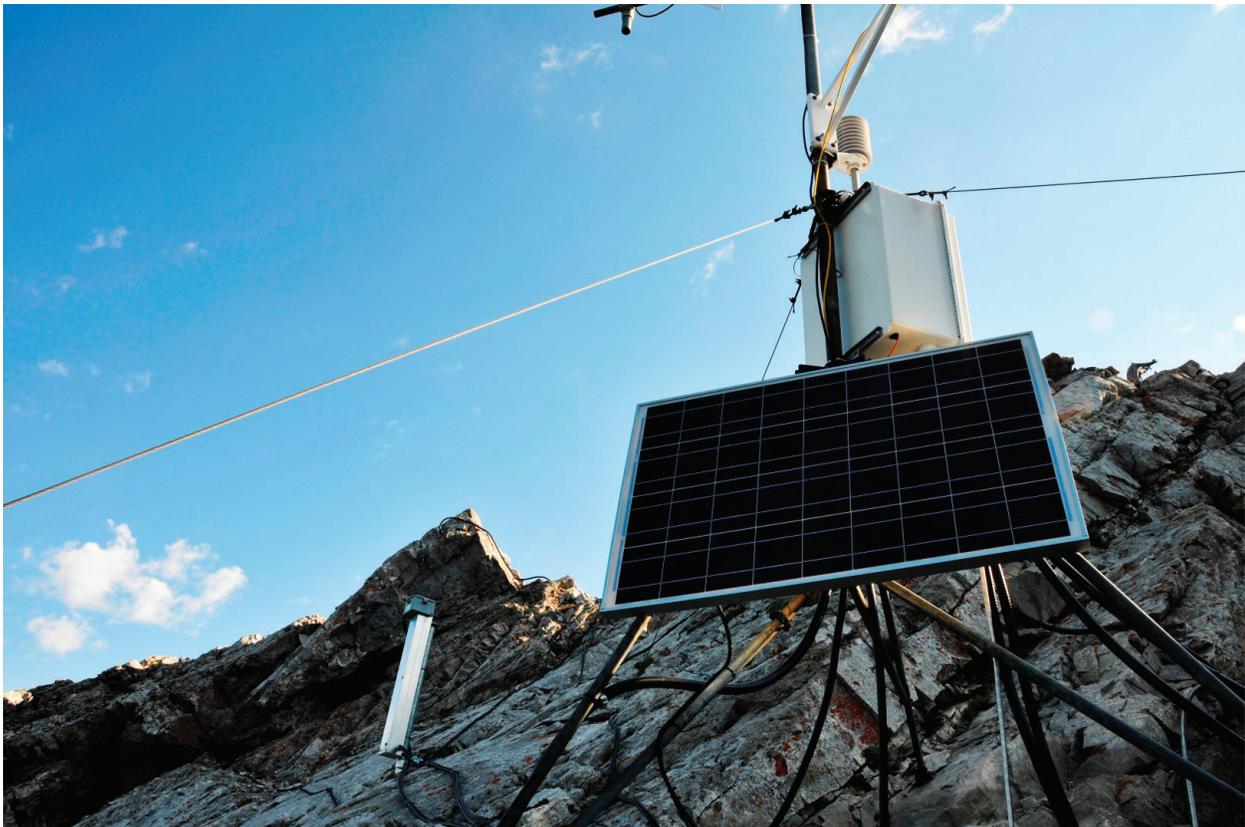
Despite replacing the original weather station batteries in 2011, there were still power issues. After the reconnaissance trip in June it was thought that the addition of a new, larger solar panel may improve charging capabilities. A new 85W panel and a 10A solar controller were installed during the August annual repair trip to supply adequate charge for the station (Figure 5).

Figure 5. New weather station solar panel.

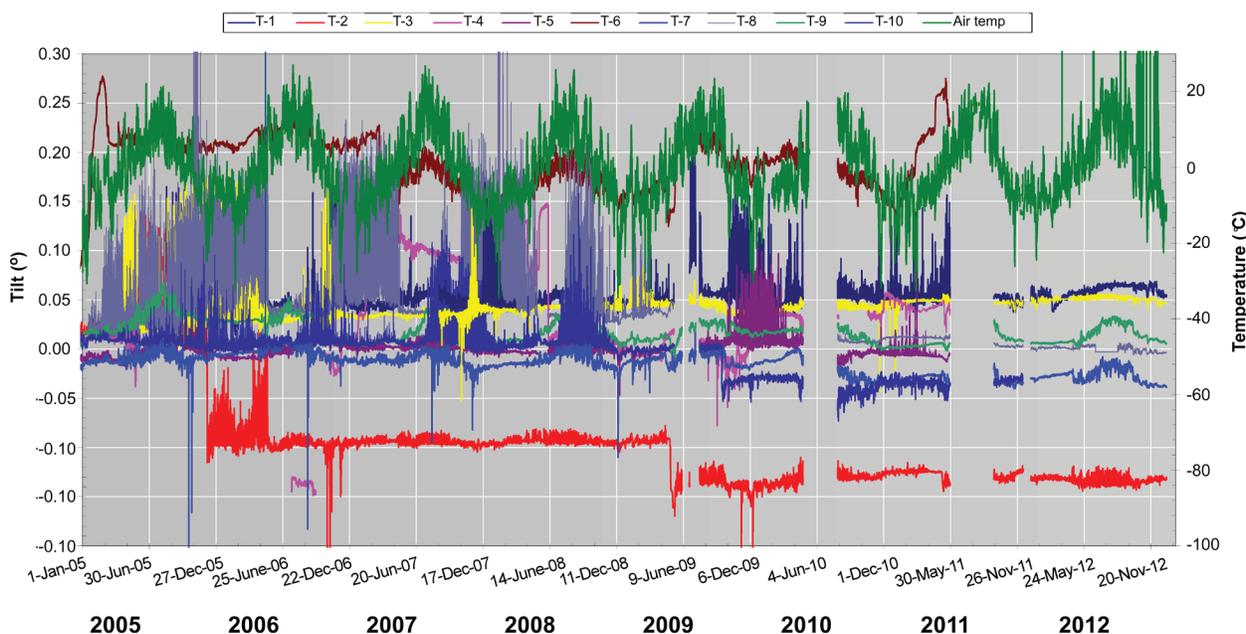
About half of the sensors show the effects of high humidity inside the instrument enclosure, making the interpretation of small rotations very difficult. In spite of this, some trends can be identified. In general, all sensors show annual fluctuations (but with no long-term cumulative rotations) and diurnal fluctuations associated with daily air temperature cycles.

Small rotations are observed by tiltmeters T-1 and T-3 (Figure 6), with the magnitude and rate of rotation at each station remaining essentially constant for the monitoring period from 2005 through 2012. This implies that the pattern of deformation of the rock mass has been constant, which is consistent with the trends seen in the crackmeter data.

Figure 6. Plot of tilt versus time for tiltmeters, South Peak, Turtle Mountain.

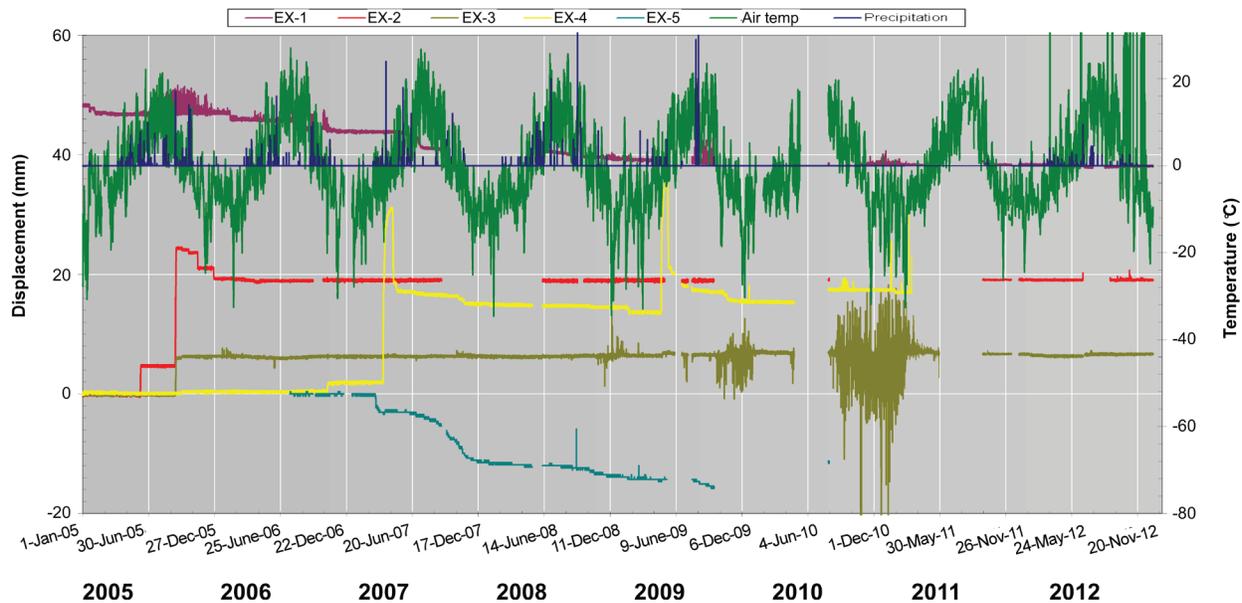
Displacement versus time plots for the extensometers do not show the cyclical daily and annual fluctuations observed in crackmeter and tiltmeter data (Figure 7). This noticeable difference likely arises from a difference in resolution between sensor types, with resolution in the extensometers two orders of magnitude lower than that of the crackmeters. Extensometers EX-2 and EX-3 continue to be extended at 19 and 6.17 mm of extension, respectively. These displacements were recorded during two periods of heavy precipitation in early June and early September of 2005; Moreno and Froese (2006) discussed the specifics of these events. In addition, the displacement versus time plot in Figure 7 shows a number of transient jumps or steps recorded by sensors EX-4 and EX-5; however, these events are believed to be associated with sensor drift rather than rock displacement. The exact cause of these steps has yet to be determined, but we believe that it will not affect the sensors' ability to measure real deformations.

Figure 7. Plot of displacement versus time for extensometers, South Peak, Turtle Mountain.

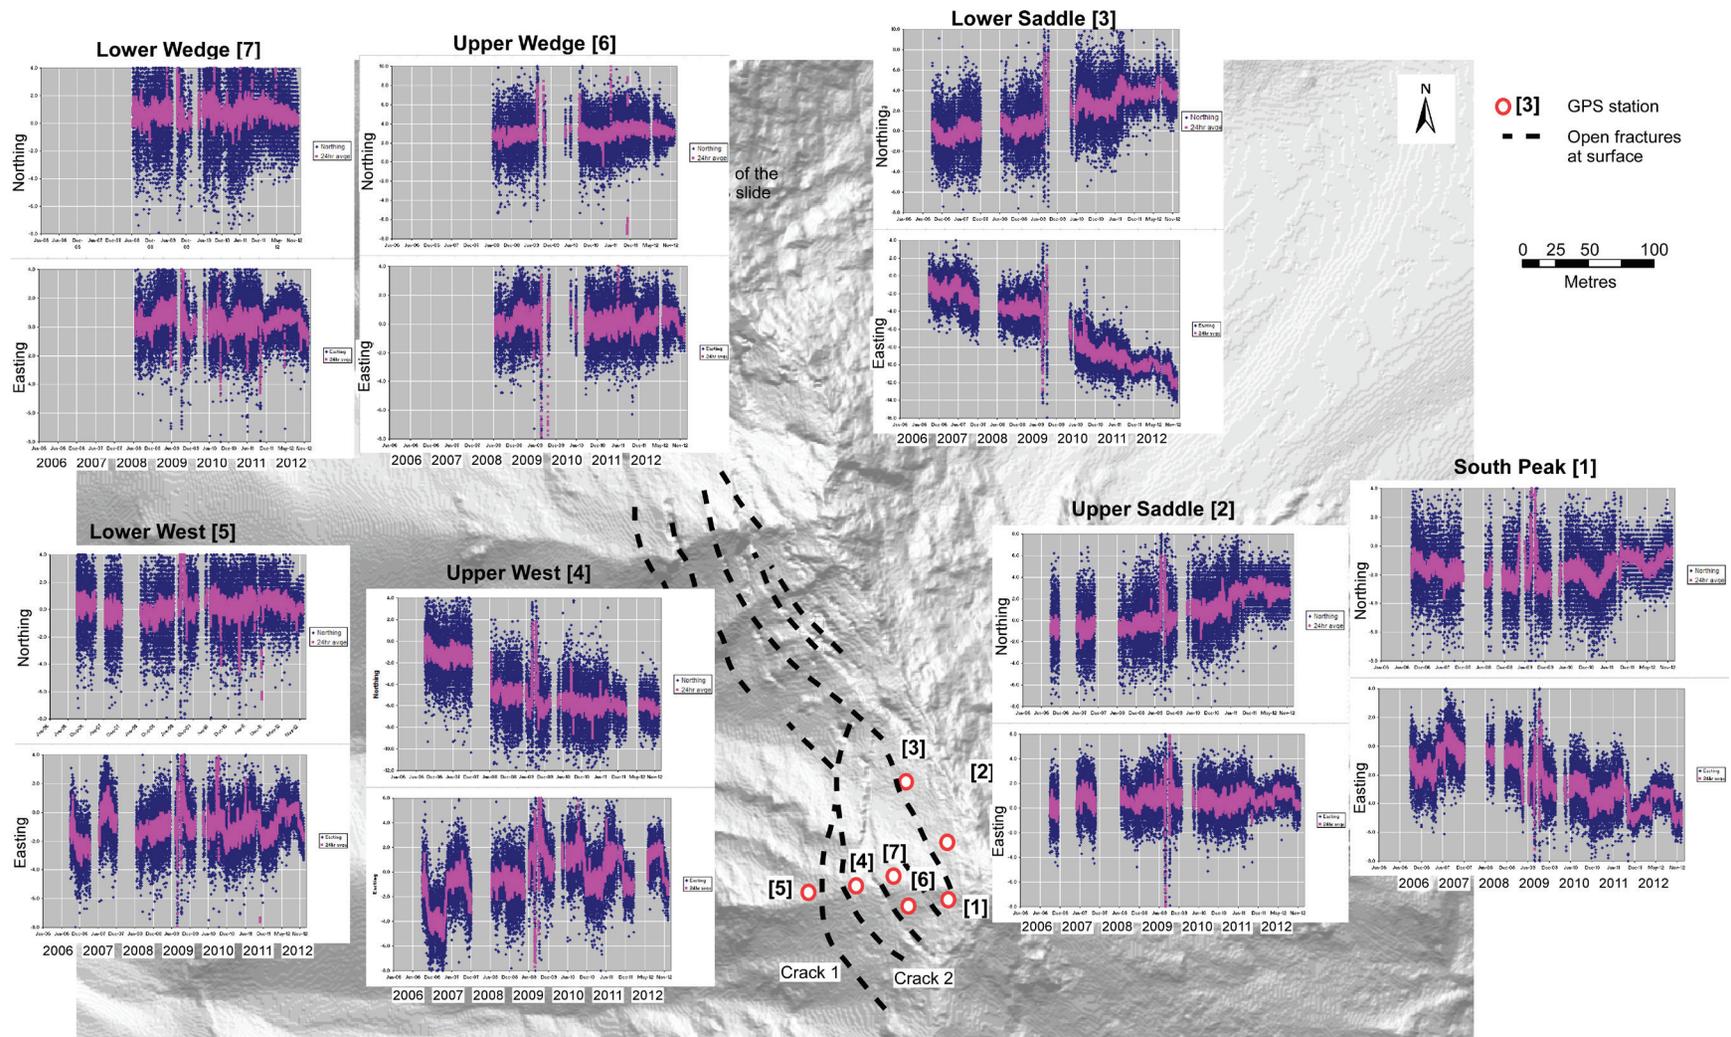
The monitoring results from the dGPS stations are shown in Figure 8. Measurable displacement rates can be seen at the Lower and Upper Saddle and Upper West stations. Annual displacement rates at the Lower and Upper Saddle stations range mainly between 0.5 and 2 mm/year, which is consistent with previous photogrammetric monitoring (Moreno and Froese, 2006). In contrast to these measurements, the Upper West station indicates a displacement of more than 6 mm. This is almost certainly incorrect and likely related to a poorly constructed concrete pillar. A detailed on-site inspection of the pillar revealed evident signs of deterioration; also, the pillar is on a heavily broken rock, which can be very susceptible to freeze-thaw events and result in large local displacements.

Figure 8. Surface displacements derived from dGPS stations during the period 2006–2012.

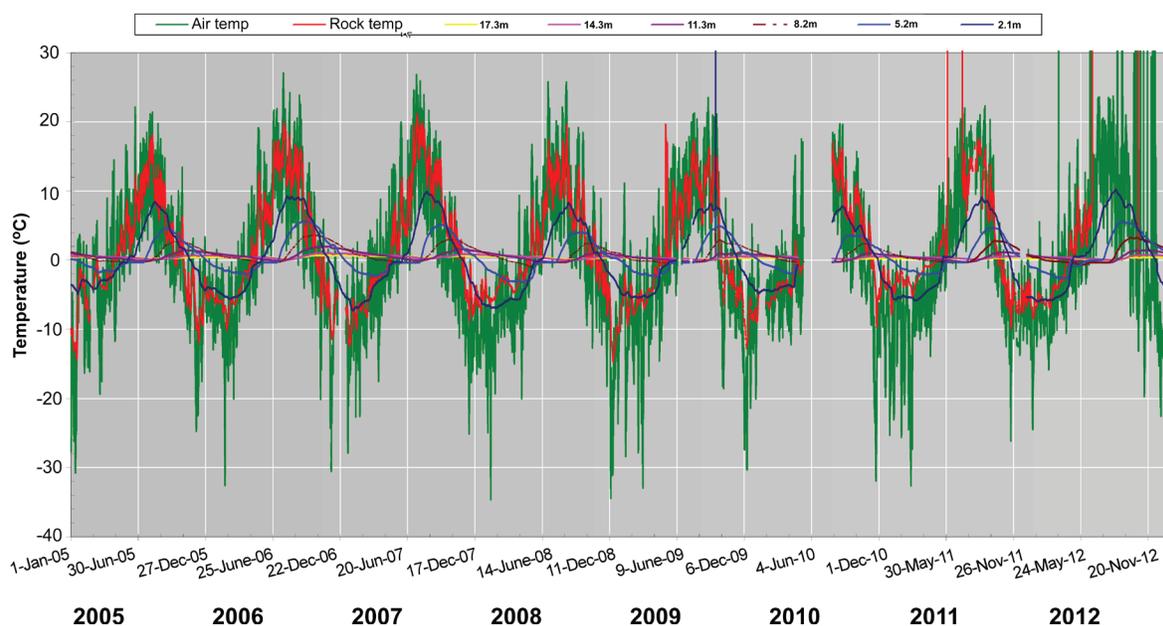
A malfunction of the thermistor at South Peak caused several anomalous high readings in 2012, and a maximum temperature could not be conclusively determined. Environment Canada reported a maximum temperature of 31.1°C on July 12, 2012. However, the malfunction did not appear to affect minimum temperatures, and a value of -24.5°C was recorded at the top of the South Peak of Turtle Mountain (Figure 9). Significant daily temperature variations were also common. Rock temperature showed the same general trend as air temperature but was more subdued (lower maximum and higher minimum readings), with a time lag of about 12 hours relative to significant changes in air temperature. Seasonal temperature fluctuations penetrate only about 15 m into the slope (Th-2) and are negligible below that depth, with significant temperature variations measured down to a depth of 8.2 m (Th-4). On the other hand, daily temperature variations are measurable only about 4 m into the slope (Figure 9).

**Figure 9. Air temperature and variation of rock temperature with depth in the borehole at the top of South Peak, Turtle Mountain, 2005–2012.**

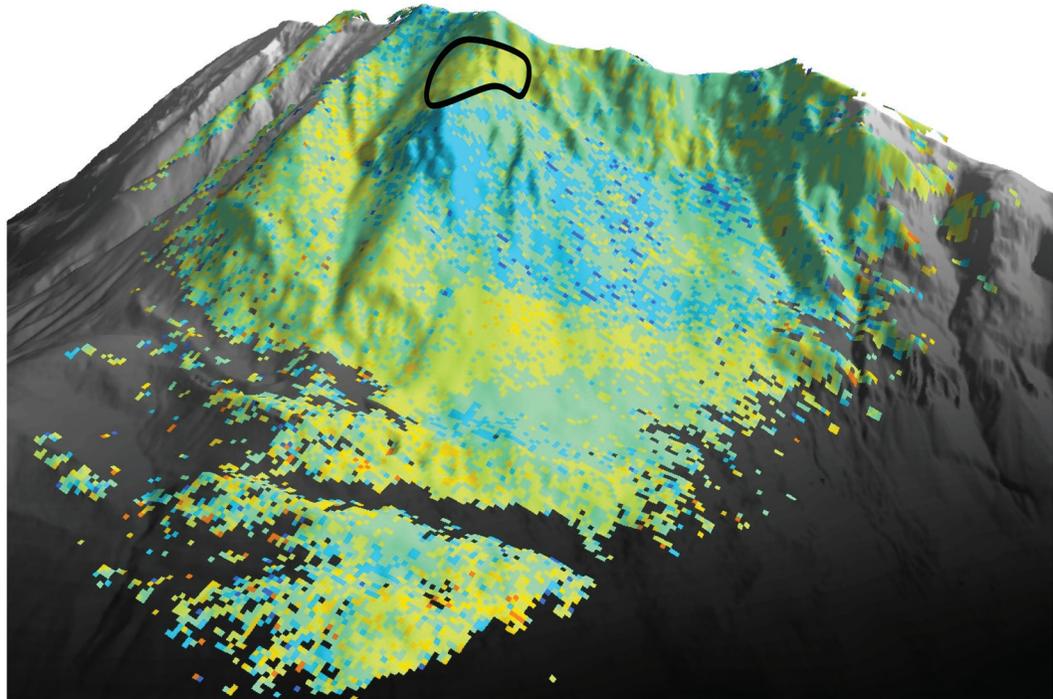
Figure 12 shows total displacement from May 30 to June 17, 2012. The data is noisy in the vegetated areas on the flanks and in the areas of debris flow. The unstable region on the North Peak observed in 2011 is not apparent in the 2012 data; however, some motion towards the instrument appears to be occurring on South Peak, which is consistent with earlier observations (Humair et al., 2011).

Figure 12. DEM of Turtle Mountain, viewed from the IBIS instrument location. Colours represent total displacement along the instrument line-of-sight between May 30 and June 17, 2012. Red and yellow indicates motion towards the instrument, blue indicates motion away, and green areas are zero displacement. Some motion towards the instrument appears to be occurring on South Peak (circled); however, the IBIS instrument is still undergoing testing due to a calibration issue with the radar head.

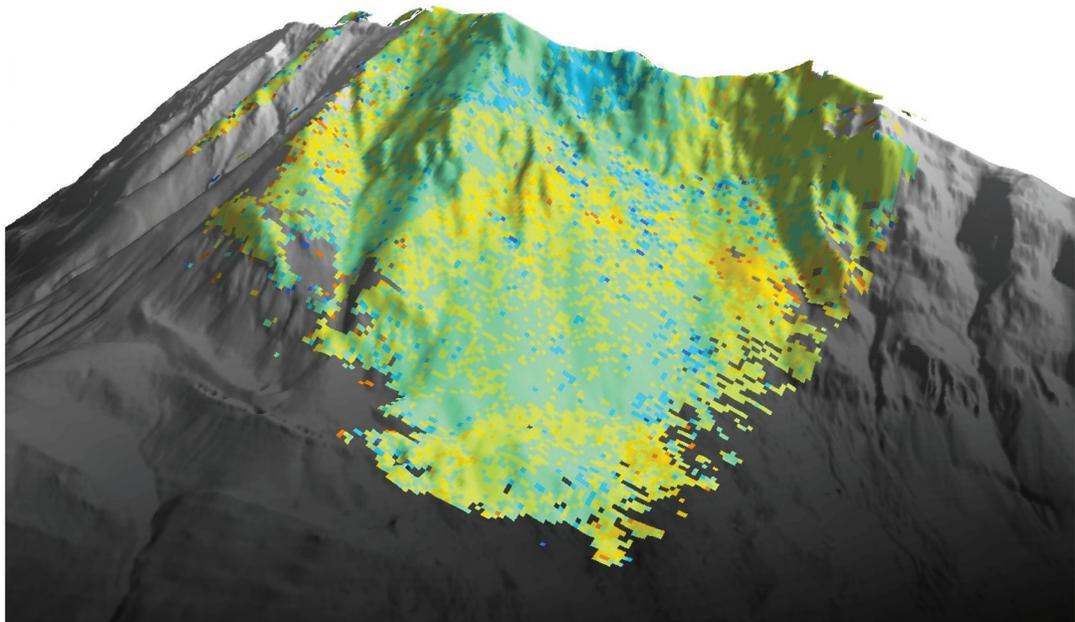
Total displacement towards the instrument during the same time period with satellite-based InSAR in 2011 (May 30–June 17, 2011) is shown in Figure 13. Note that during those few weeks in 2012, most of the toward-satellite motion appears to be occurring on North Peak rather than on South Peak. Since we only have a few weeks of data for 2012, further comparisons would be difficult to make. Although the radar head calibration problems in 2012 and the limited size of the dataset make it difficult to draw reliable conclusions, these results are consistent (both in location and deformation rate) with the South Peak instability that has been observed previously (Humair et al., 2011; Moreno and Froese, 2012). GB-InSAR measurements will be repeated in 2013 with the recalibrated radar head to obtain a full summer of observations; we will then see if those results are consistent with what was observed in 2011.

Figure 13. Displacement between May 30 and June 17, 2011 measured using satellite-based InSAR data. Note that no obvious displacement is occurring on the South Peak, whereas a displacement towards the instrument of a few millimetres has occurred on North Peak.
