OPEN FILE REPORT 1959-6

DUNVEGAN LANDSLIDE

E.W. BROOKER

1959

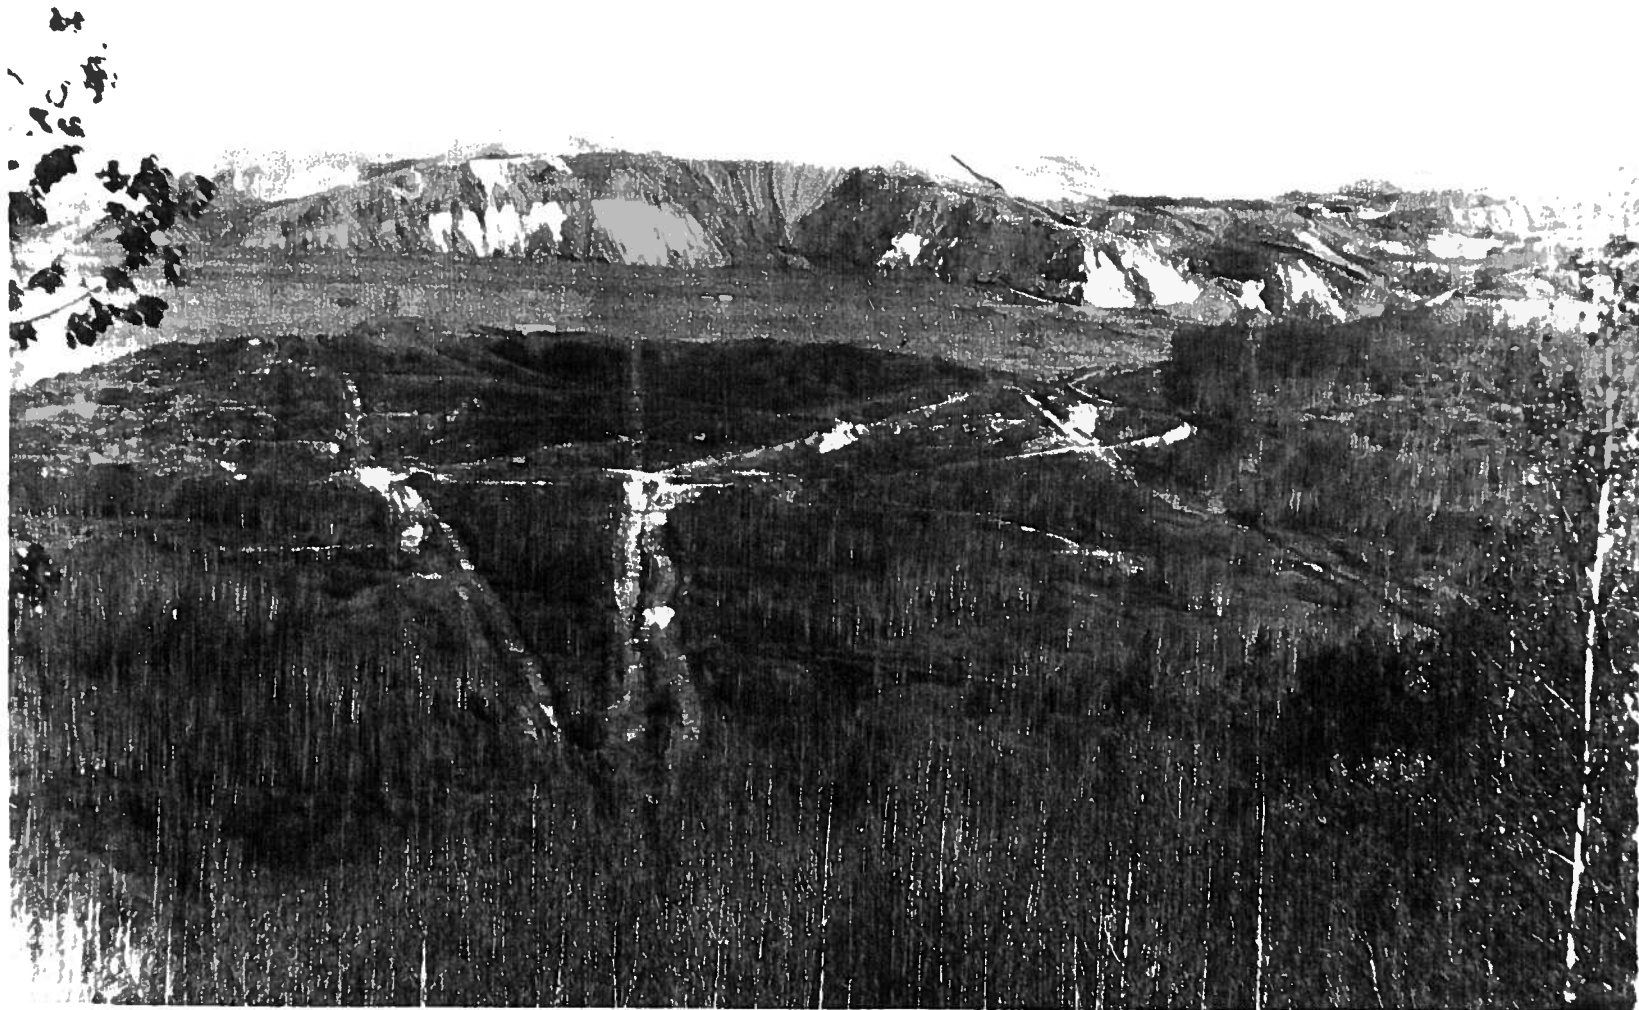
**Fig. 2**  
**(Same as Fig. 1 but closer)**

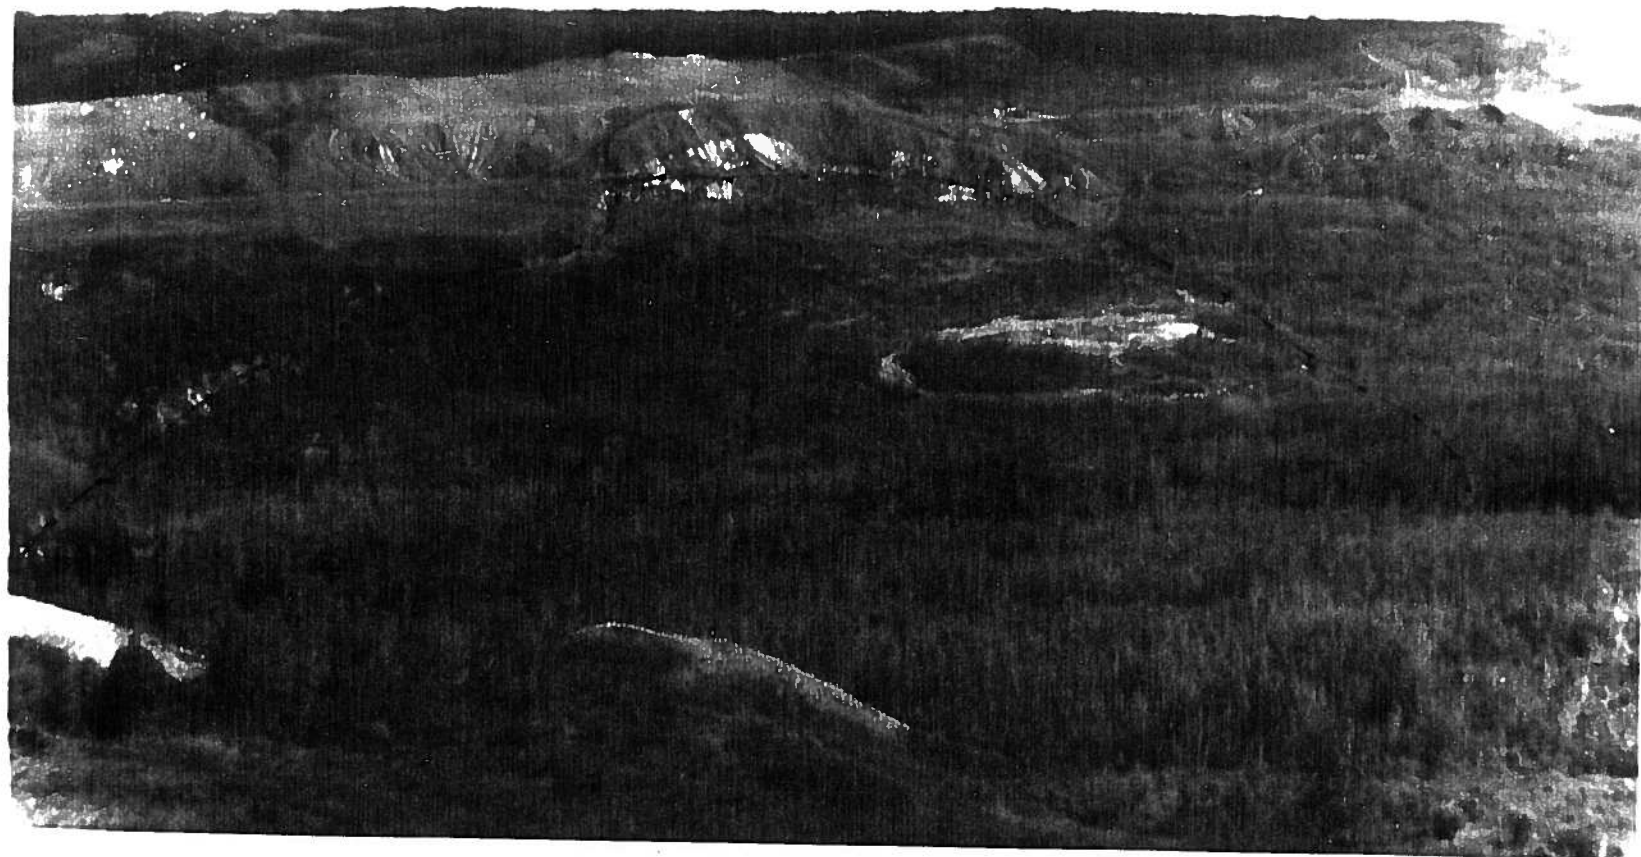
Examination of the slide area showed that there had been a seventy foot vertical drop of the grade. The crown of the slide was at the top of the fill against the natural ground. The ground below this was extremely broken and rugged as evidenced by the photographs.

At the north flank of the slide there was a vertical displacement of some thirty feet. Along the south flank the ground is again broken and cracked. Between the flanks there is an extensive network of cracks averaging about three feet wide and twenty feet deep.

**Fig. 3**  
**View of landslide after slide of May 1959.**  
**Note broken line shows boundary of slide.**

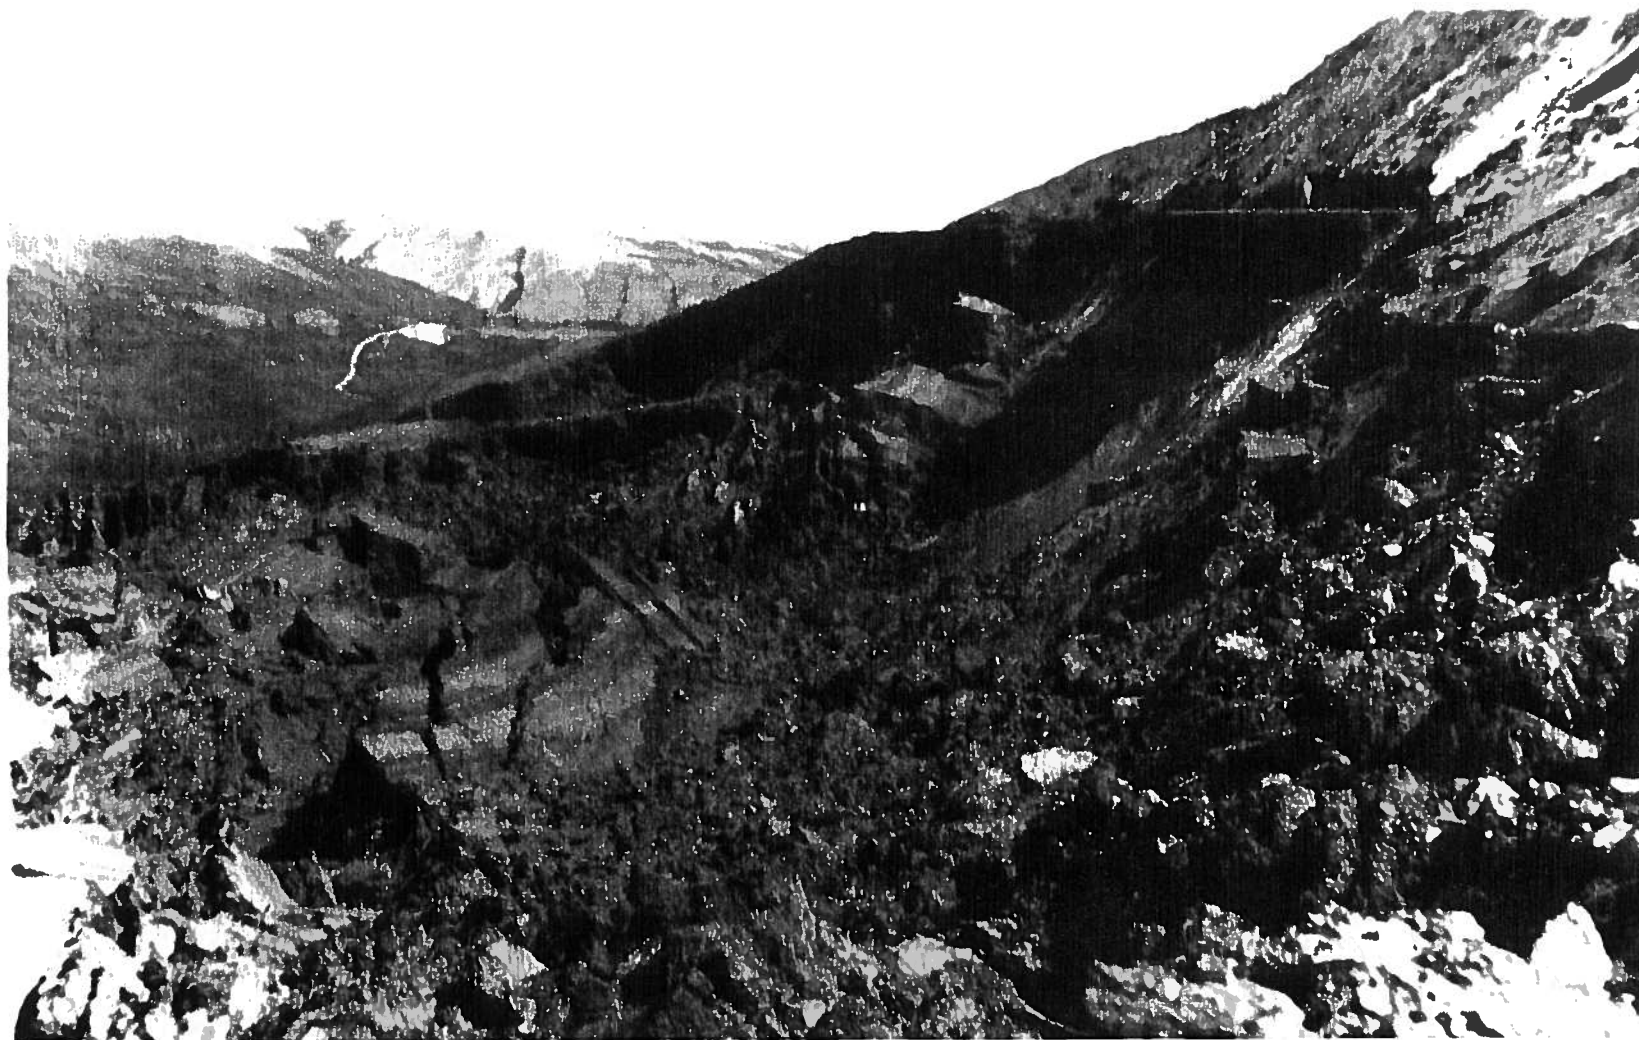
Fig. 4  
Looking south into slide escarpment.  
Man standing on original highway grade.

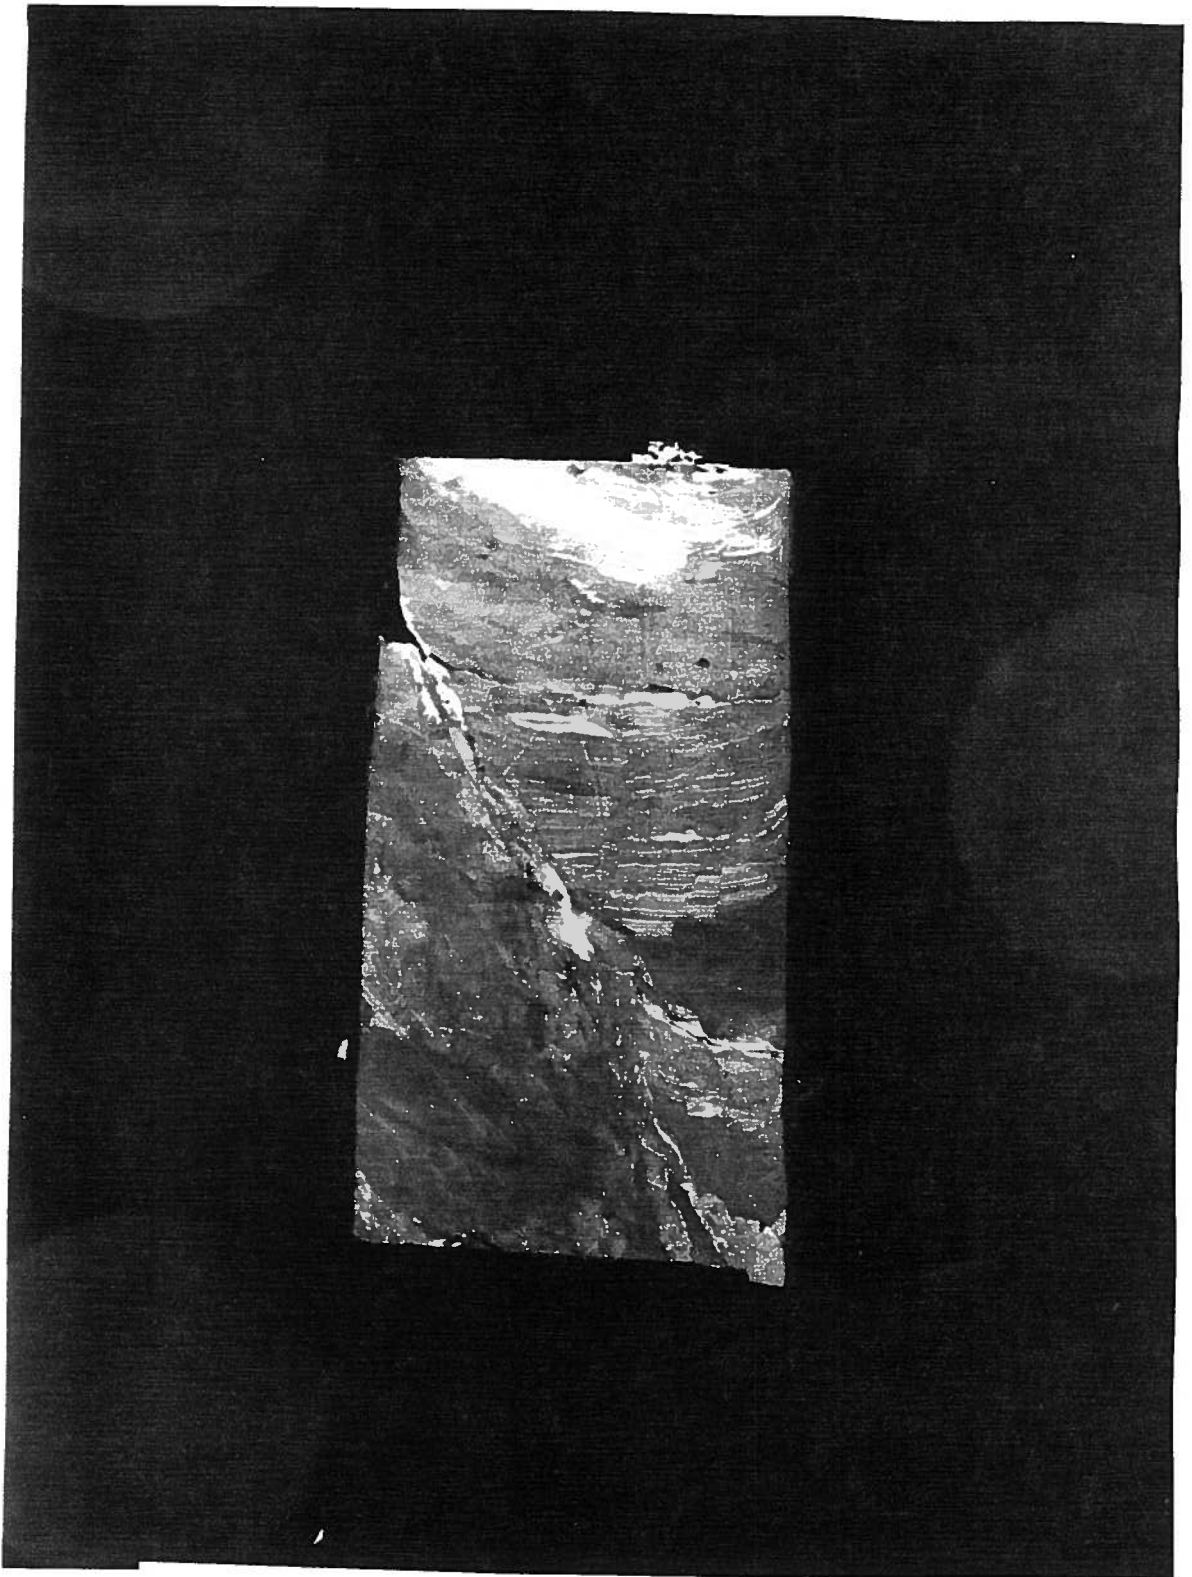
It is interesting to note the triaxial specimen tested (Photo 9). A seam of silty-fine sand will be observed along the plane of failure of the specimen. The importance of this is that, by luck, both samples tested displayed this characteristic and this parallels exactly the conditions prevailing in the field at the time of failure. It will be noted on Fig. 14 the surface of failure passed through semi-continuous layers of material identical in plasticity characteristics with that found in the lab specimens. One of the specimens tested gave an unusually high strength (Fig. 12). Upon slicing the subsequent examination of this specimen, no indication of such a plane of weakness was observed. This would appear to demonstrate the effects of thin seams of silty sand on the strength of a soil mass.

The effective angle of internal friction found for the first two samples was  $20\ 1/2^\circ$ , which checks perfectly with observed field conditions and computations, whereas the specimen in which no faults existed, displays a possible angle of internal friction of  $30^\circ$ . The latter angle is highly inconsistent with the probable field conditions.

Fig. 6  
Failed sample from Triaxial compression test.  
Note the plane of failure  
is in a pre-existing slit seam.

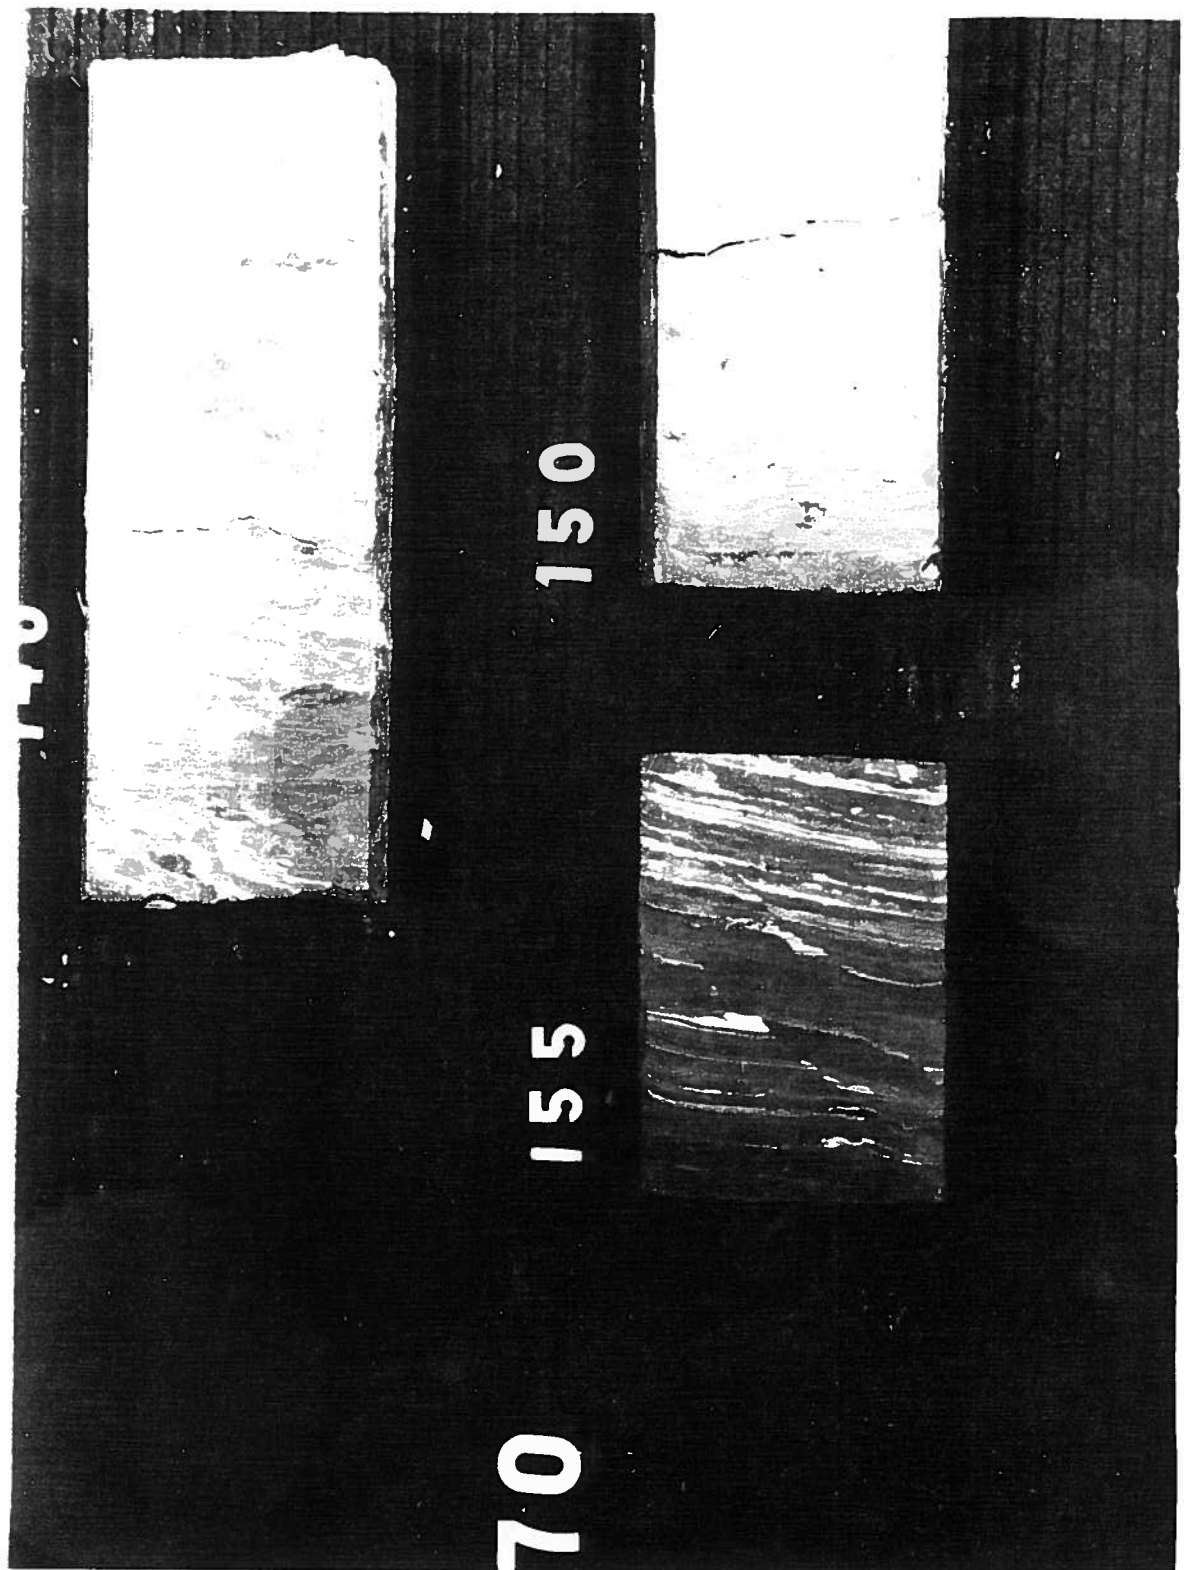
Fig. 8  
Sliced samples from  
Test Hole 70 Depth 140-155 ft.  
Note laminations and slickensides.

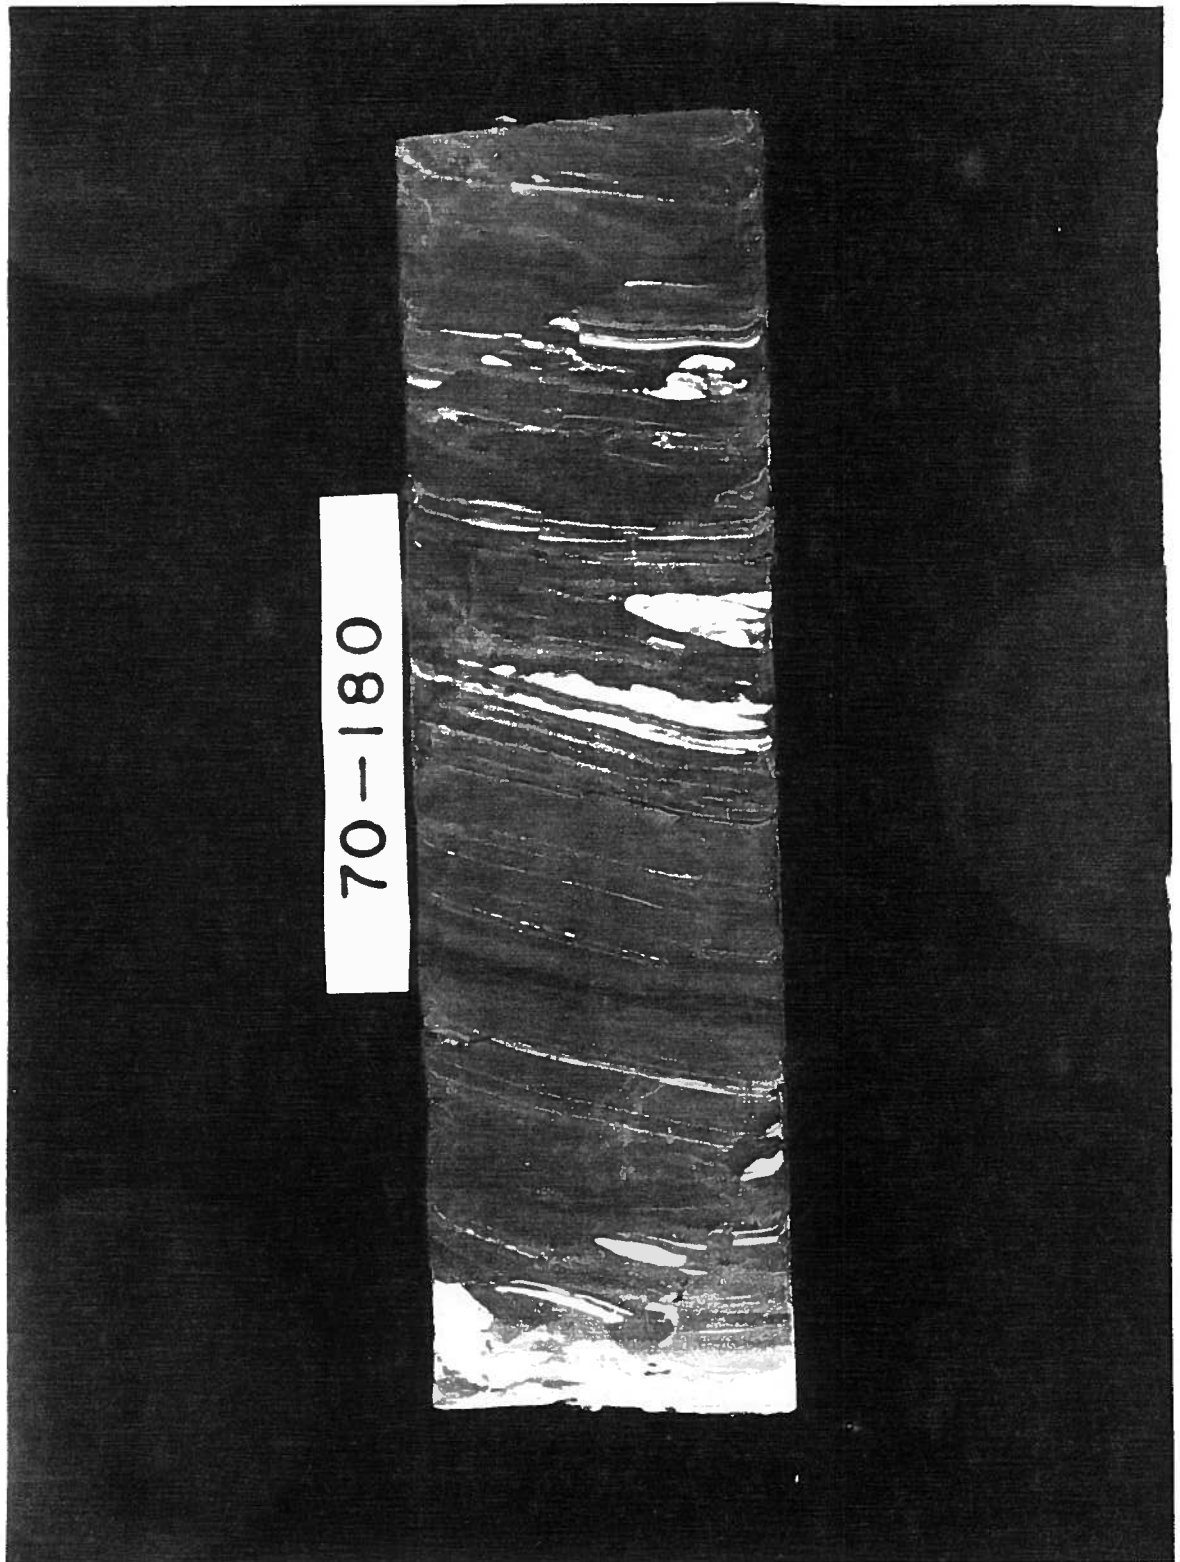
These borings were advanced into soft sandstone about ten feet and indicate the overlying material to be overconsolidated stiff laminated clay shales of medium to high plasticity, containing slicken-side and fissures. This material is interbedded with thin silt layers of low plasticity and seams of fine to medium sand varying in thickness from about one-half inch to two feet. The materials show inclination of strata (Figs. 6 - 9), and indicate previous geologic disturbance resulting in fissures. It is interesting to note that evidence of previous disturbance can be found at depths of 180'.

Fig. 9  
Sliced samples from  
Test Hole 70 depth 180 ft.  
Note dip of laminations and  
slickensides even at this depth.

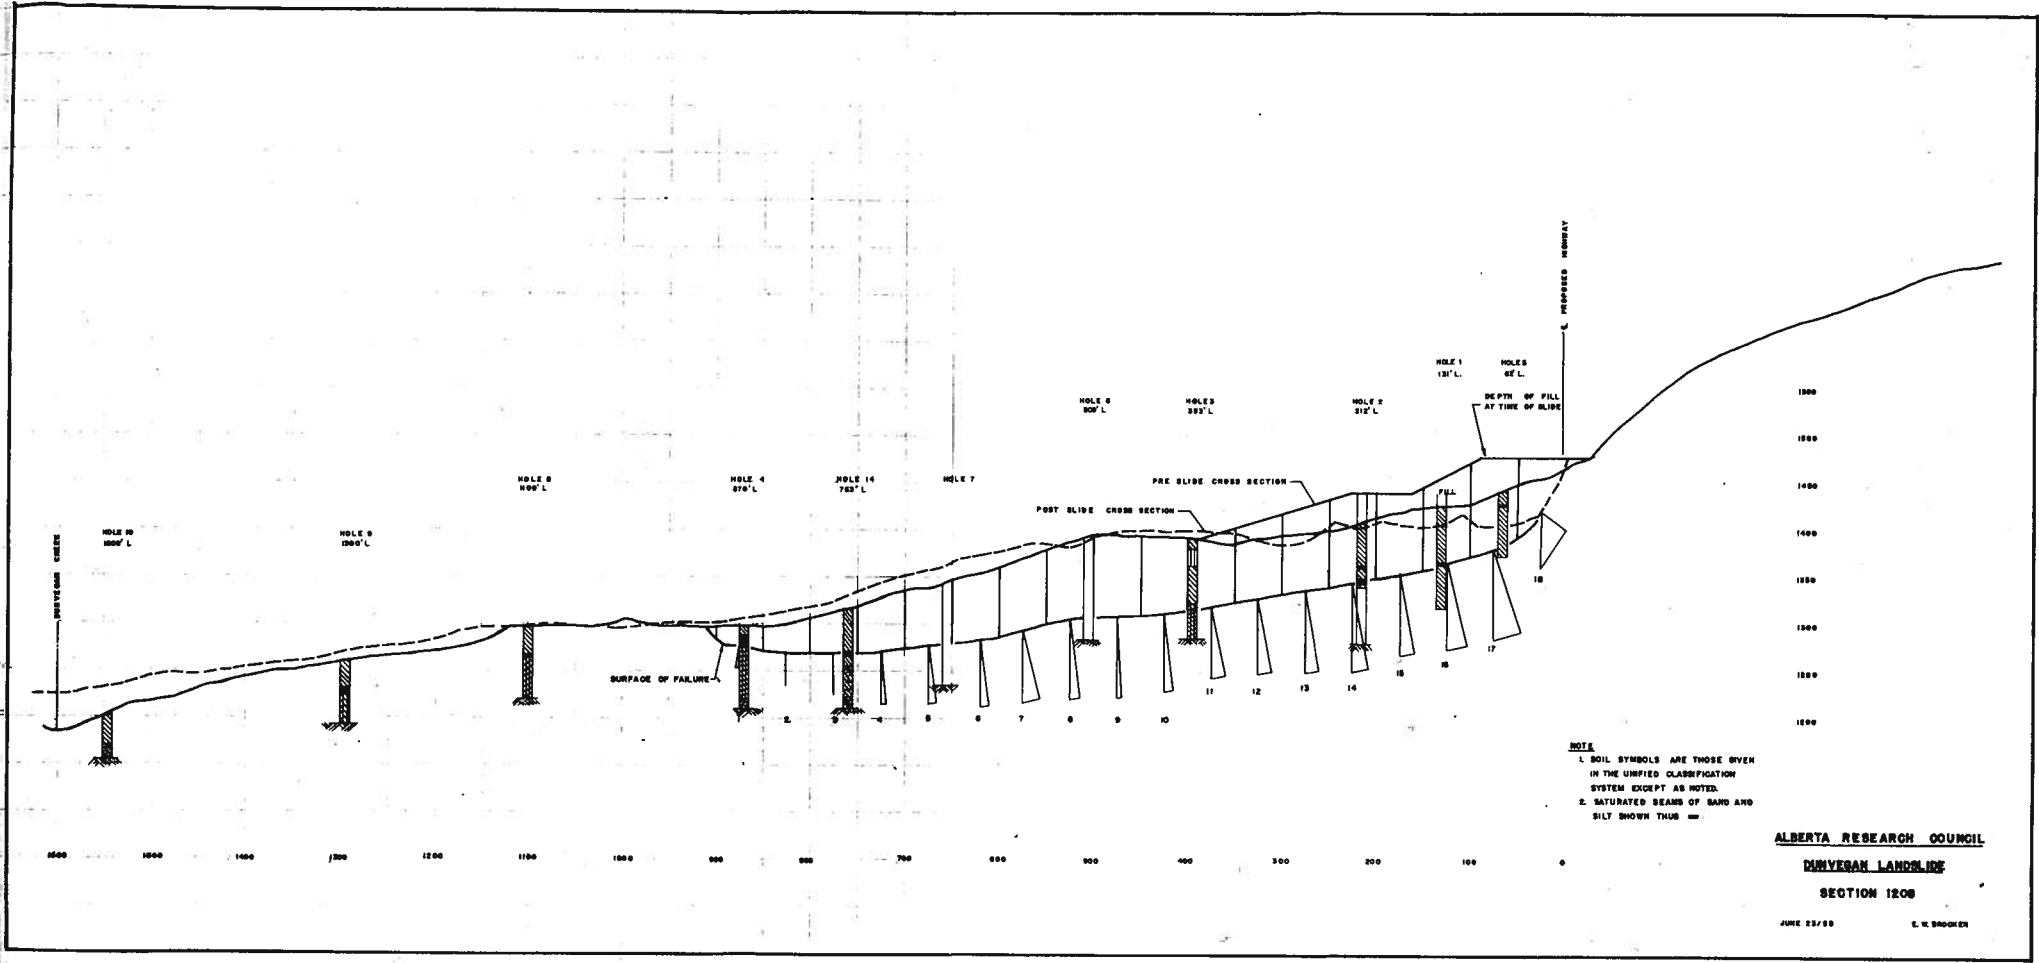
**ALBERTA RESEARCH COUNCIL**  
**DUNVEGAN LANDSLIDE**  
**SECTION 1200**  
 JUNE 23/59 C. W. BROOKER

The use of these same cased holes as probe wells was, however, of greater reliability and by using 1/2" O.D. coupled rods as a probe, the depths at which sliding occurred was found on line 1208+04 (Fig. 14).

The most comprehensive and reliable data was gathered from test holes along line 1208 (Fig. 14). Examination of these test holes shows that the surface of failure passes through and/or along successive seams of saturated, silty fine sand. It is significant that at the location of the proposed drainage trench a toe was first evident. The bottom of this trench was in a quicking condition when the major slide movements took place.

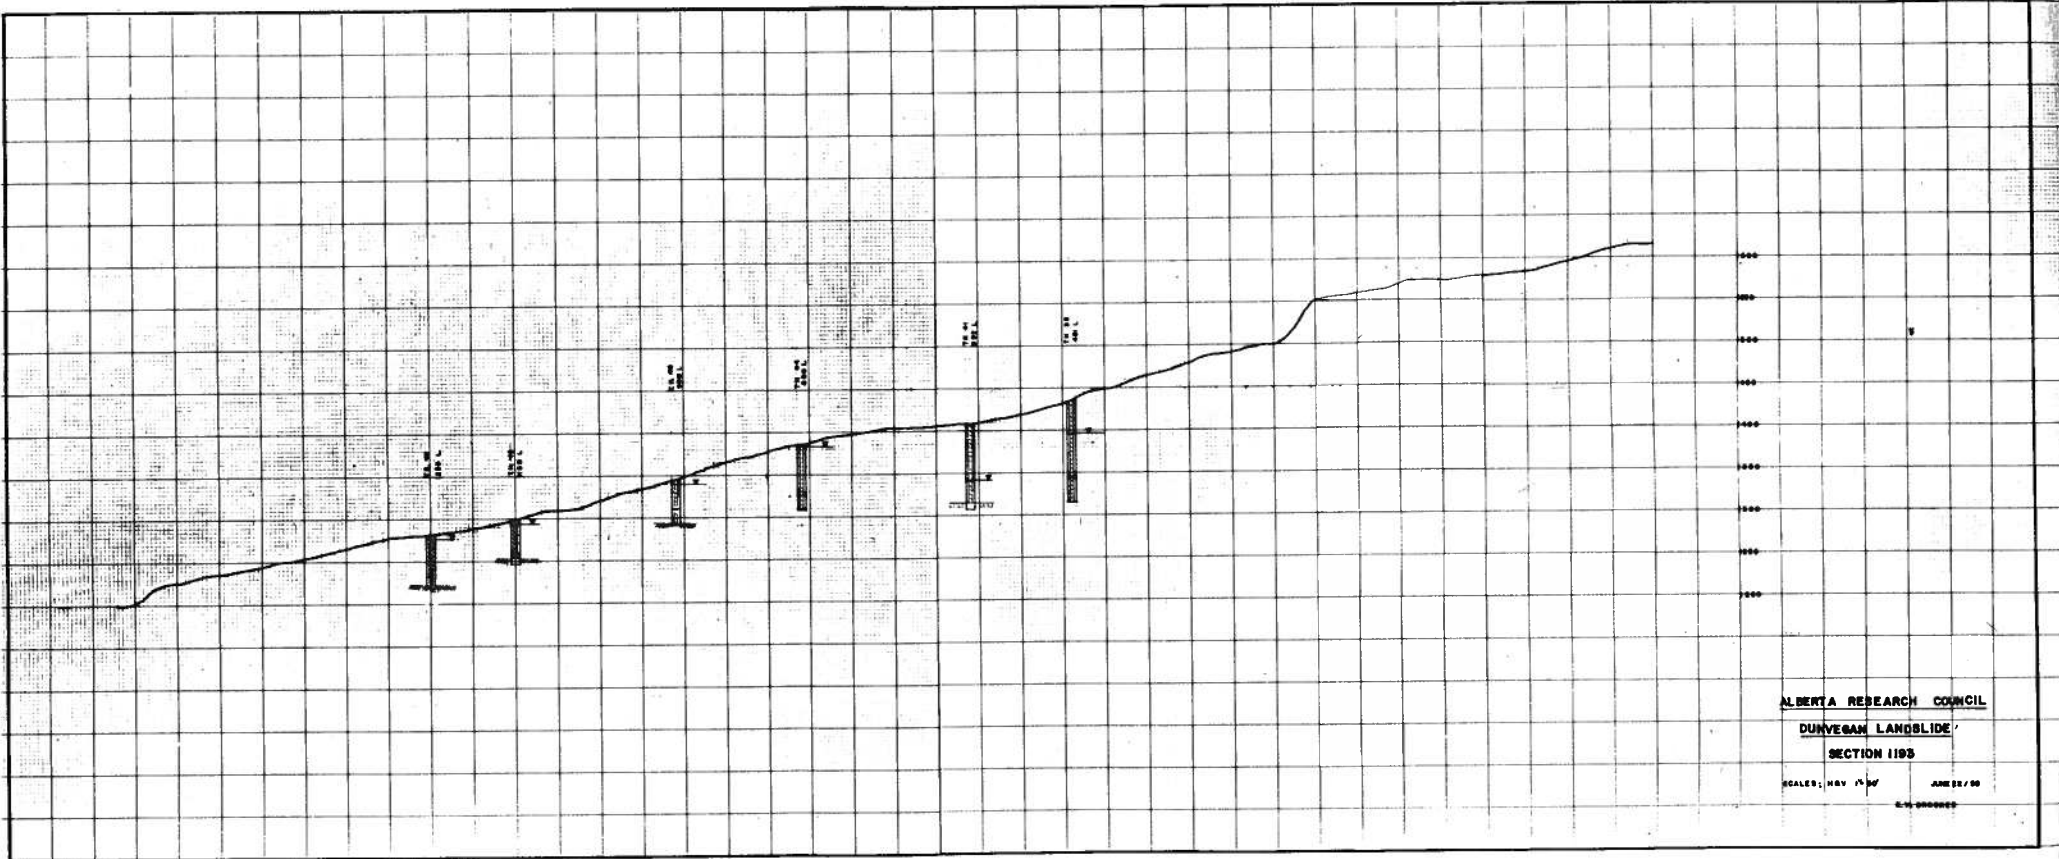
ALBERTA RESEARCH COUNCIL  
 DUNVEGAN LANDSLIDE  
 SECTION 1193  
 SCALE: H.V. 1" = 50'      ANS/2/50  
 S.M. 0000000

Examination of test wells along line 1193 directly adjacent to the primary slide area on the south revealed the water conditions as outlined in Table I. The distances from the proposed highway center line to these holes were obtained from existing survey stakes while the elevations were obtained from a line of trigonometric levels run for the purpose of obtaining the ground cross-section of line 1193. It is evident from these data that from distances 592 to 1245 feet left of center line the ground water table is, for all practical purposes, at the ground surface. In contrast no other observation wells established in the primary slide area showed this condition. This conflict may be explained by the fact that all observation wells on line 1193 were established during the late summer of 1958 while most other wells were established in the spring of 1959. Experience has shown that considerable time is often required before open test holes reflect the true ground water conditions.

There has been an element of doubt that the water in the test holes along line 1193 actually displays the true piezometric levels, or if it is actually from the surface run-off filling the holes. There are several strong arguments in favour of the former condition as follows:
