TOUR OF THE HIGHVALE
OPEN PIT COAL MINE
JUNE 2, 1985
CIM-CSPG CONFERENCE

FIELD TRIP GUIDEBOOK NO. 1

THE PETROLEUM SOCIETY OF CIM AND
CANADIAN SOCIETY OF PETROLEUM GEOLOGISTS
JOINT CONFERENCE
EDMONTON, ALBERTA 1985

Open File Report 1985-7

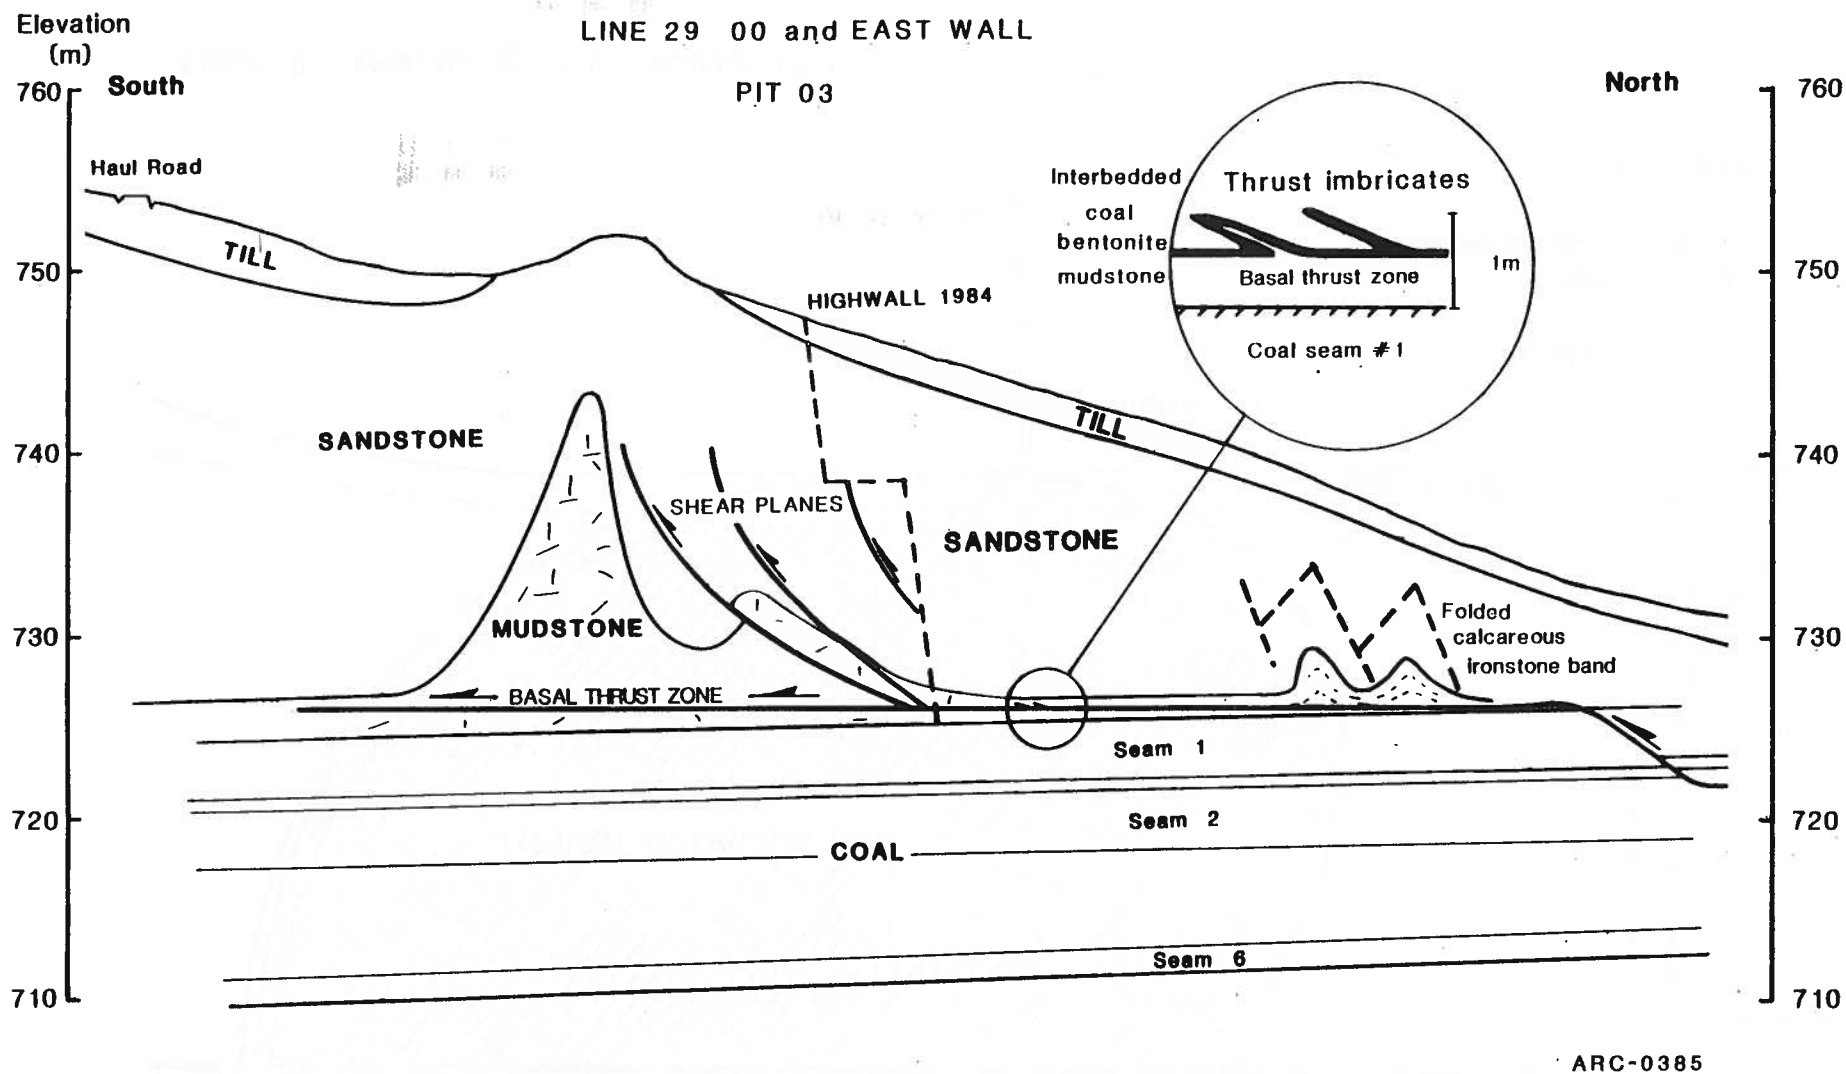
Geologic studies reveal the area to be deformed. The schematic cross-section (figure 10) shows the general structural setting near ramp 3-1. The bedrock sequence has been folded and faulted by compression and thrusting directed generally toward the south. Large scale folds and faults have been exposed in the east face of the pit and the small pit southeast of ramp 3-1 and small scale deformation features are common (Fenton et al. 1983 and Nikols, 1985).

Figure 10. Schematic cross-section along ramp 3-1 and test line 29+00 showing deformation.

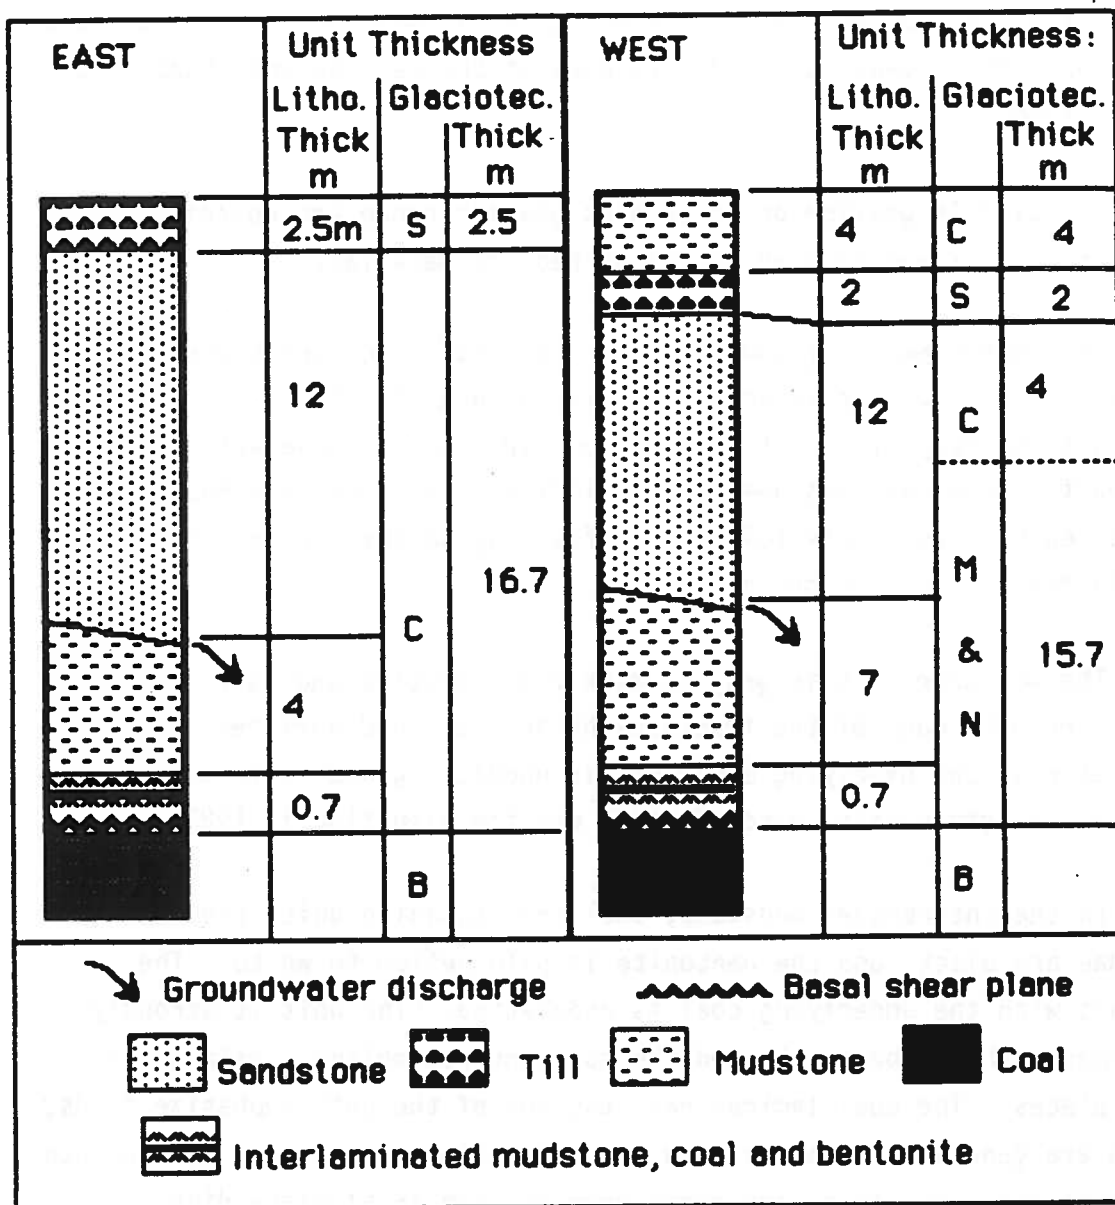
The stratigraphy exposed in the cuts above and below the bench (figure 16) show a relatively thin (0 to 3 m) till unit, overlying a thick sandstone unit. The till is overlain by thrust bedrock material in the western portion. The sandstone rests directly on the mudstone in the east half of the area. The mudstone overlies a unit, about 1 m thick consisting of mudstone with laminae of bentonite and coal. This

Figure 16. Lithologic and glaciotectionic units exposed in the south wall of Pit 03 between ramps 3-1 and 3-2.

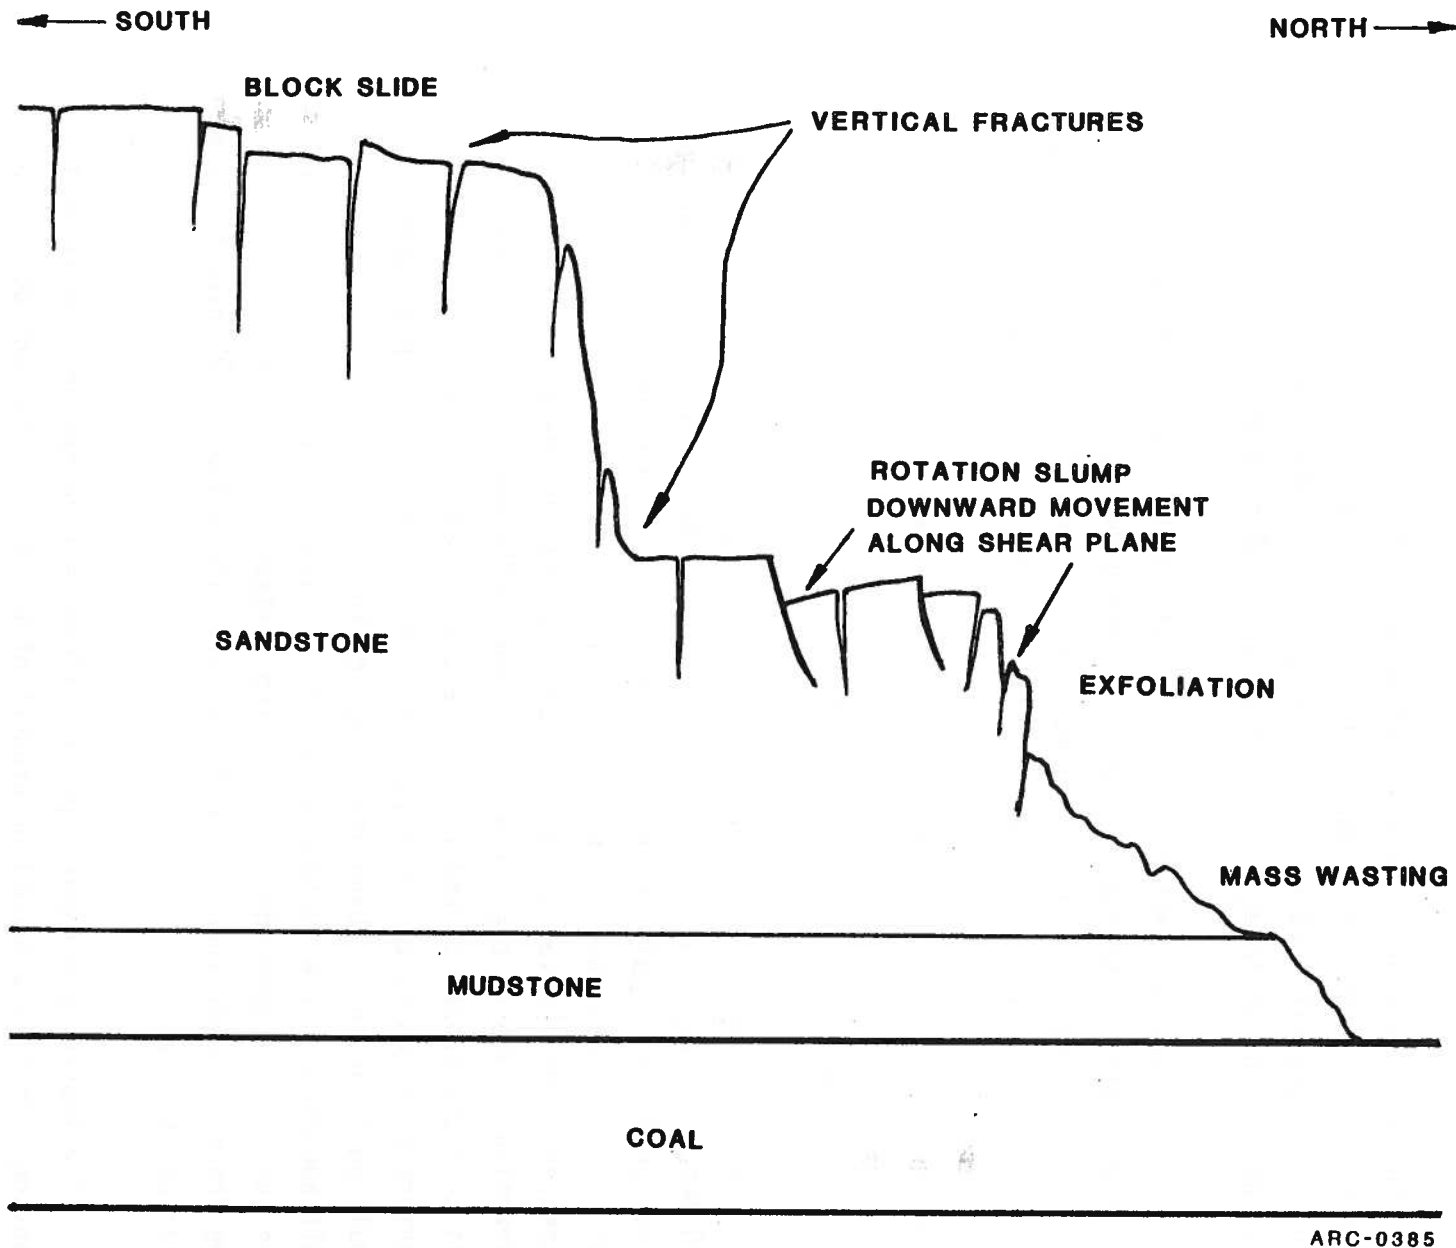
The surface manifestation of the failures is shown in figure 17. The first exfoliation consists of the falling away of sheets or slices of the sandstone about one to three metres thick. The vertical fractures are a series of cracks, likely due to stress release, that trend approximately parallel to the face and develop over the area between ramps 3-1 and 3-2 extending into the area at least 50 m back from the upper edge of the pit face. The fracture extends to depths of more than 4 m and width increases with time.

Figure 17. Schematic drawing of observations data on the failure at the east end of Pit 03 highwall.

Any model to explain the failures in the highwall of Pit 03 between ramps 3-1 and 3-2, must take in account the above observations summarized in figure 17: the highwall failure is composite, the product of a series of smaller failures of a variety of types consisting of exfoliation, mass wasting at the toe, rotational slump, and block slide. The last two types are of major importance because they involve the failure of large volumes of sediment and the destruction of the bench and adjacent land surface.

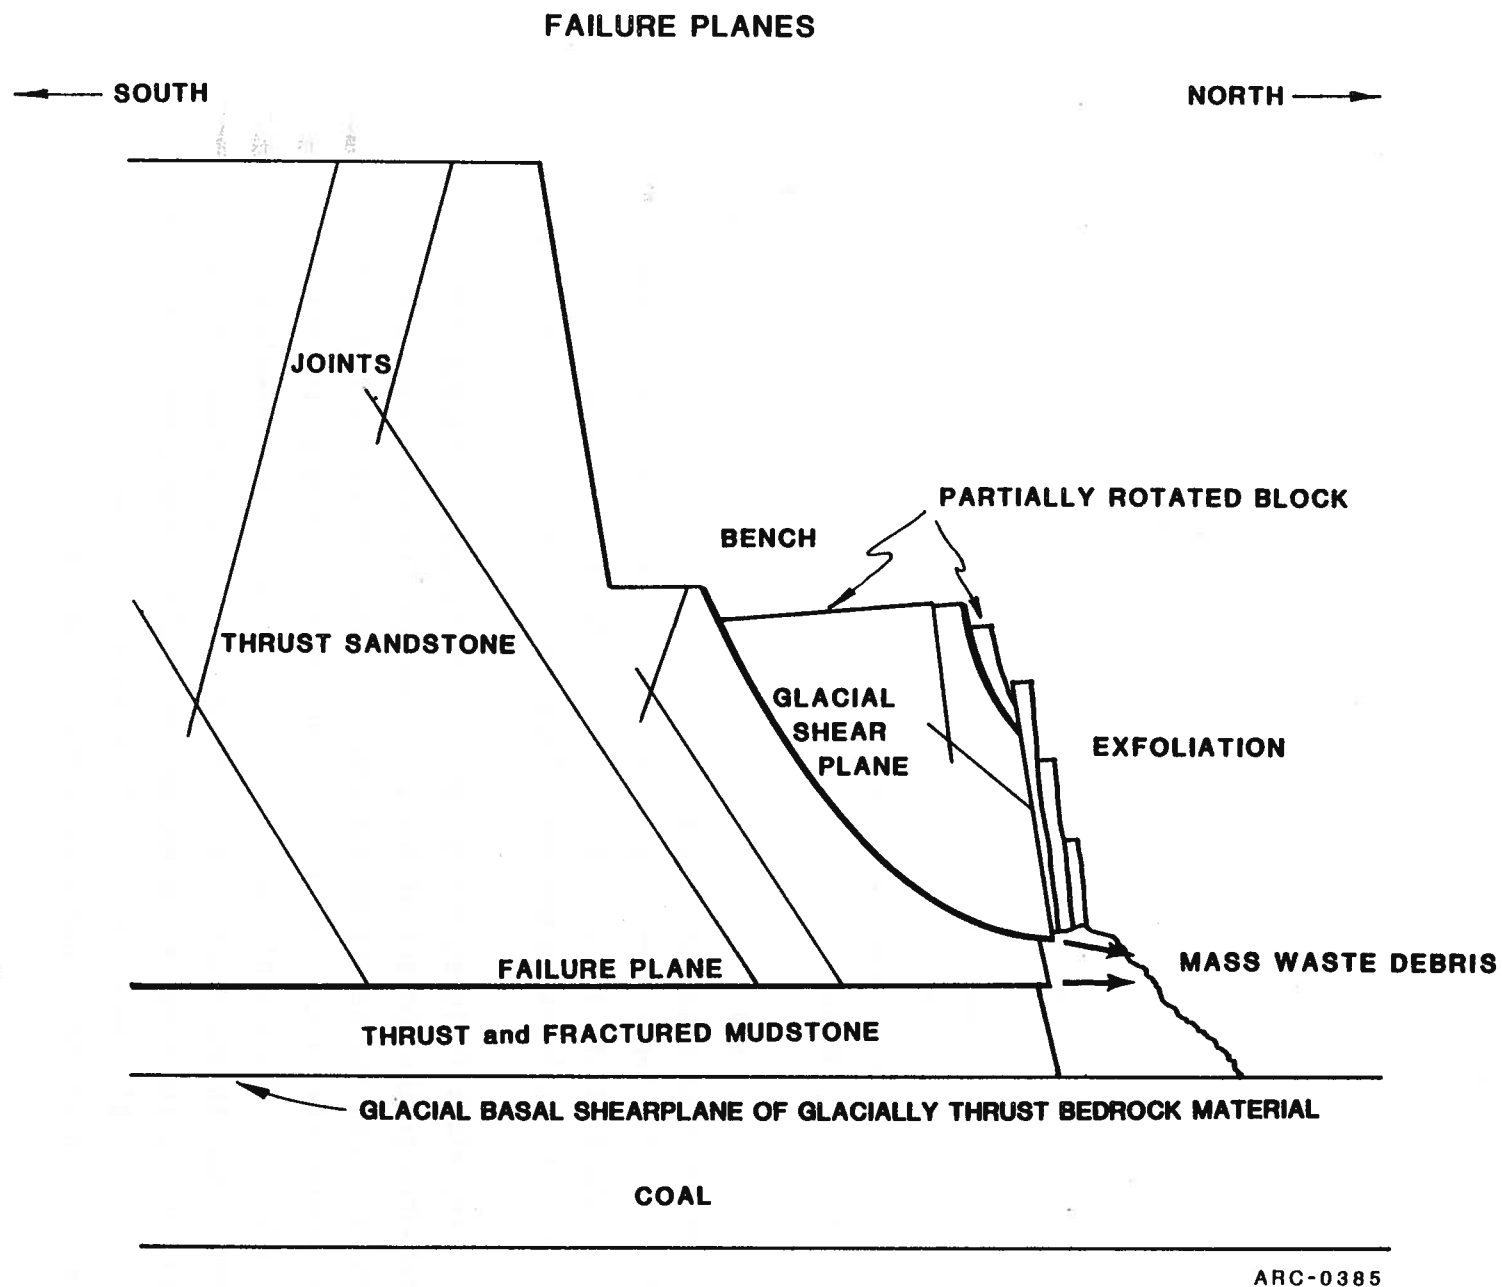
The rotational slumps, particularly the large ones are likely the result of remobilization of pre-existing glacial shear planes (figure 18). Some, particularly the small ones may form spontaneously as a result of the low strength of the sandstone. Groundwater contributes at least to the remobilization of the relict shear planes.

The block failures are believed to be caused by elevated water pressures at the contact of the sandstone and fractured mudstone units compounded by the saturated and weakened condition of the overlying sandstone, the latter conditions produced by the glacial thrusting and saturation. The dip of the contact toward the pit undoubtedly also contributes to the block sliding (figure 10). The vertical fractures manifesting the block slide may be the result of the slide itself but are more likely due to opening of pre-existing joints, or perhaps a combination of joints and shear planes (figure 18).

Figure 18. Model for the failure east end of Pit 03 highwall.
