Turtle Mountain Field Laboratory, Alberta (NTS 82G): 2011 Data and Activity Summary

AER/AGS Open File Report 2013-18

F. Moreno, J. Pearce, and C.R. Froese

Alberta Energy Regulator
Alberta Geological Survey

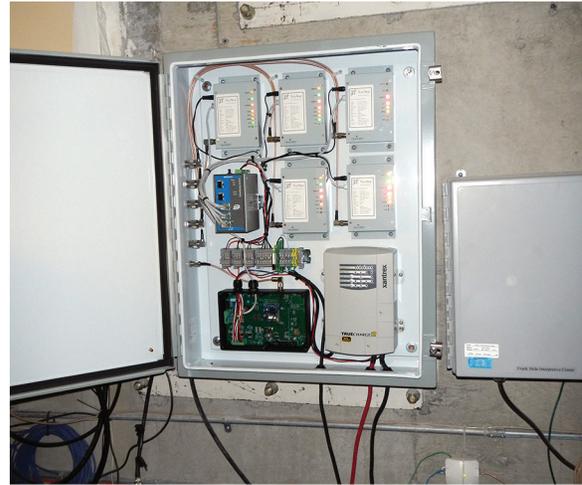
Figure 3. TMMS communication equipment located in the FSIC attic a) before and b) after reconfiguration.

Intelligent power management devices (WMA100 units) were installed at the FSIC, dGPS, and South Peak radio sites. These power management devices are capable of

Having the communication intelligently managed by the power manager allows for a truly redundant dGPS communication infrastructure. Without these devices, there was a possibility of data loss if one data communication link failed.

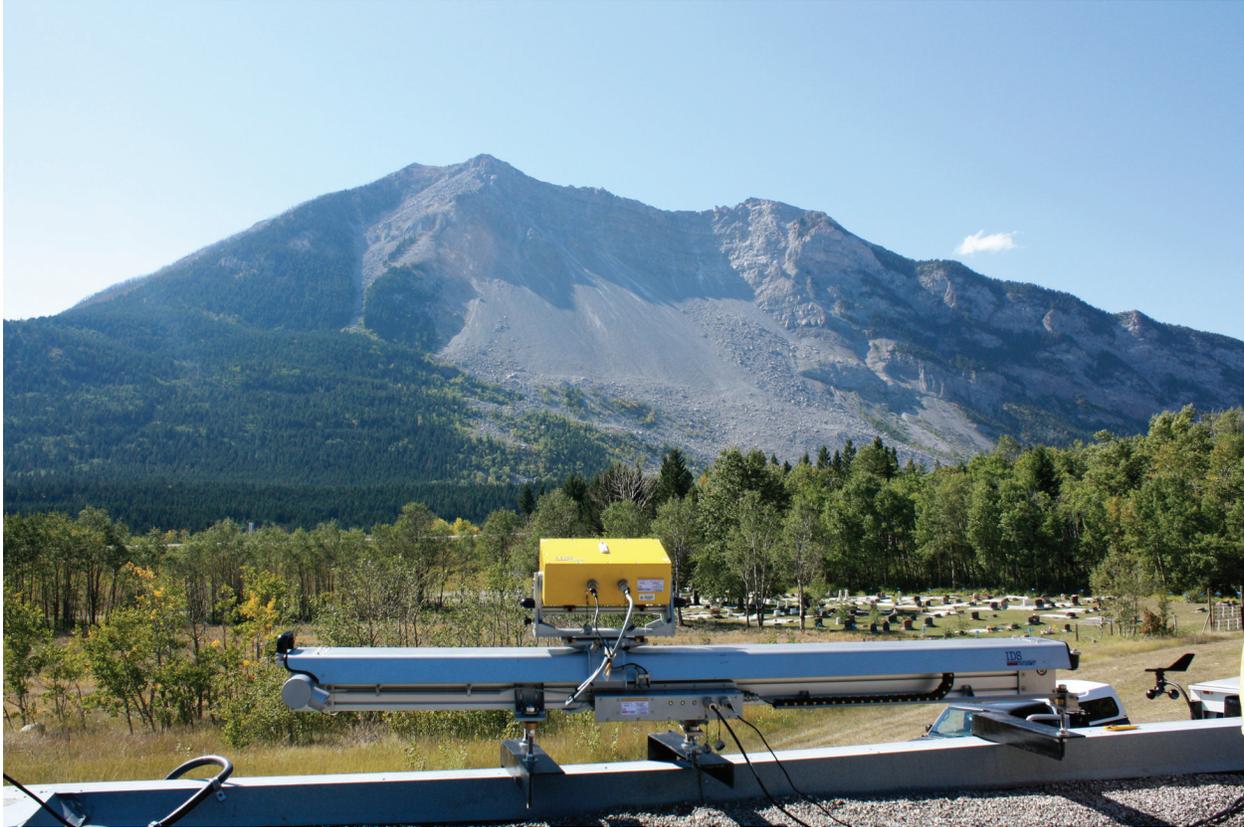
Figure 15. The IBIS system installed in front of Turtle Mountain. The maximum distance from the radar head to the furthest point on the mountain face is about 2.9 km.

In April 2011 we installed a ground-based interferometric synthetic radar (GB-InSAR, also called IBIS) device for monitoring small displacements on the east face of the mountain. Since the instruments at the top of the mountain are vulnerable to lightning strikes and require frequent maintenance or replacement, a ground-based radar system provides a continual means of observing the mountain face remotely. It is much less likely than the mountain-top instruments to be struck by lightning, and maintenance can be performed without climbing the mountain. We installed the system on the roof of a pumphouse located just under 3 km east of the base of the mountain (see Figure 15).

IBIS is built by Ingegneria Dei Sistemi (IDS) in Italy and can measure small displacements at each point on the mountain face with accuracies of up to 0.1 mm. The radar head is mounted on a 2 m horizontal rail and it slides slowly across the rail (each sweep lasts about 2 minutes), then returns and begins a new

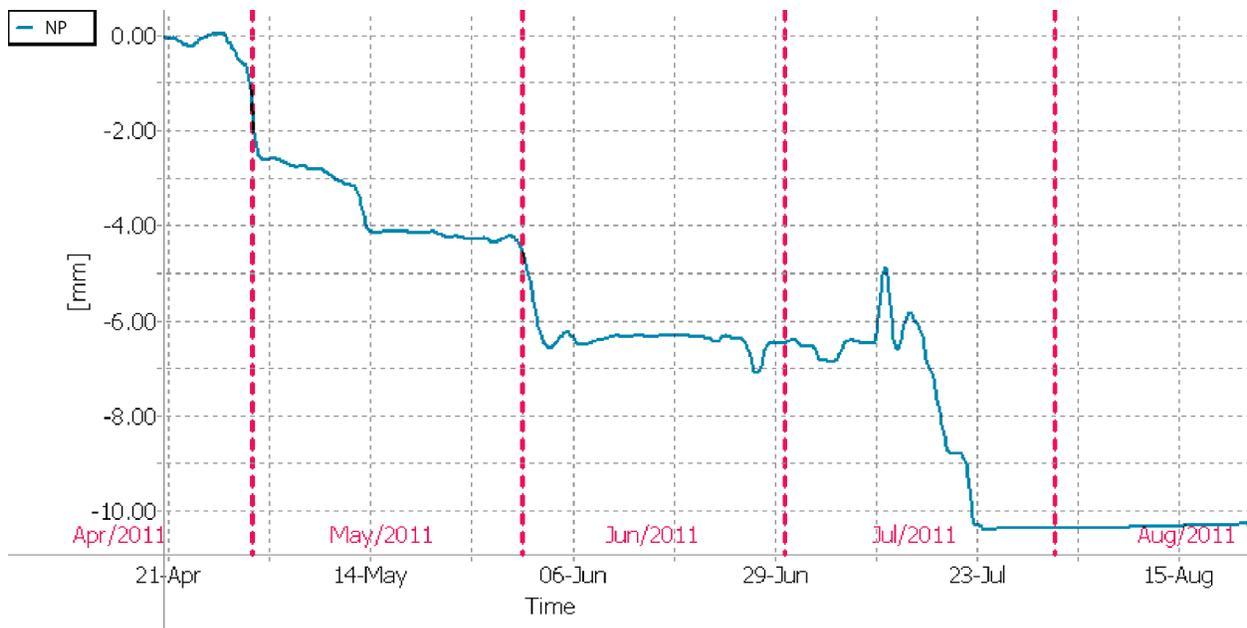
Figure 17. Time history of displacement averaged over the North Peak unstable area (NP) in the previous figure. Note that data collection was interrupted due to technical difficulties with the IBIS instrument, so displacement was not measured after July 25, 2011. Displacements are in millimetres, with negative displacements indicating motion towards the instrument.

Average displacement as a function of time for the North Peak unstable area is plotted in Figure 17. Most of the displacement appears to be occurring over short discrete intervals with long periods of stability in between. Although the velocities appear large in those intervals, a plot of velocity as a function of time (Figure 18 shows that the maximum velocity reached over the entire four-month interval is about 0.04 mm/hour, or about 1 mm/day).
