**Turtle Mountain Field
Laboratory, Alberta (NTS 82G):
2016 Data and Activity
Summary**

AER/AGS Open File Report 2018-07

D.E. Wood, J.A. Yusifbayov, D.K. Chao and T.C. Shipman

July 2018

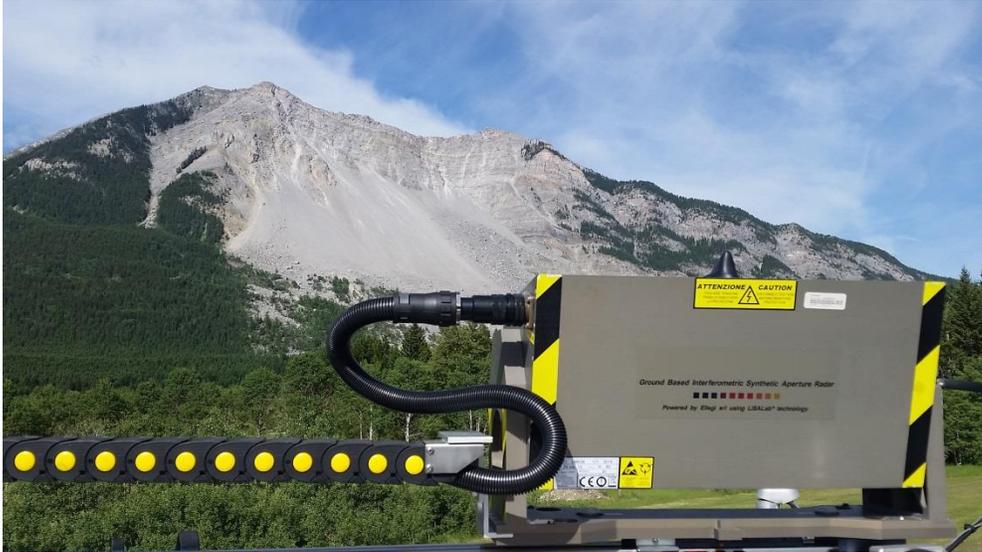
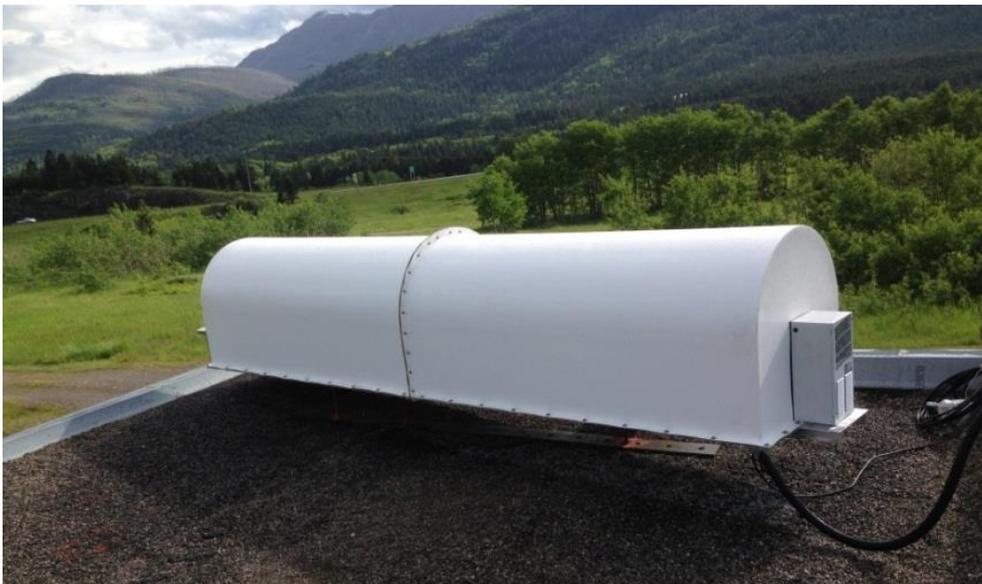
Figure 3. a) LiSAmobile system without radome and temperature regulation unit; b) LiSAmobile system assembled with the radome.

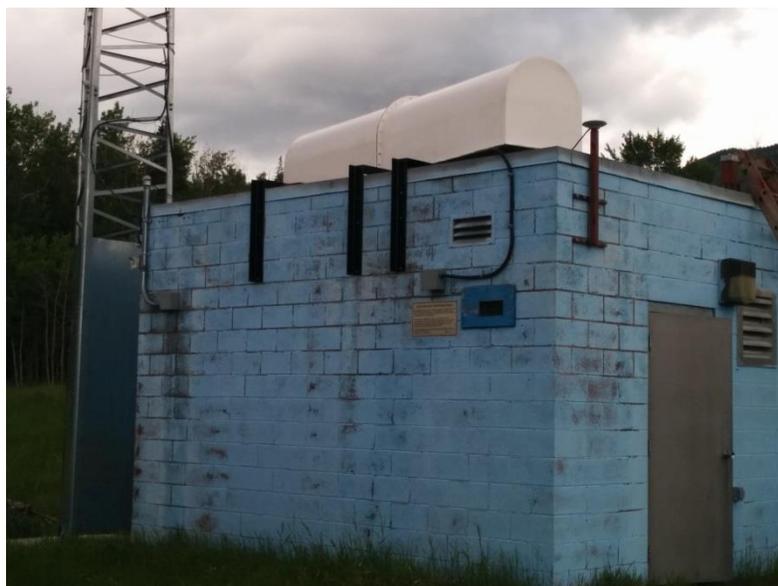
Figure 4. LiSAmobile system at the Bellevue pump house station.

LiSAmobile was installed at the Bellevue pump house (Figure 4) in June 2014 to monitor small displacements on the eastern face of Turtle Mountain. The LiSAmobile GB-InSAR uses the interferometric synthetic aperture radar technique to measure small displacements at each point on the surface of the mountain.

LiSAmobile consists of two main parts: the radar head and mechanical components. The radar head is an active radar sensor that transmits microwave pulses towards an object and receives in return a backscattered signal (Figure 5). The radar head, which consists of two antennas (transmit and receive), is attached to a linear positioner (cradle) mounted on a horizontal track. The travel distance of the radar head along the track can be adjusted to allow for optimal scanning coverage of the mountain face. The radar head travels back and forth along the 2.5 metre track once every ~8.5 minutes.
