Turtle Mountain Field Laboratory, Alberta (NTS 82G): 2008 Data and Activity Summary

F. Moreno and C.R. Froese

Energy Resources Conservation Board
Alberta Geological Survey

September 2009

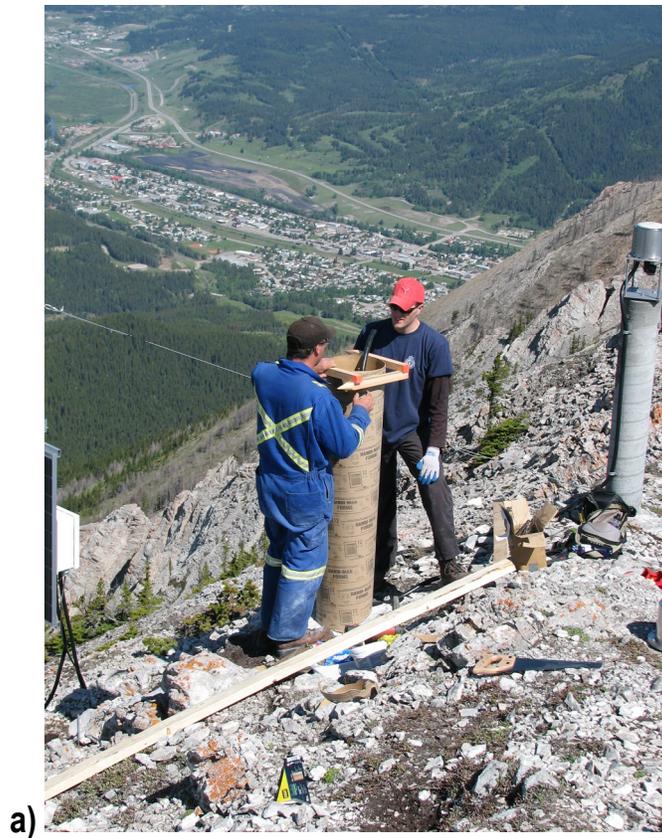
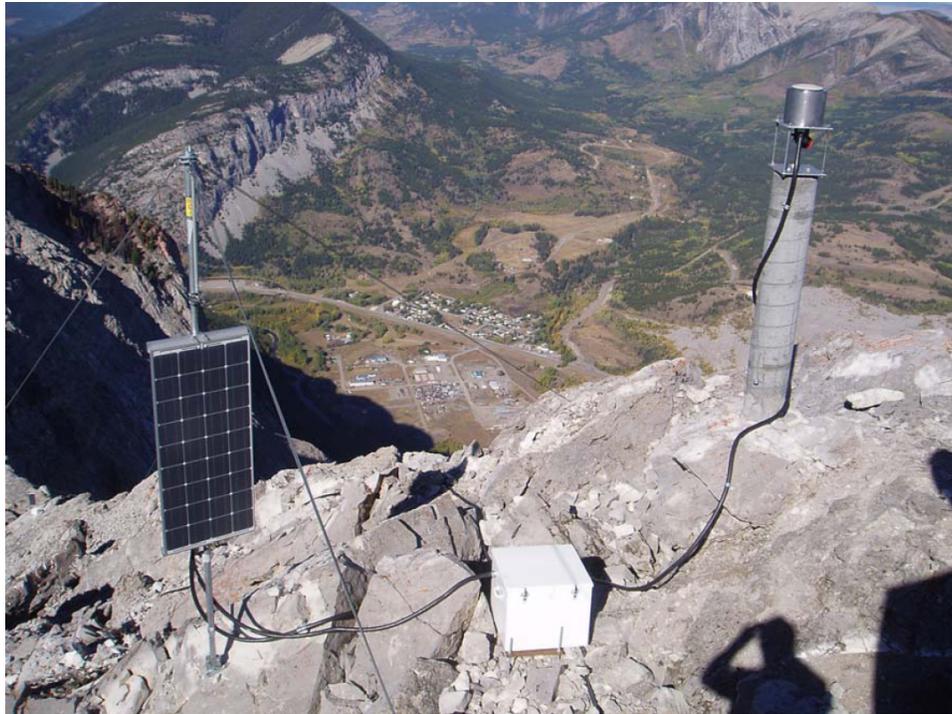
Each station comprises a reinforced concrete pillar mounted with a dual-metal-plate assembly and a fixed GPS antenna. Staff from McElhanney and AGS installed each of the concrete pillars on top of the mountain using materials transported to the site by helicopter (Figure 3). The GPS antenna is connected to a GPS data recorder and a wireless server inside a waterproof plastic enclosure, allowing true real-time communication. The enclosure, radio antenna and solar panel are attached to a guyed mast that is bolted to the rock outcrop. Deep-cycle marine batteries inside an insulated battery box (Figure 3) power each station.

Figure 3. a) Construction of GPS pillar at Third Peak station. b) Typical finished differential GPS installation on Turtle Mountain, showing concrete pillar with Novatel antenna (right), battery box (centre) and solar panel (left). Enclosure hidden behind solar panel. Photo: G. Bjorgan, McElhanney Consulting Services Ltd.
