Turtle Mountain Field Laboratory, Alberta (NTS 82G): 2010 Data and Activity Summary

F. Moreno and C.R. Froese

Energy Resources Conservation Board
Alberta Geological Survey

Moreno, F. and Froese, C.R. (2012): Turtle Mountain Field Laboratory, Alberta (NTS 82G): 2010 data and activity summary; Energy Resources Conservation Board, ERCB/AGS Open File Report 2011-03, 32 p.

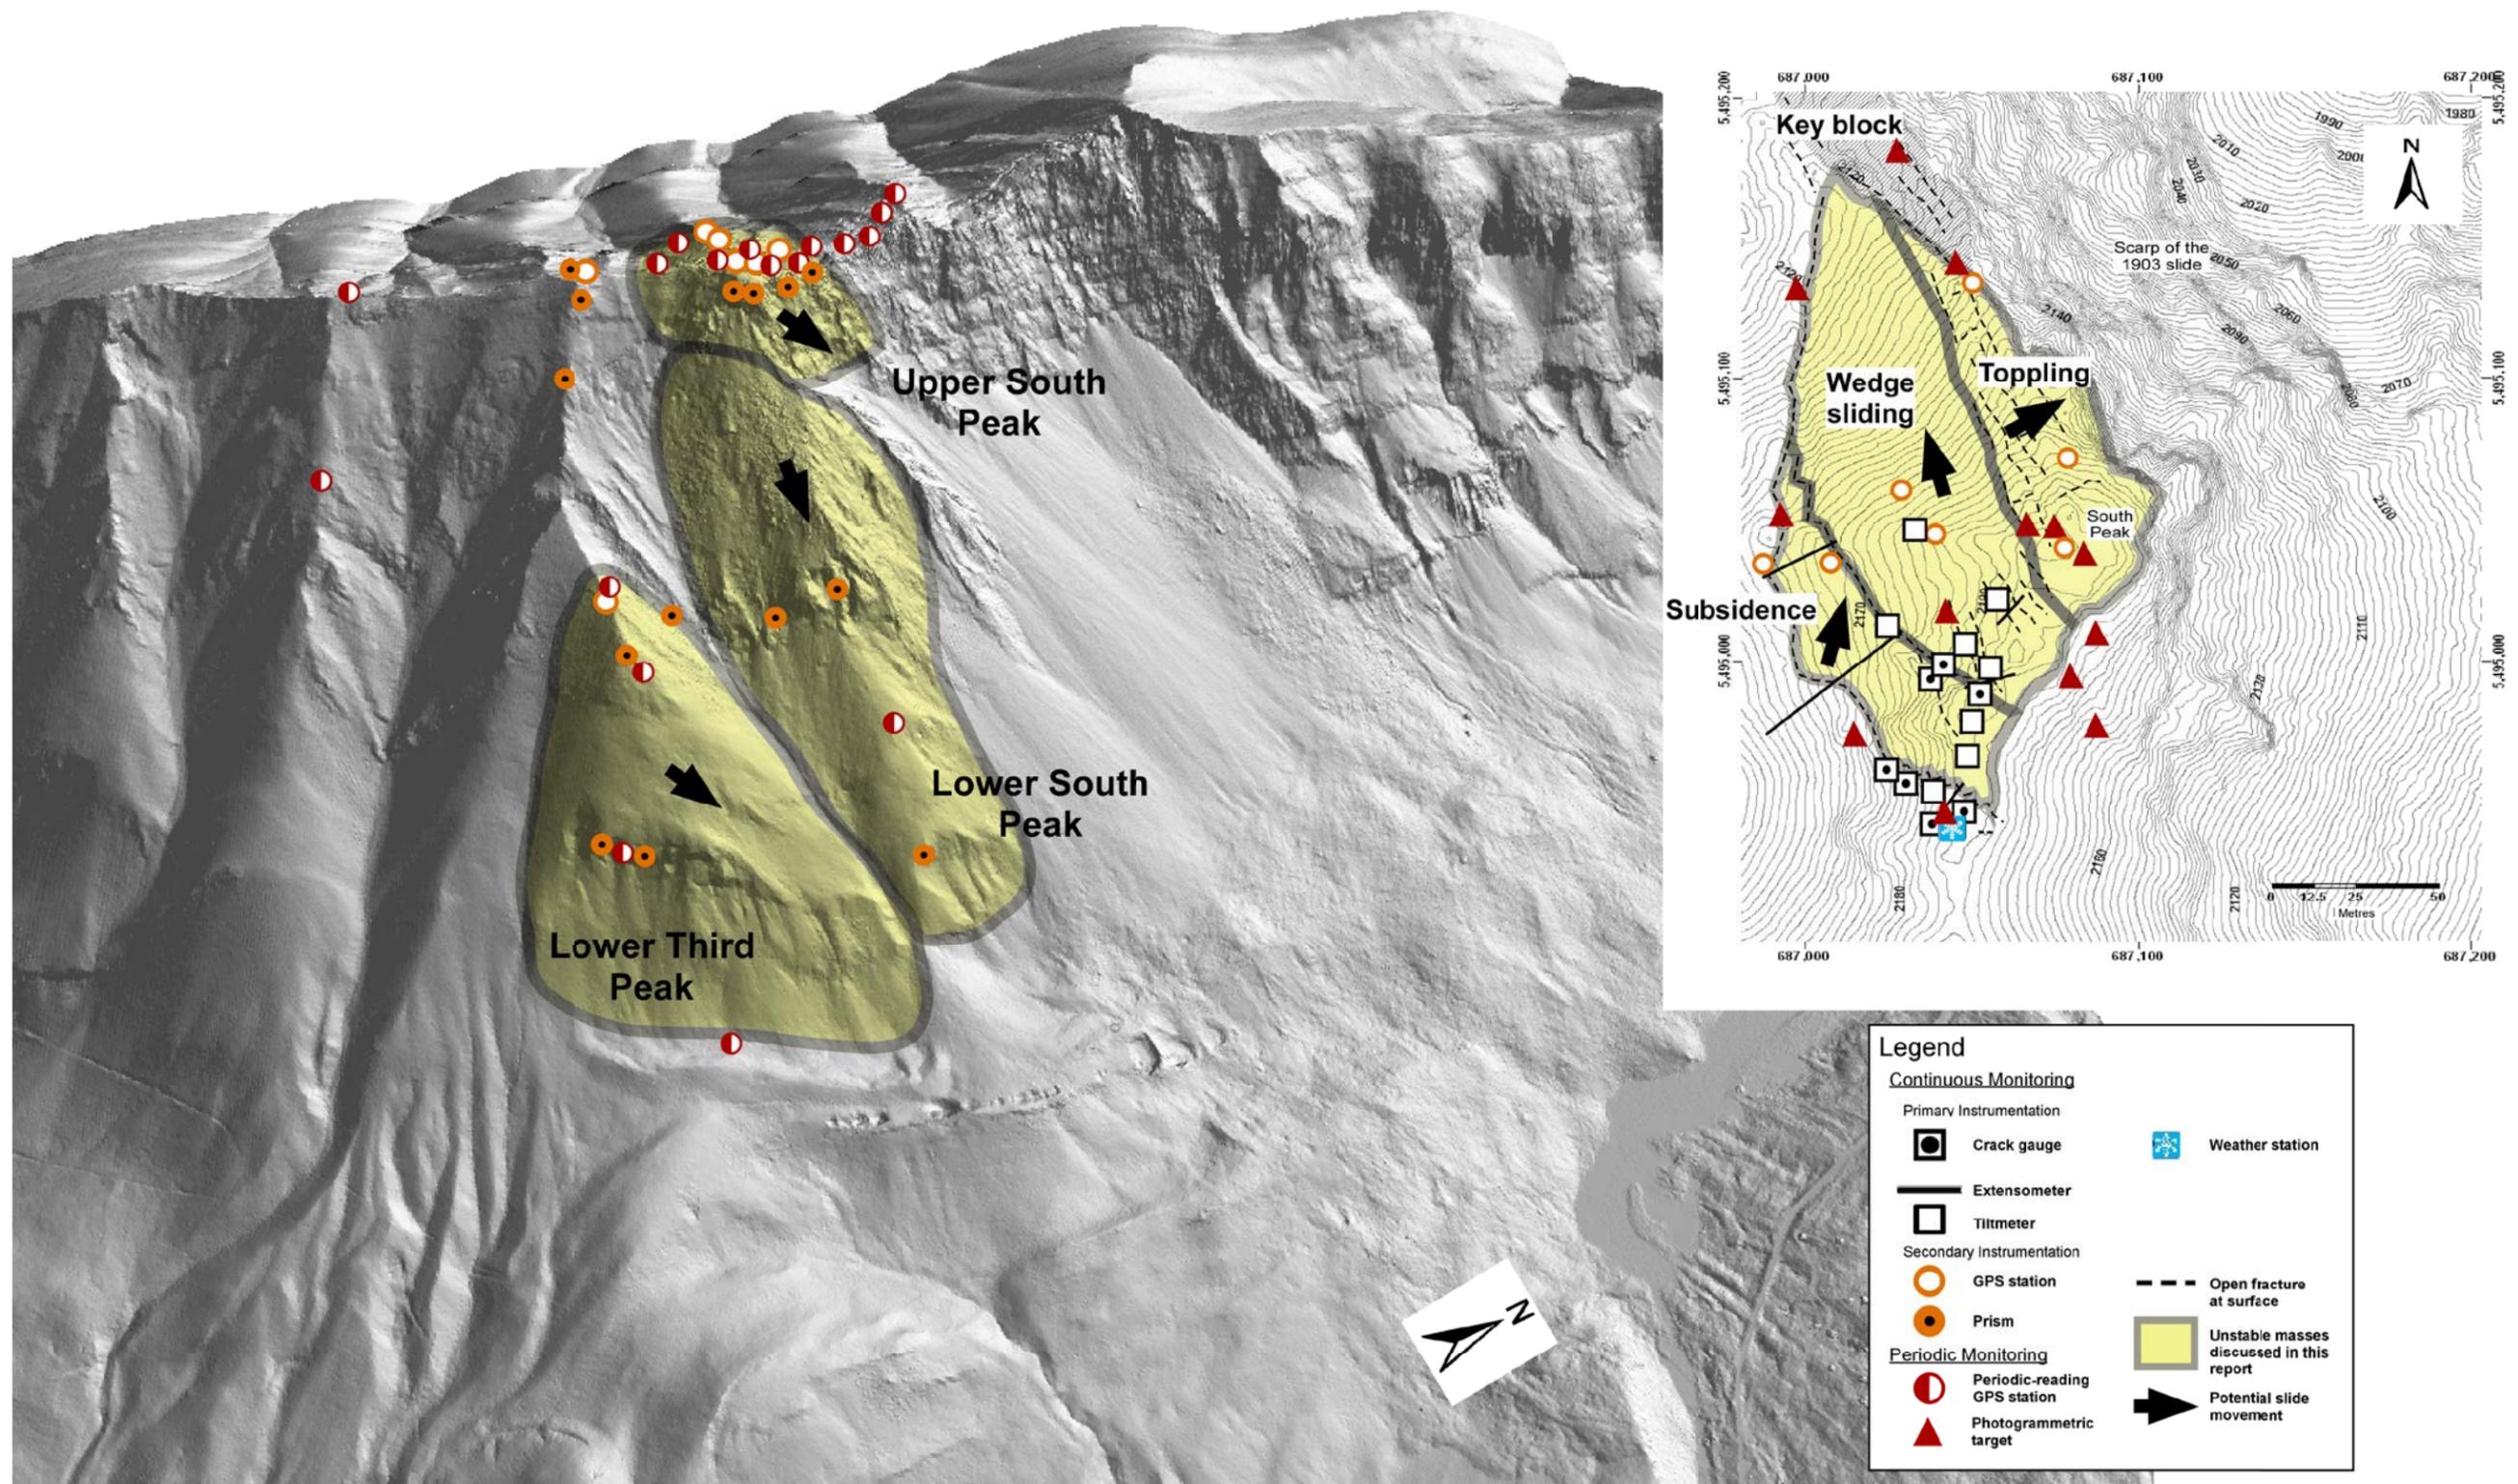
Figure 2. Overview, as of December 2010, of the monitoring network on Turtle Mountain as a whole and South Peak of Turtle Mountain in particular (inset), southwestern Alberta. For better clarity, primary monitoring instrumentation is shown only on the inset.

The questions pertaining to possible rockslide scenarios and their geological controls have been the subject of extensive investigation (Moreno and Froese, 2008b; Pedrazzini et al., 2011). This included fracture mapping across the entire slope in the summers of 2007 and 2008, combined with high-resolution digital-elevation-model (DEM) analyses. According to these studies, there are three unstable blocks that could be involved in a deep-seated multi-block failure. Two are in the area encompassing the South Peak, referred to as the Upper and Lower South Peak instabilities, and a third is in the lower slope below Third Peak (Figure 2).

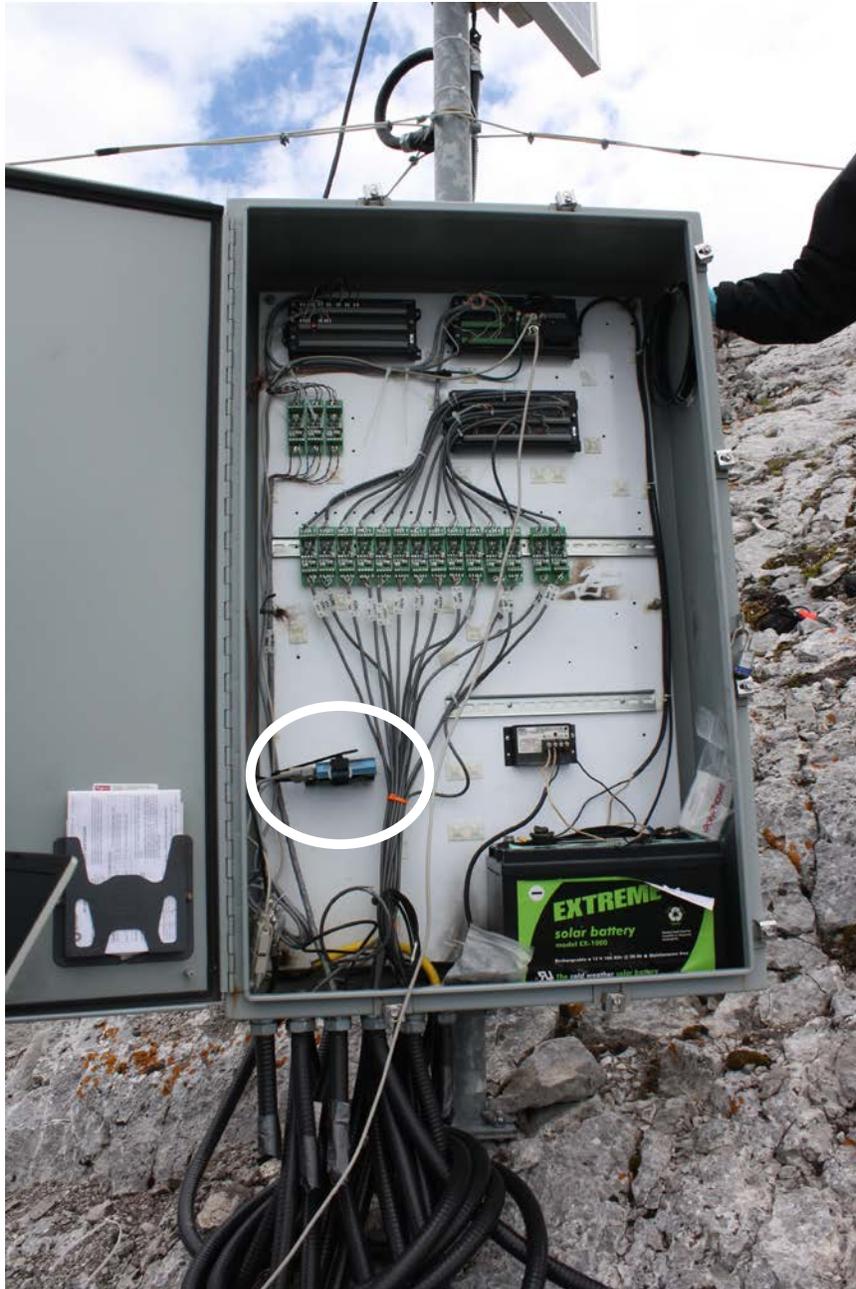
Figure 3. Physical layout of equipment installed at the borehole datalogging site on Turtle Mountain, southwestern Alberta. Cellular modem can be seen in the lower left (white circle).

drowned by other radio sources, most likely a nearby cellular communication tower built recently in Blairmore. Since a radio connection was no longer possible, it was decided to switch to cellular modems. Two cellular modems were purchased, activated and tested on the ground, and installed successfully at the borehole and weather stations (Figure 3). To lower power consumption of the system, the modems are programmed to be on for only a few minutes each hour to send recorded data.

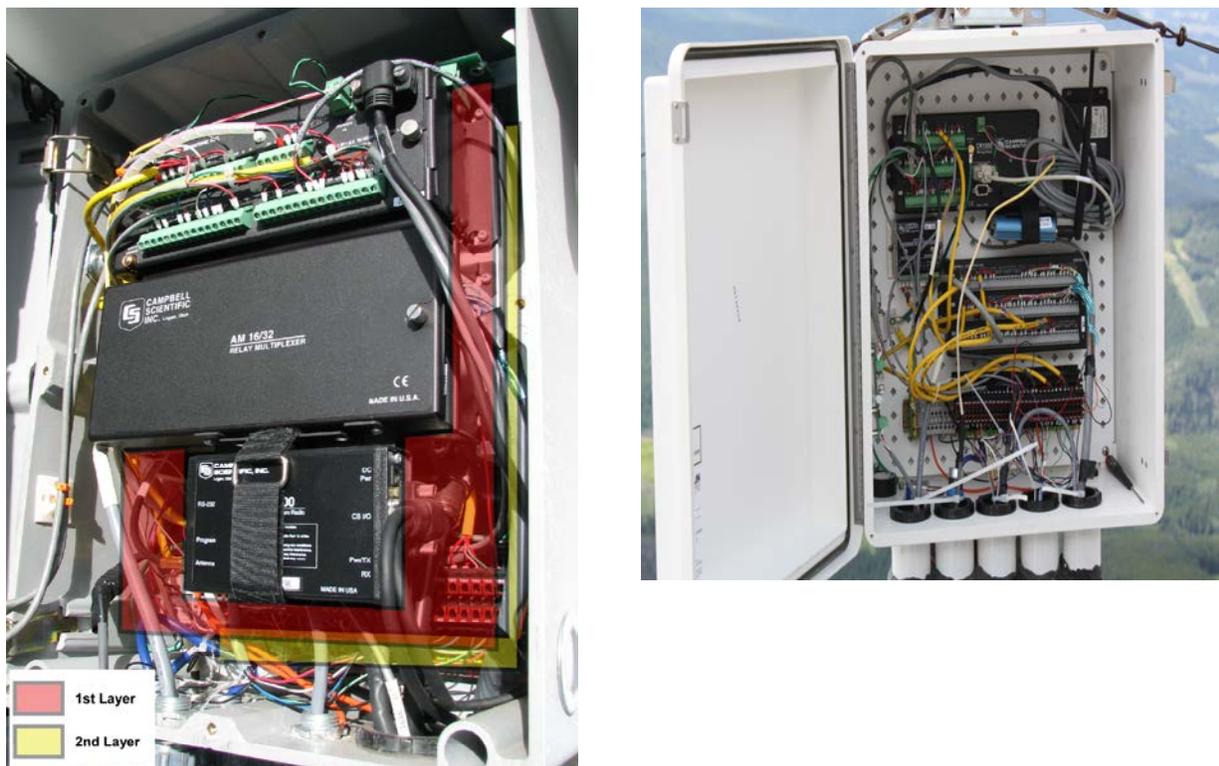
Figure 4. Physical layout of equipment installed at weather station datalogging site on Turtle Mountain, southwestern Alberta. Limited space in the old enclosure (left) made repair work difficult. The new enclosure (right) is a significant improvement because all equipment is now in a single layer.

The enclosure at the weather station also needed attention. Due to its small size, the equipment and cables inside were arranged in two layers, making any work on this site very difficult. This had been a problem for some time, so a decision was made to replace the old enclosure with a larger one in which all the equipment could be accommodated in a single layer (Figure 4).

The datalogging equipment was also upgraded. The old equipment was obsolete, necessitating replacement with a new model, the CR1000 datalogger. The default setting for this datalogger was for weather sensors to take readings every 5 seconds and for primary sensors to take them every 15 seconds. This was far too frequent, so a new program was written to change the data-collection frequency for all sensors to hourly readings. This will extend the life of the datalogging equipment and reduce the energy consumption of the station, thus reducing demand on the battery.

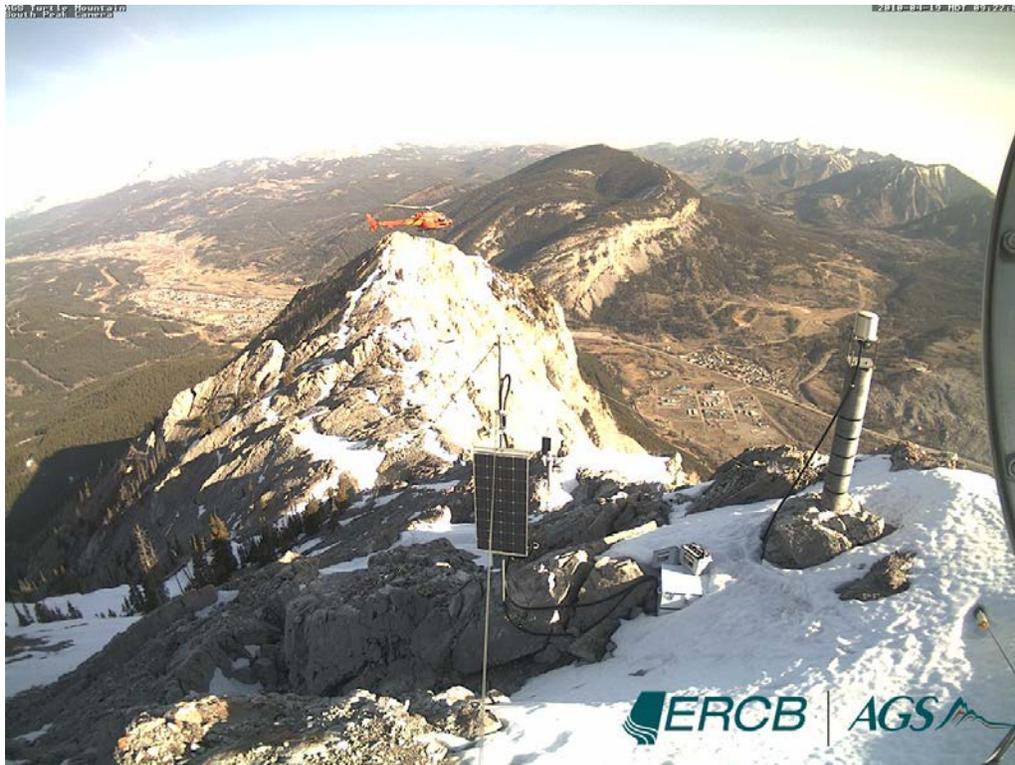
Figure 5. Battery slinging operations, with the helicopter used for battery hauling visible in the middle distance (image taken from a webcam installed on the South Peak of Turtle Mountain).

The majority of the GPS stations on the mountain had been using two 90 A·h 8G27 gel-cell batteries as the storage medium for solar energy. These batteries had reached the end of their useful life and were starting to exhibit power problems. To resolve these issues, the old gel-cell batteries were replaced with new 90 A·h absorbed glass mat (AGM) batteries. These new batteries have several advantages over the gel-cell batteries, including longer expected life (4–6 years) and the expectation that they will perform much better in the harsh environment on Turtle Mountain. To expedite the process of moving almost 950 kg of batteries around the mountain, a helicopter was used to carry them from the South Peak to each of the GPS stations (Figure 5). This methodology worked out quite well: it was both faster and safer than manually moving batteries around the mountain.

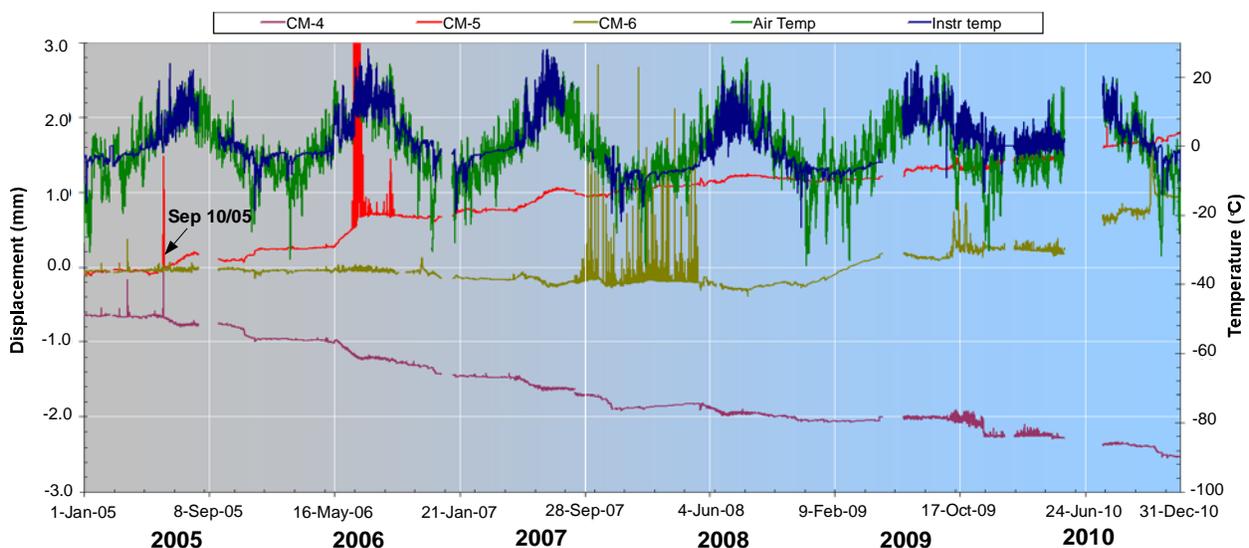
Figure 6. Plot of displacement versus time for crackmeter set B, South Peak, Turtle Mountain.

These instruments provide time series of crack opening and temperature over a period of six years (Figures 6 and 7). Monitoring results show diurnal and annual cycles that correlate with air-temperature cycles. The annual cycles exhibit an active phase, with displacements occurring in early autumn to late winter, and a relatively inactive phase, with limited to no displacement in spring to late summer. Instruments in set B have recorded displacement rates of up to 0.4 mm/year and crack-width changes, related to daily air-temperature cycles, of approximately 0.02 mm.

The fracture-opening measurements from crackmeter set C (Figure 7) also show the very slow long-term trend seen in set B (Figure 6). Examination of the records shows a mean annual displacement rate of <0.4 mm/year; as is the case with set B, this most likely reflects fracture opening due to seasonal air-temperature changes.

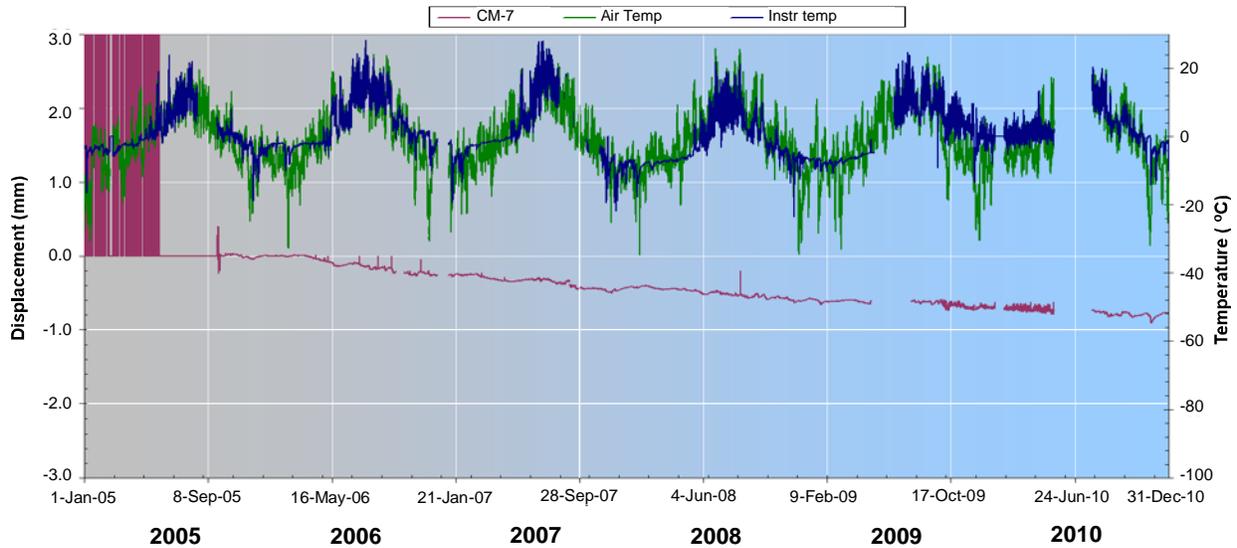
Figure 7. Plot of displacement versus time for crackmeter CM-7 of set C, South Peak, Turtle Mountain.

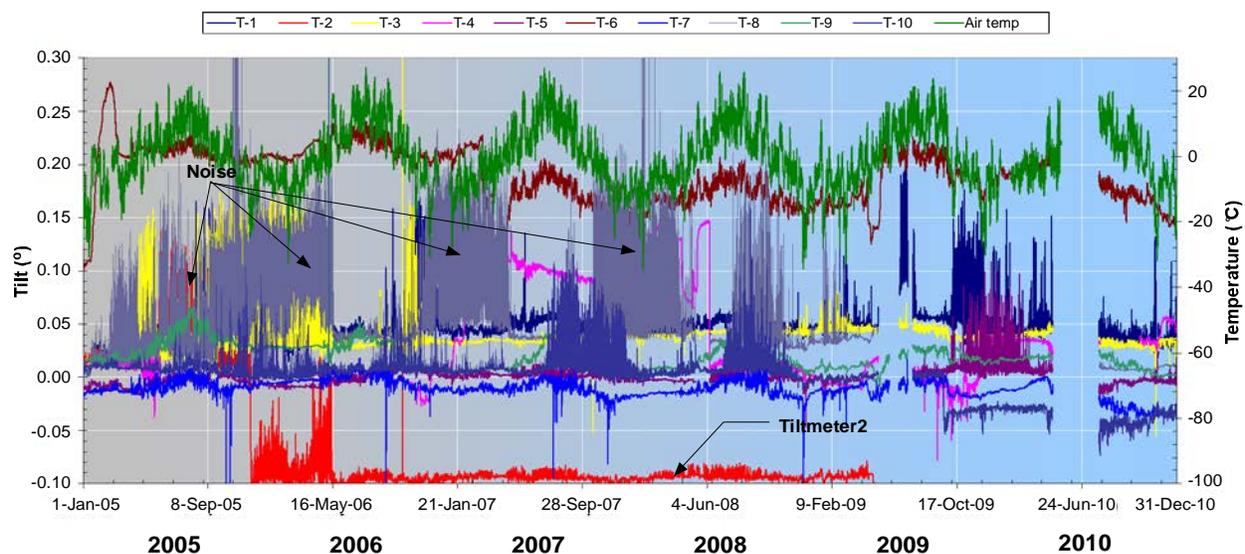
Figure 8. Plot of tilt versus time for tiltmeters, South Peak, Turtle Mountain.

The results from the tiltmeter network are important because they allow an understanding of the rotational component of the displacements. This system, consisting of 10 sensors, was installed during 2005 by AMEC Earth and Environmental (2005). The sensors are in two clusters, one at the sliding wedge and the other at the subsiding zone behind the sliding wedge (Figure 2). Spatial coverage is therefore limited, with no sensors situated within the most active part of the rock mass at the northeastern part of South Peak. The monitoring results between 2005 and 2010 are shown in Figure 8. About half of the sensors show the effects of high humidity inside the instrument enclosure, making the interpretation of small rotations very difficult. In spite of this, some trends can still be identified. In general, all sensors show annual fluctuations, but with no long-term cumulative rotations, and diurnal fluctuations associated with daily air-temperature cycles.

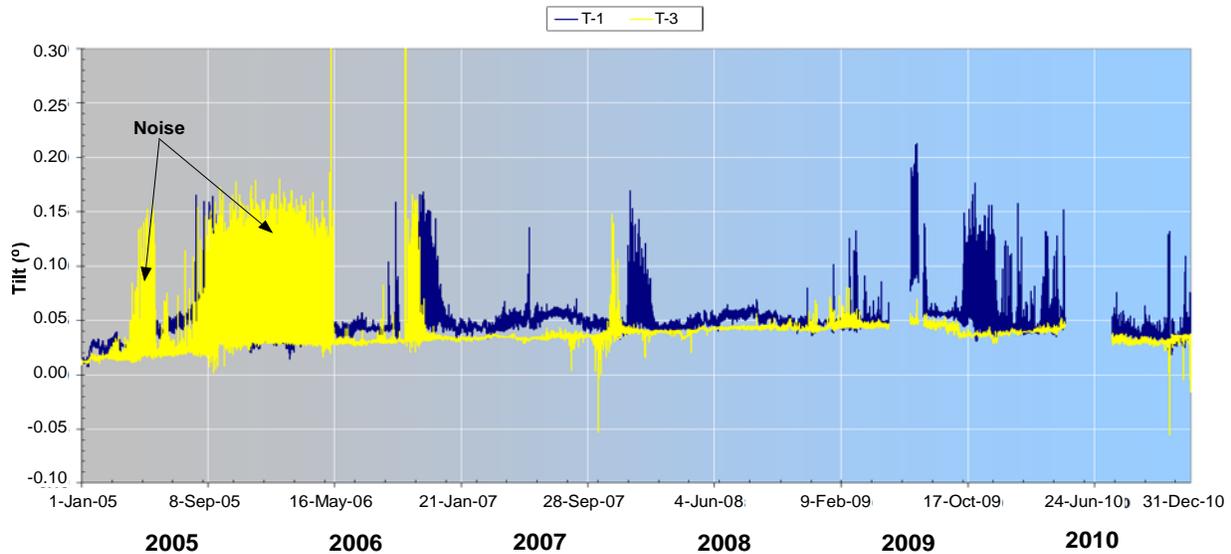
Figure 9. Plot of displacement versus time for tiltmeters T-1 and T-3, South Peak, Turtle Mountain.

Small rotations are found in tiltmeters T-1 and T-3 (Figure 9), with the magnitude and rate of rotation at each station remaining essentially constant for the six-year span of monitoring. This implies that the pattern of deformation of the rock mass has been constant, which is consistent with the trends seen in the crackmeter data.

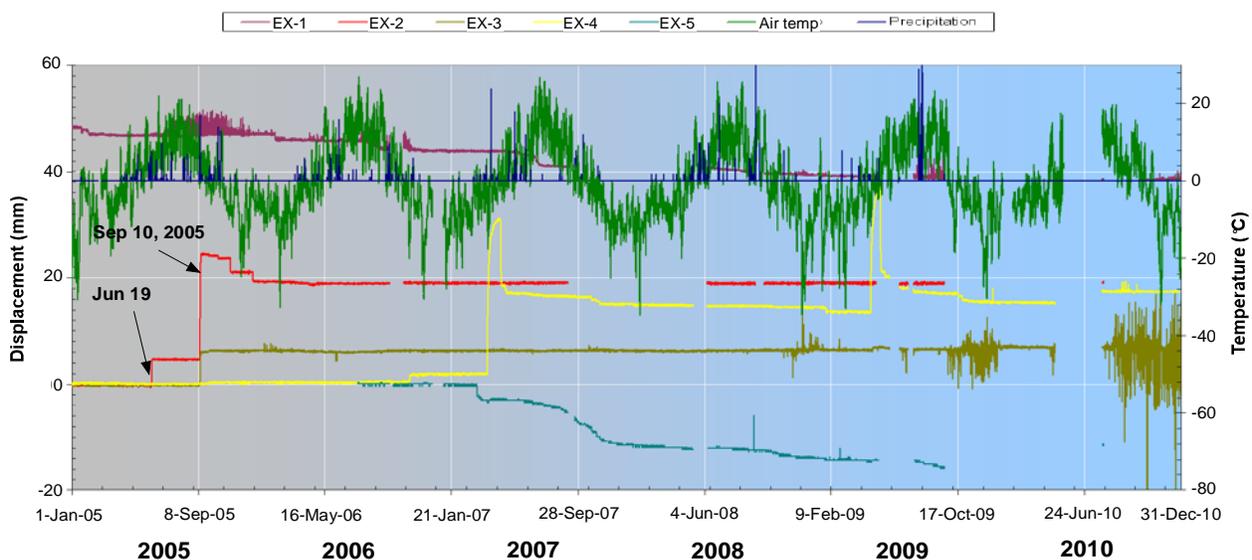
Figure 10. Plot of displacement versus time for extensometers, South Peak, Turtle Mountain.

Displacement versus time plots for all extensometers do not show the cyclical daily and annual fluctuations observed in crackmeter and tiltmeter data (Figure 10). This noticeable difference likely arises from the difference in resolution between the sensor types, with resolution in extensometers two orders of magnitude lower than that of the crackmeters. Extensometers EX-2 and EX-3 continue to be extended at

19 and 6.17 mm, respectively. These displacements were recorded during two periods of heavy precipitation in early June and early September of 2005; Moreno and Froese (2006) discussed the specifics of these events. In addition, the displacement versus time plot in Figure 10 shows a number of transient jumps or steps recorded by sensors EX-4 and EX-5; however, these events are believed to be associated with sensor drift rather than rock displacement. This belief is supported by the fact that no displacement has been recorded by other types of sensors located near EX-4 and EX-5. The exact cause of this sensor drift has yet to be determined, but we believe that it will not affect the sensors' ability to measure real deformations.

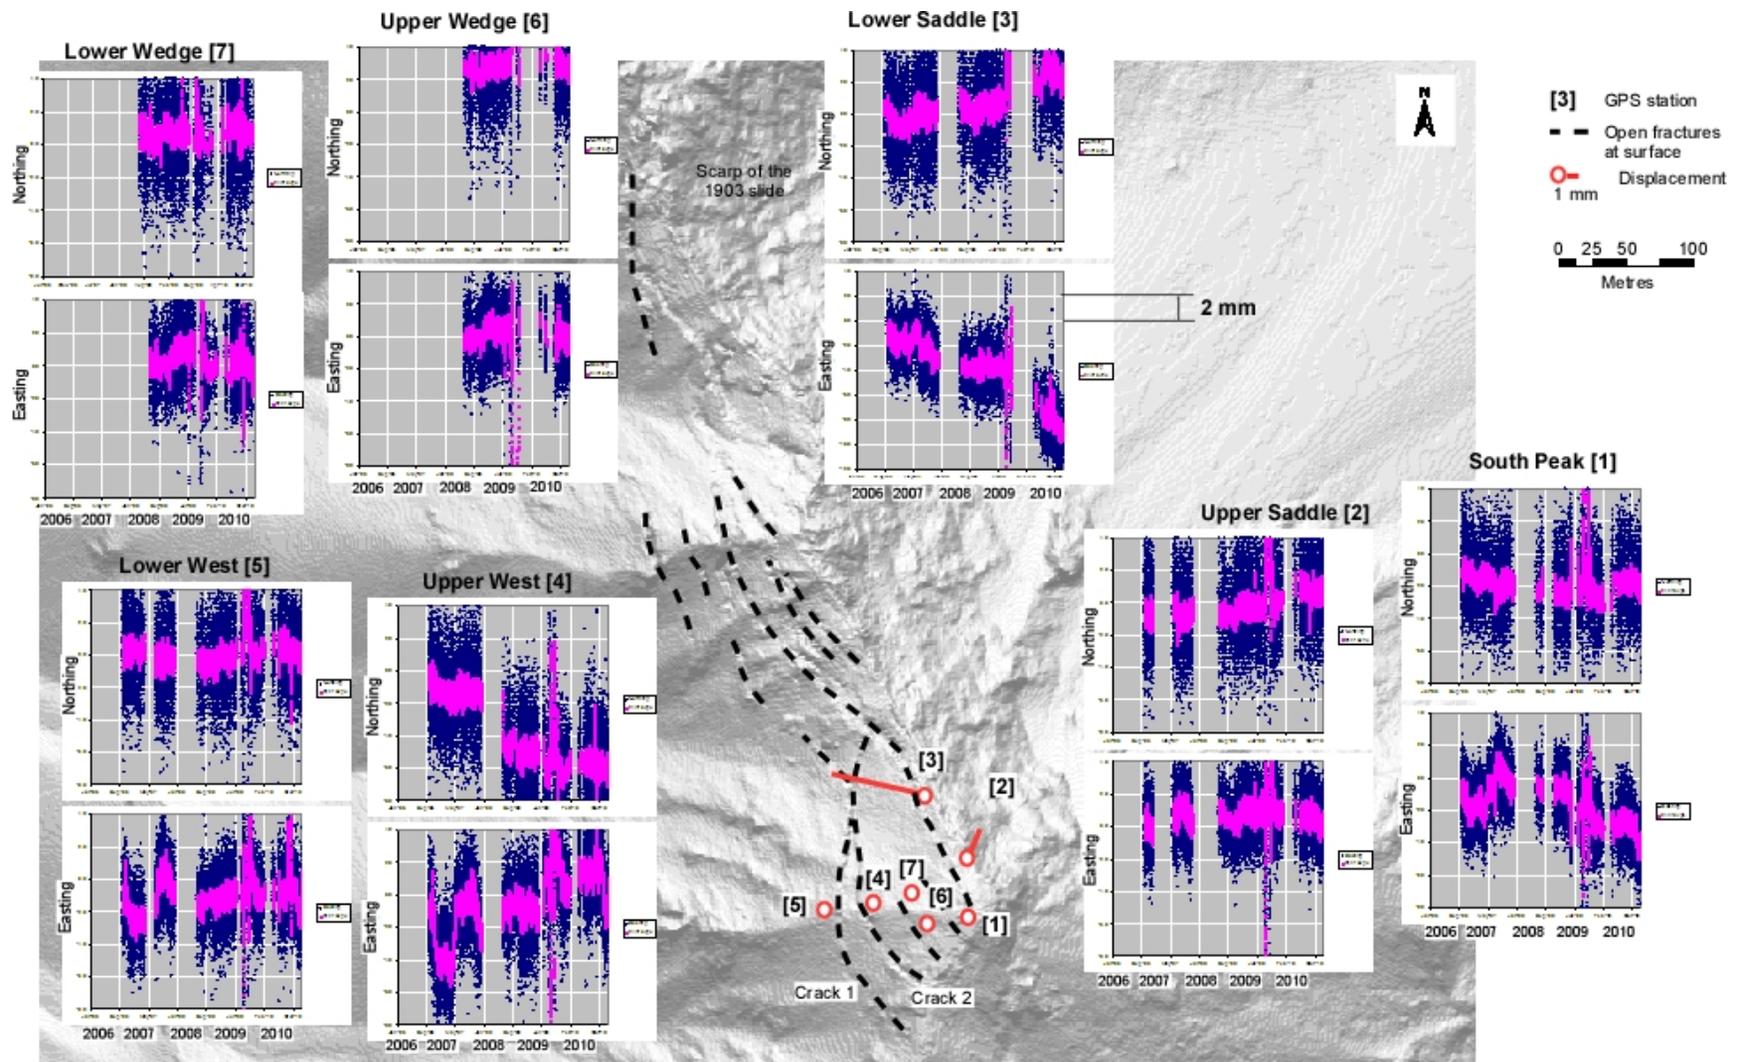
Figure 11. Surface displacements derived from dGPS stations during the period 2006–2008: horizontal component of the surface-displacement vectors (red lines) plotted on a map of the South Peak of Turtle Mountain. The displacement vectors of the dGPS stations are absolute, since they are referenced to an external coordinate system. dGPS stations: [1] South Peak; [2] Upper Saddle; [3] Lower Saddle; [4] Upper West; [5] Lower West; [6] Upper Wedge; [7] Lower Wedge.

The Upper West station indicates a displacement of more than 6 mm. This is almost certainly incorrect and likely related to a poorly constructed concrete pillar. A detailed onsite inspection of the pillar revealed signs of deterioration; also, the pillar is on heavily broken rock. This material can be very susceptible to freeze-and-thaw events, which can result in large local displacements.

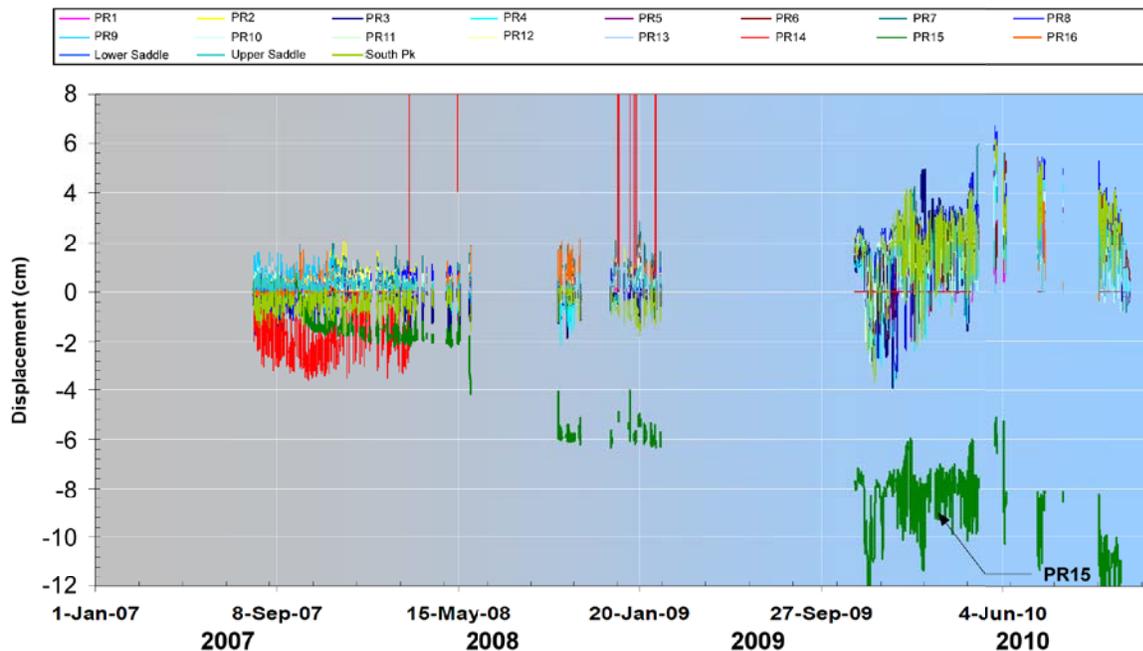
Figure 12. Plot of displacement versus time for electronic-distance-measurement (EDM) prisms at Turtle Mountain.

As discussed in Moreno and Froese (2008b), twenty prisms were installed during the summer of 2007. Figure 12 shows the results of the 15 months of available data. In general, all records show evidence of the annual displacement fluctuation seen most clearly with the crackmeters. However, with the exception of prism PR-15, it is not possible to give a definite magnitude and direction of displacement at this time due to the small scale of the displacements measured.

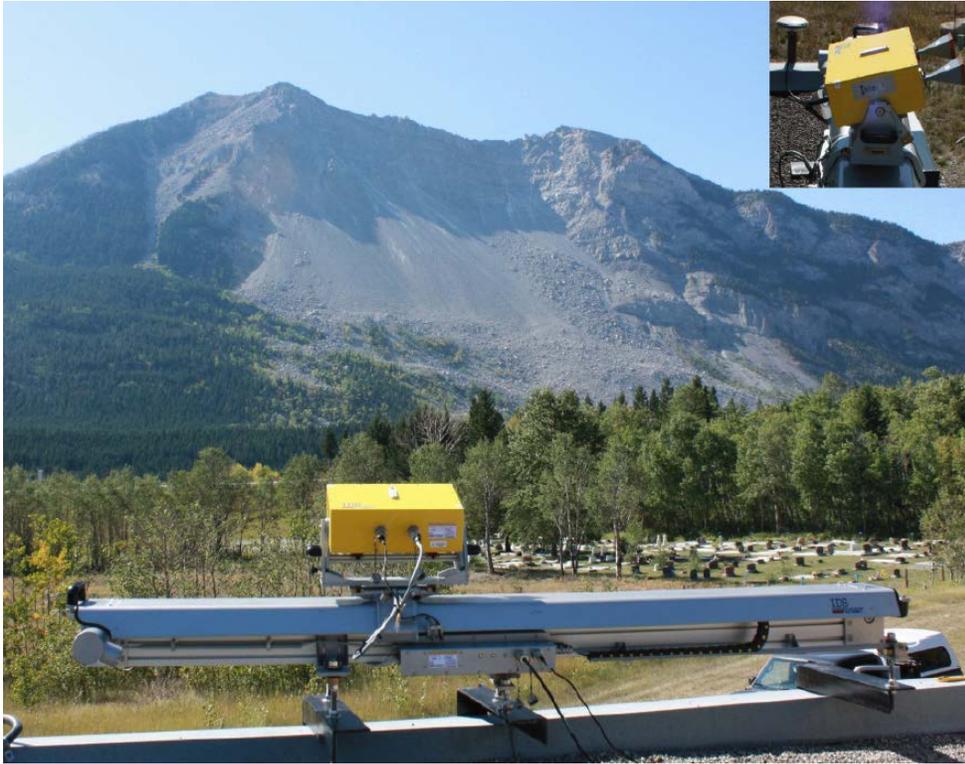
Figure 13. The IBIS-L GB-InSAR system is installed on a rooftop, facing the unstable slopes on Turtle Mountain. The farthest point on the mountain crest is approximately 3200 m away.

At this point, the GB-InSAR monitoring campaign at Turtle Mountain has consisted of a three-month calibration period in the fall of 2009 and a four-month monitoring period in the spring/summer of 2010. In the fall of 2009, the data from the GB-InSAR were compared with the web-camera images and the

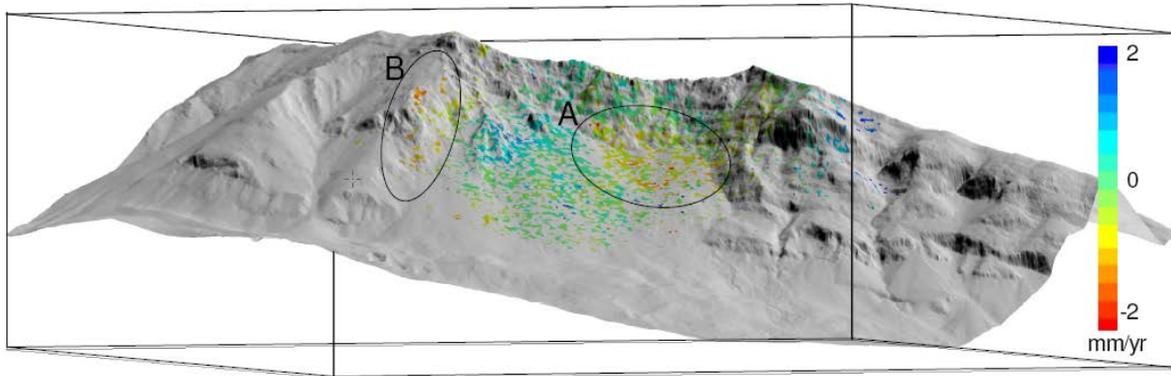
Figure 14. Digital elevation model of Turtle Mountain, as viewed from the instrument location. The colours represent the average velocity along line-of-sight from September 2009 to April 2010. Negative velocities represent movement toward the sensor. Area 'A', in the upper portion of the talus slope, shows increased movement due to oversteepening and continued accumulation from above. Movement in area 'B', on the lower portion of South Peak, is consistent with field mapping in this heavily fractured area.

The readings in the spring of 2010 provided a broader view of the movements on the eastern face, with the main zones of movement observed being on the slowly creeping talus slopes on the lower two-thirds of the face (Figure 14).

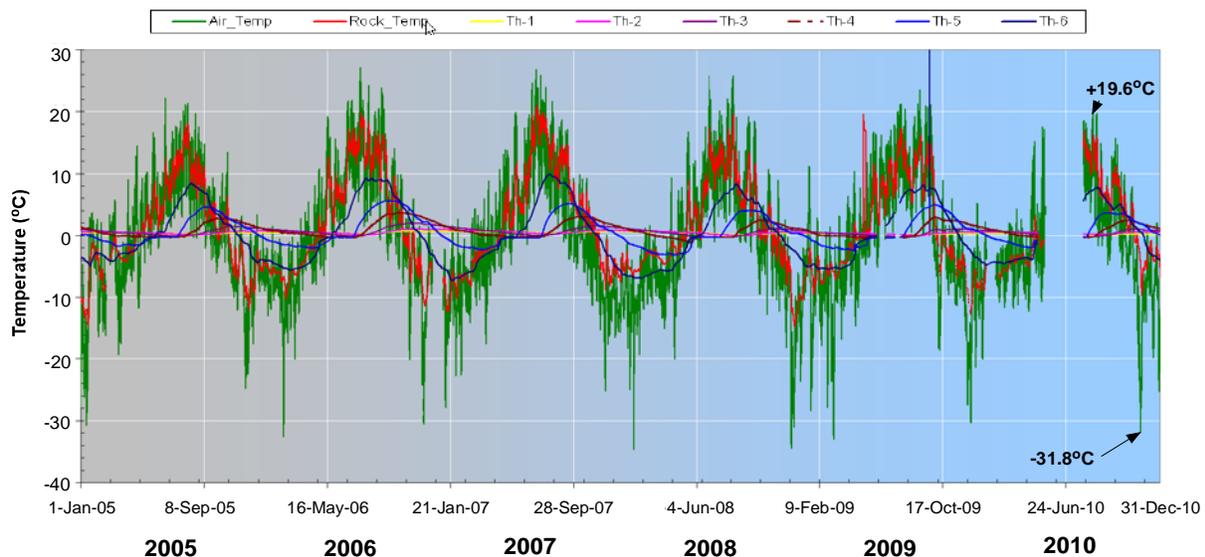
Figure 15. Air temperature and variation of rock temperature with depth in the borehole at the top of South Peak, Turtle Mountain, 2005–2009.

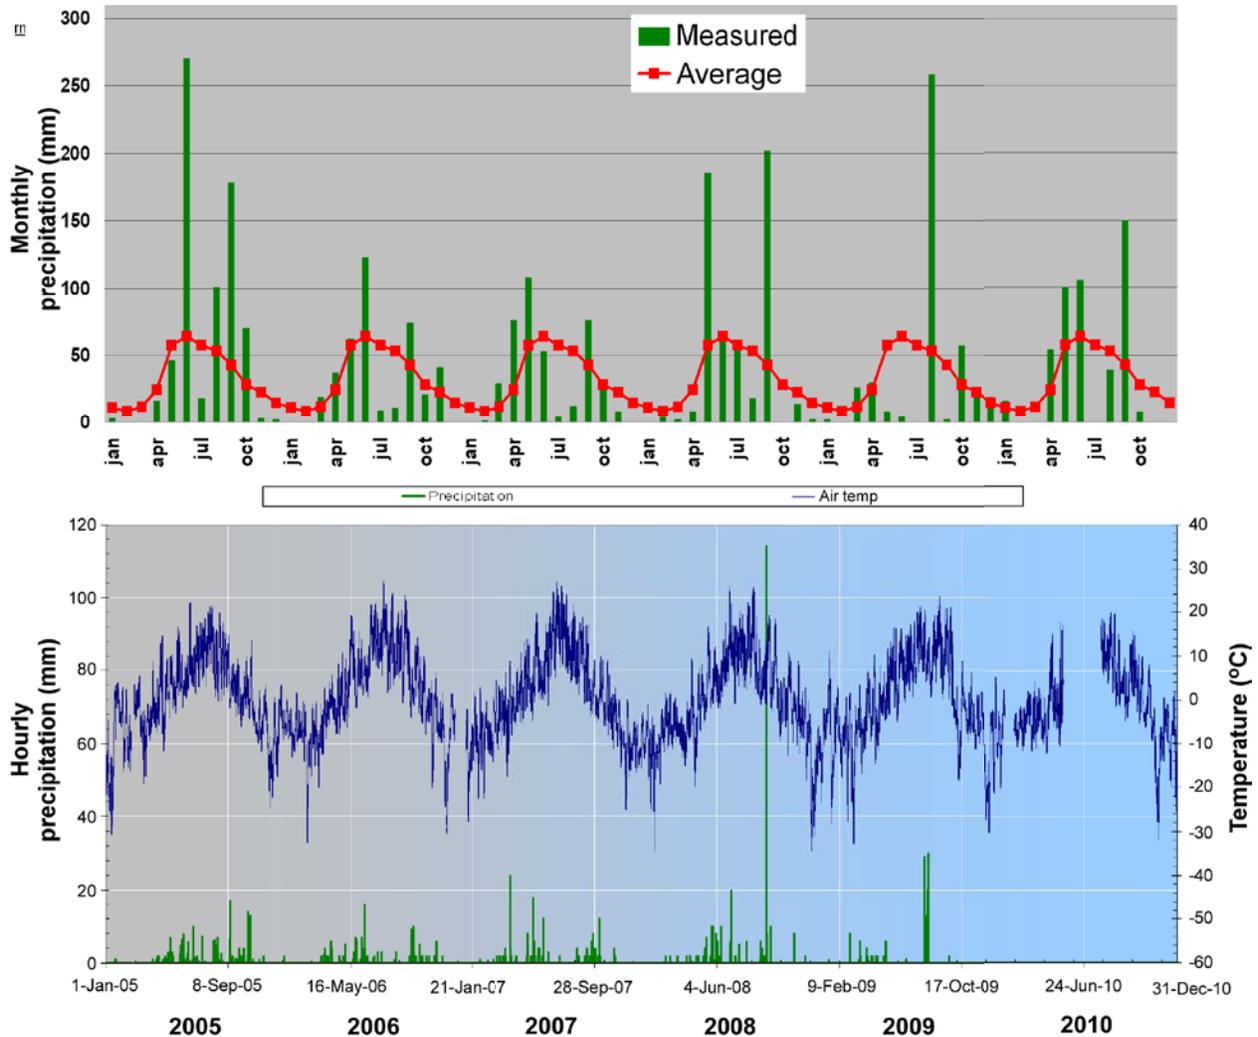
Figure 16. Top: Measured monthly precipitation (2005–2010) and average monthly precipitation (1971–2000). Bottom: Temperature and hourly precipitation near Turtle Mountain, 2005–2010.

Above-normal precipitation during the reporting period was recorded on the South Peak of Turtle Mountain. Total precipitation in 2010 was 472 mm, 18% greater than the average annual precipitation of 397 mm, which is based on data measured between 1971 and 2000 at the nearby Coleman weather station

of Environment Canada. Winter precipitation was below normal (Figure 16). Below-normal precipitation was recorded during early spring, whereas an above-normal amount was seen during late spring, which brought the overall precipitation during this season to above normal. Precipitation was above normal for much of the summer but decreased significantly after July 1. Above-normal precipitation was recorded during the fall months (September, October and November).

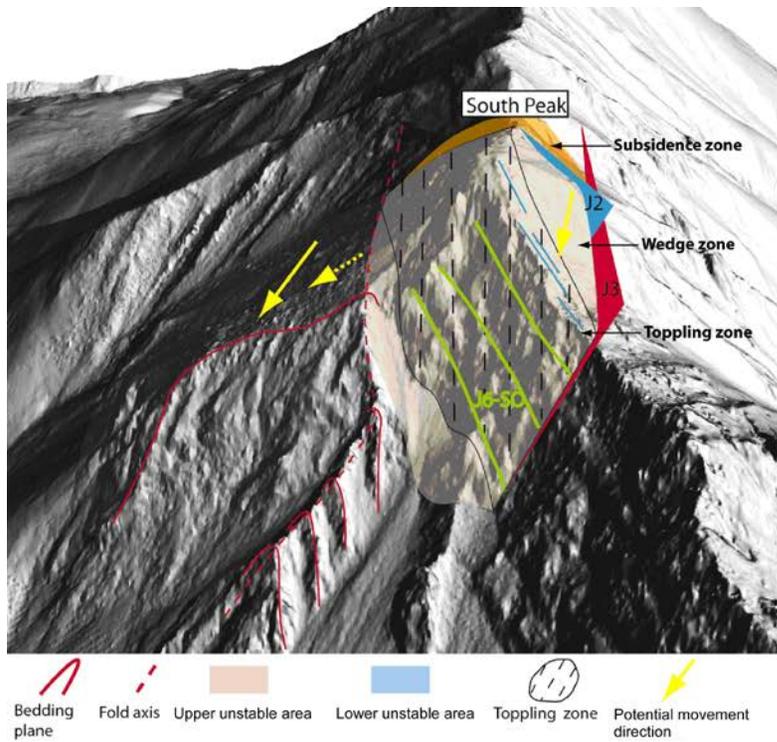
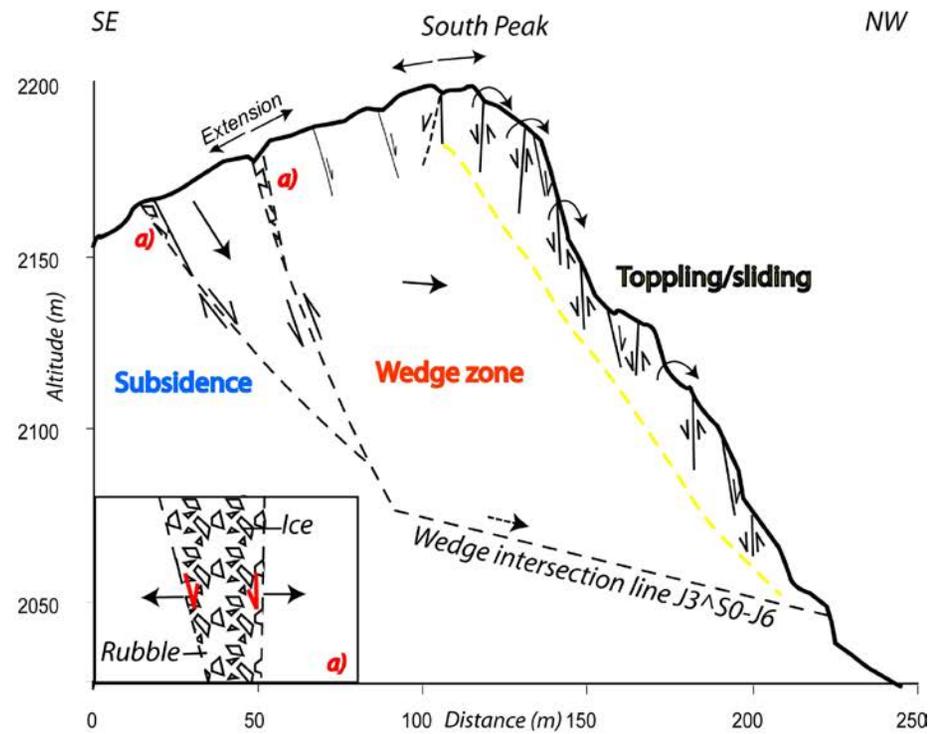
Figure 17. Conceptual model of the unstable area on Upper South Peak, based on structural and monitoring data (Froese et al., 2009).

The toppling zone is characterized by linear fractures that trend approximately parallel to the slope face, largely controlled by J2 and locally by J1 and J3. In this zone, the available monitoring points consist of five photogrammetric targets, ten EDM prisms, three continuous-reading dGPS stations and two periodic-reading dGPS station (Figure 2). With the exception of EDM prism PR15, displacement data from the EDM network are on the same order of magnitude as measurement errors and are therefore not included in this discussion. Table 1 provides an overview of the displacements observed for the photogrammetric targets, and Tables 2 and 3 present displacement data for the continuous- and periodic-reading dGPS stations, respectively.

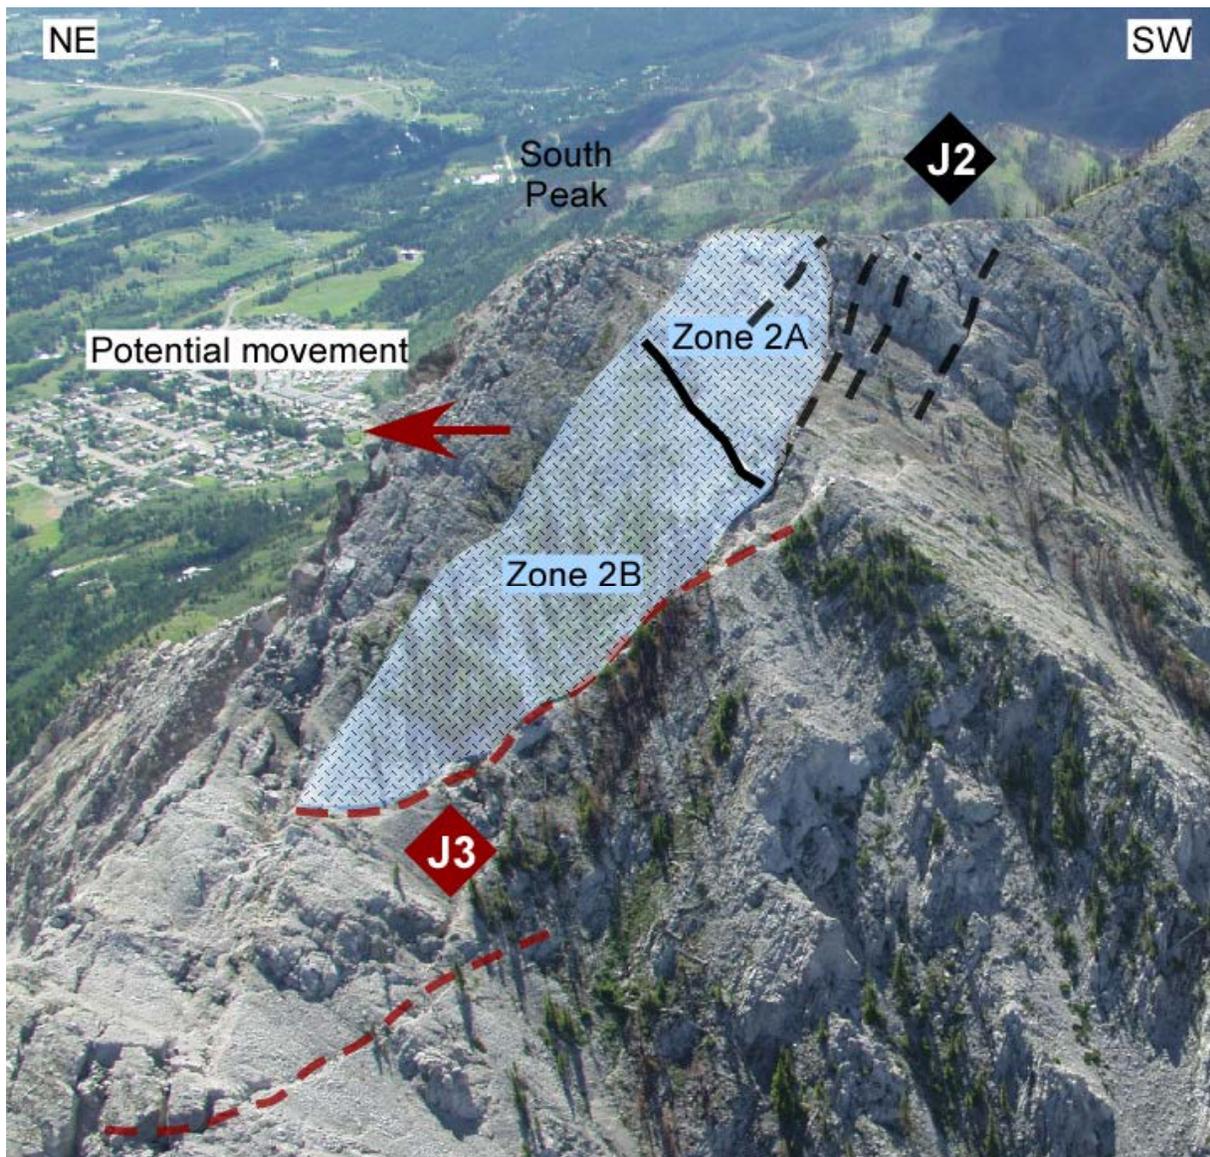
Figure 18. Close-up of the postulated wedge-failure zone. This zone is bounded by joint sets J2 and J3, and, at the base, by the bedding plane on the western limb of the Turtle Mountain anticline.

This zone covers the largest unstable area delineated on the South Peak. It is controlled by the BP/J6 discontinuity along the western limb of the Turtle Mountain anticline and either discontinuity J2 or J3, as shown in Figure 18. Differentiation between a J2^{BP/J6}- and a J3^{BP/J6}-controlled wedge will be dependent on the location of the moving portion of Zone 2 relative to the surface topography. Location of the J2^{BP/J6} (Zone 2A) and J3^{BP/J6} (Zone 2B) wedge sliding zones is provided in Figure 18.

Monitoring in this zone initially consisted of four tiltmeters, two extensometers and one crackmeter set, most of them in Zone 2A. This network was extended to Zone 2B in 2007 with the addition of two periodic-reading dGPS stations and, in 2008, with the addition of two continuous-reading dGPS stations. Monitoring is complemented with one photogrammetric target (P-20). Unfortunately, most of the sensors display different degrees of noise in their readings, which makes small displacements almost impossible to detect. Therefore, discussion of displacements is limited to only those sensors that are known to have operated normally (T-1, T-3, set B, Point 15 and P-20).
