Turtle Mountain Field Laboratory, Alberta (NTS 82G): 2010 Data and Activity Summary

F. Moreno and C.R. Froese

Energy Resources Conservation Board
Alberta Geological Survey

Moreno, F. and Froese, C.R. (2012): Turtle Mountain Field Laboratory, Alberta (NTS 82G): 2010 data and activity summary; Energy Resources Conservation Board, ERCB/AGS Open File Report 2011-03, 32 p.

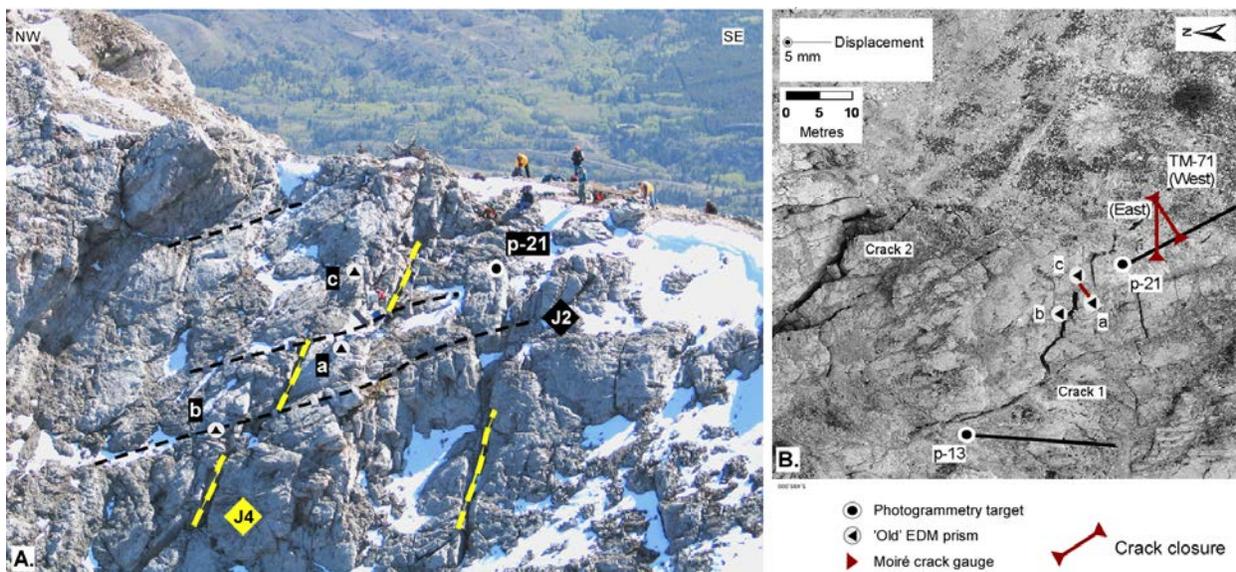
Figure 19. A) Close-up of the postulated wedge-failure zone. This zone is bounded by joint sets J2 and J3, and, at the base, by the bedding plane on the western limb of the Turtle Mountain anticline (Froese et al., 2009). B) Horizontal displacement vectors of measured displacement in the subsidence zone.

There is good agreement of the results from photogrammetric targets P13 and P21 with those obtained from the two Moiré crack gauges. Both sets of instruments indicate deformations that are both down and into the slope (to the south-southeast) and are consistent with visual observations that this highly broken zone is subsiding into the void created by the sliding wedge that forms Zone 2. In addition, the results from the readings of the EDM prisms between 1982 and 2006 indicate a decrease in crack width between targets A and C, rather than the opening that was expected when these targets were originally installed. In

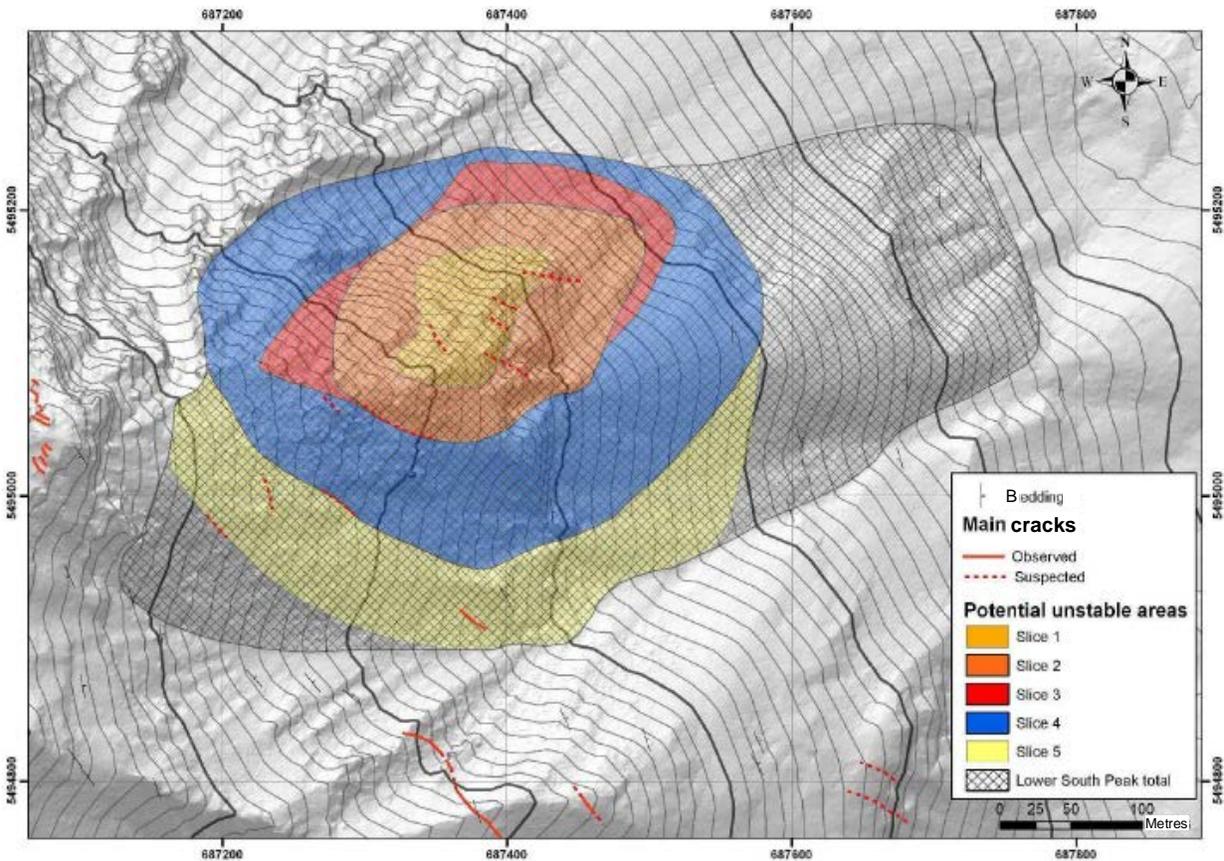
Figure 20. Instability areas detected in the lower South Peak area (Pedrazzini and Jaboyedoff, 2008).

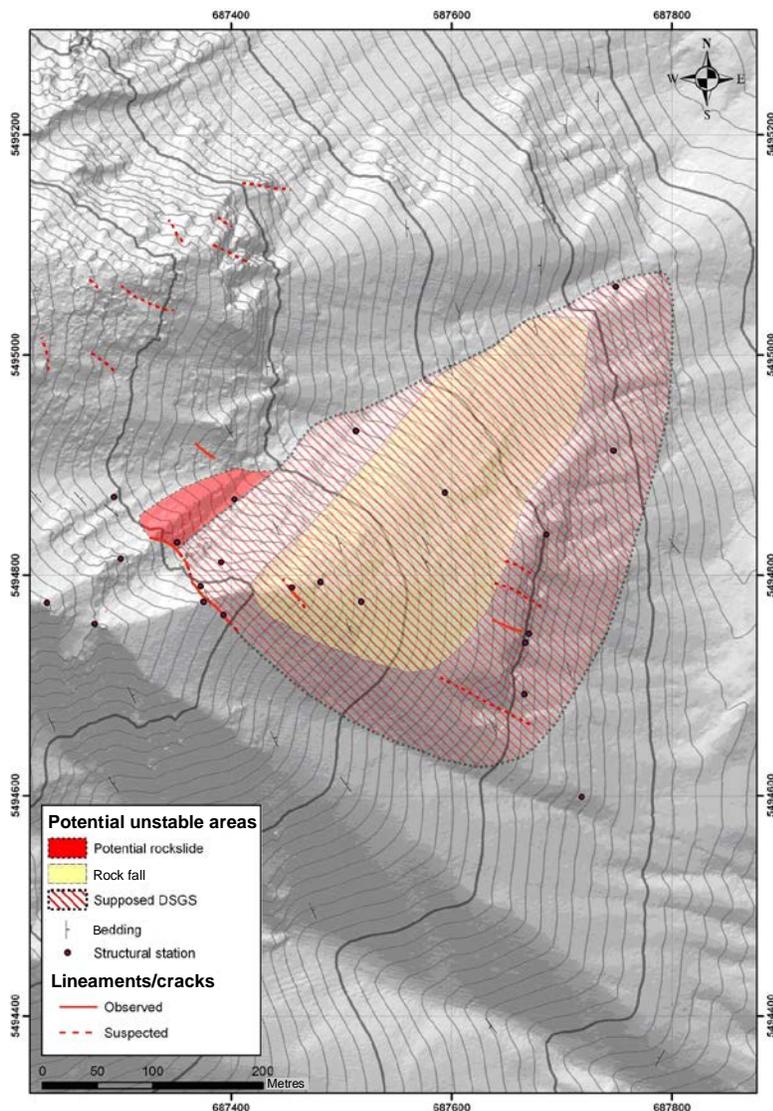
Figure 21. Instability areas detected in the lower Third Peak area (Pedrazzini and Jaboyedoff, 2008).

Geological investigations in the lower Third Peak area resulted from the discovery of two significant fractures in its upper part (Figure 21). These fractures show movement to the northeast, with accumulated displacements of approximately 20 cm (Pedrazzini et al., 2011), suggesting a reactivation of discontinuity set J2. Kinematic analyses and measured displacement vectors of the cracks reveal that different potential rockslide scenarios are possible, one a deep-seated gravitational slope (DSGS) deformation and several superficial unstable masses (Figure 21). The large instability can be well differentiated in its upper part, but the lateral and toe limits are difficult to define, either in the field or by

DEM analyses. The most likely mechanism for these two unstable blocks corresponds to a planar failure following the J1 discontinuity, with the BP acting as a lateral release surface and J2 playing the role of rear limit. Other kinematically possible sliding mechanisms include wedge failure formed by the J1^J3 or J2^J3 discontinuities; however, this type of mechanism could not be recognized during field mapping. Calculated volume for the DSGS area ranges between 1.9 and 2.2 million m³ (Pedrazzini and Jaboyedoff, 2008). However, this estimate can be taken only as rough approximation of the potential unstable volume due to the difficulty in identifying the limits of the instability. The volume of the small superficial unstable area was estimated to range between 0.57 and 0.85 million m³ (Pedrazzini and Jaboyedoff, 2008).

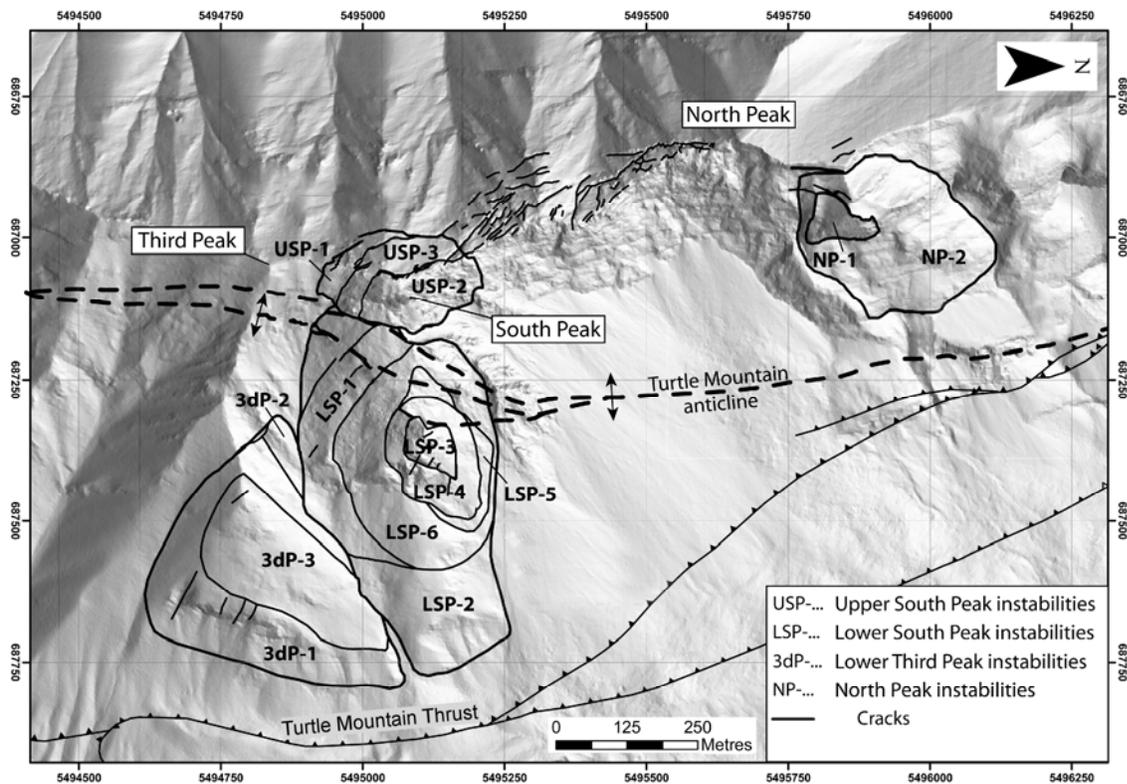
Figure 22. Outlines of the 14 unstable zones identified in the Third Peak, South Peak and North Peak areas of Turtle Mountain (modified from Pedrazzini et al., 2011).

Several new areas of potential instability have been discovered on Turtle Mountain, as described in the previous sections and reported in (Figure 22), in addition to the area initially recognized by Allan (1931). To determine the significance of these potential landslides on planning for emergency response

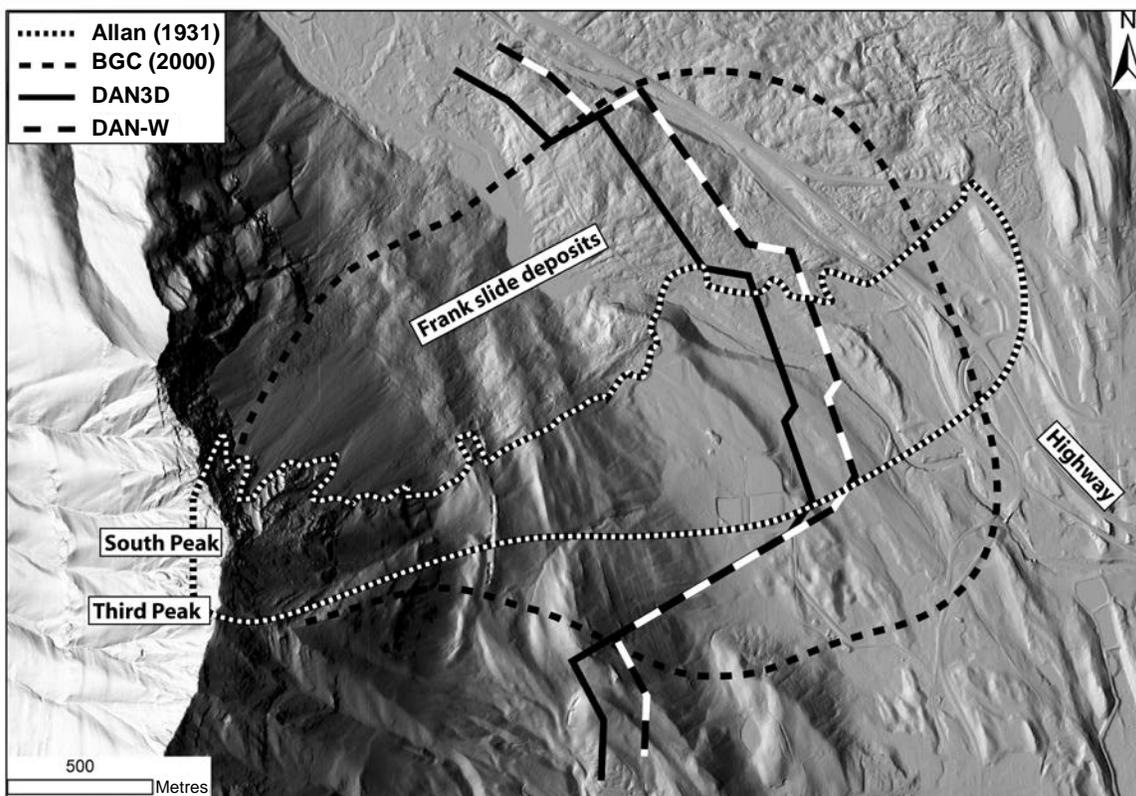
Figure 23. Updated runout scenario envelope compared to the previous estimates for a single large event from South Peak and Third Peak. Adapted from Pedrazzini et al. (in press). Abbreviation: BGC, BGC Engineering Inc.

and land use below the eastern slopes of Turtle Mountain, the specific runout scenarios for the various zones needed to be determined. In the time that has passed since previous hazard-characterization studies (Allan, 1931; BGC Engineering, 2000), new numerical methods of landslide motion analysis have been developed and tested. As part of the recent studies, two such numerical models have been used to estimate the possible consequences of the potential failures that have been identified (Hung, 2008). Analyses were completed using both a three-dimensional (3-D) model, DAN3D, and a two-dimensional (2-D) model, DAN-W. The two models were calibrated by back-analysis of the 36 million m³ 1903 Frank Slide and other smaller rock avalanches. A summary of the maximum runout distances from the 2-D and 3-D analyses of the 12 new source zones is given by the maximum runout envelopes in Figure 23. The 2-D maximum runout distances are typically somewhat longer than the 3-D results due to the concentration of energy in a narrow path. The direction of movement of the 3-D slide and the assumed 2-D profile often did not agree, showing the sensitivity of the 3-D models to topographic details. As shown on Figure 23, the limits to both the 3-D and 2-D analyses for the piecemeal failure of the 12 separate volumes is less extensive than the previous limits outlined by Allan (1931) and BGC Engineering (2000), and therefore present a more optimistic case for considering land-use restrictions in the valley bottom.
