# **Turtle Mountain Field Laboratory, Alberta (NTS 82G): 2012 Data and Activity Summary**

J. Warren<sup>1</sup>, A.J. Morgan<sup>2</sup>, D.K. Chao<sup>1</sup>, C.R. Froese<sup>1</sup> and D.E. Wood<sup>1</sup>

December 2014

Warren, J., Morgan, A.J., Chao, D.K., Froese, C.R. and Wood, D.E. (2014): Turtle Mountain field laboratory, Alberta (NTS 82G): 2012 data and activity summary; Alberta Energy Regulator, AER/AGS Open File Report 2014-09, 16 p.

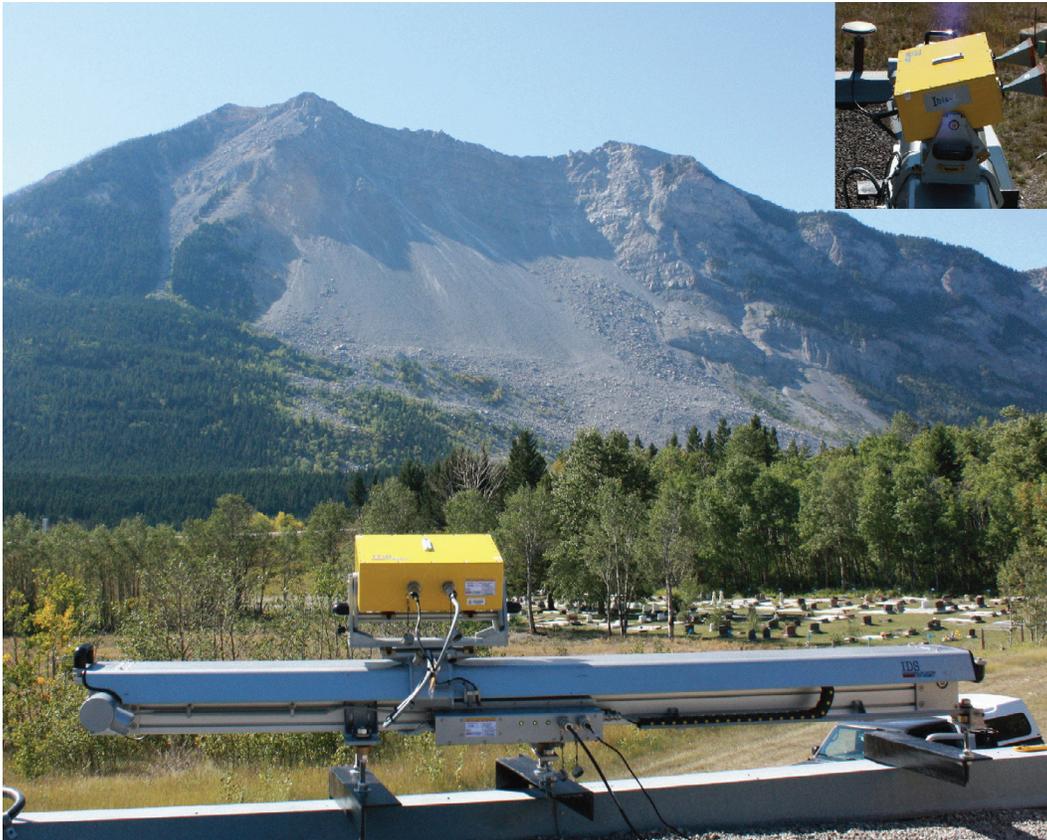
Subtraction of two successive phase maps gives an interferogram, which is used to calculate the total displacement that occurs between the two acquisitions, for each point on the mountain face. The instrument was re-installed on May 9, 2012, to acquire data for summer 2012. However, the system failed after one day, was restarted on May 30, and failed again on June 17. The vendor (Ingegneria Dei Sistemi [IDS]) determined that the problem was with the calibration of the radar head, which was shipped to Italy

**Figure 11. The IBIS system installed in front of Turtle Mountain. The instrument is located approximately 3 km from the mountain face.**

for repair. The instrument was returned late in the fall and too late for more data gathering, resulting in limited data acquisition for the 2012 season.
