SAND AND GRAVEL RESOURCES OF THE
PEERLESS LAKE (SOUTH HALF OF 84B)

LESSER SLAVE LAKE (NORTH HALF OF 830)
MAP AREAS, ALBERTA

Open File Report 86-5

D.W. SCAFE
P.C. SHAM
1986

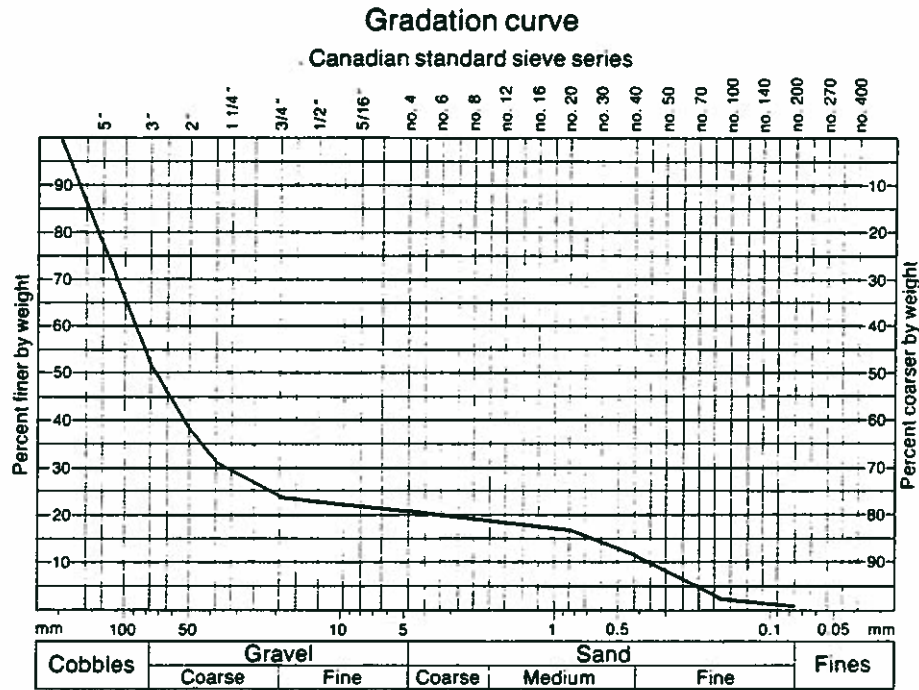
Deposit No. 1

Description: Field checked. Preglacial gravel, east of Pelican Mt. (east of eastern boundary of map area), fractured quartzite. Maximum clast to 20 cm, till overburden 1.0 - 2.0 m. Clean sand below gravel, very good access, potential gravel area, crushing required.

Gradation: 49% cobbles 30% gravel
 20% sand 1% fines

Remarks: Sample was taken outside study boundary, extension of Deposit No. 1.

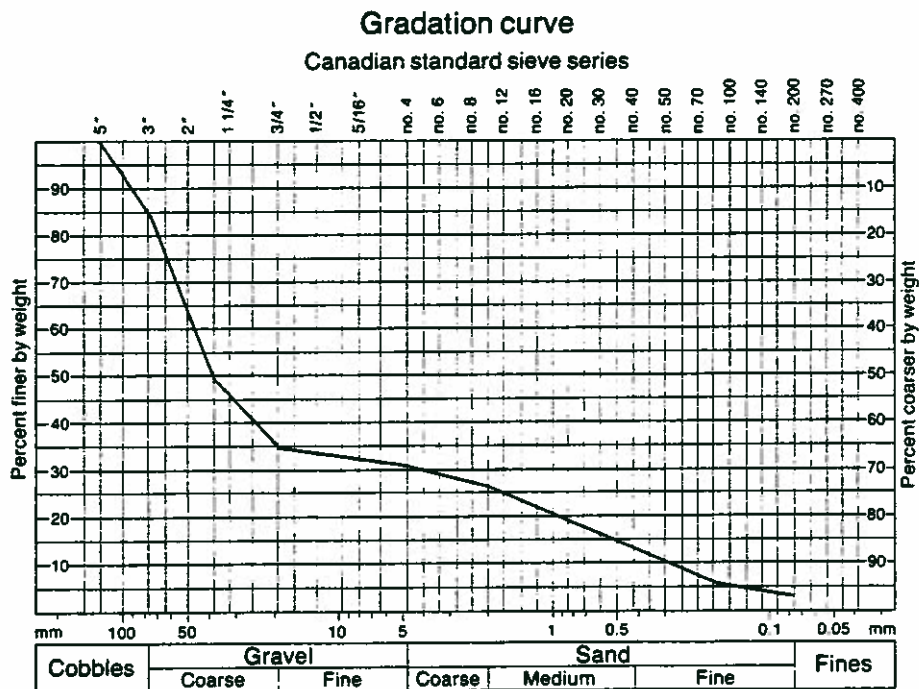
Description: Field checked (two locations). Marten Mt., preglacial gravel, potential gravel area, gravel located on higher elevation (>1,000 m), good access. Near Meridian Tower. Recommend further investigation.

Gradation: 15% cobbles 55% gravel
 28% sand 2% fines

Remarks: Sample was taken outside of study boundary, extension of Deposit No. 3

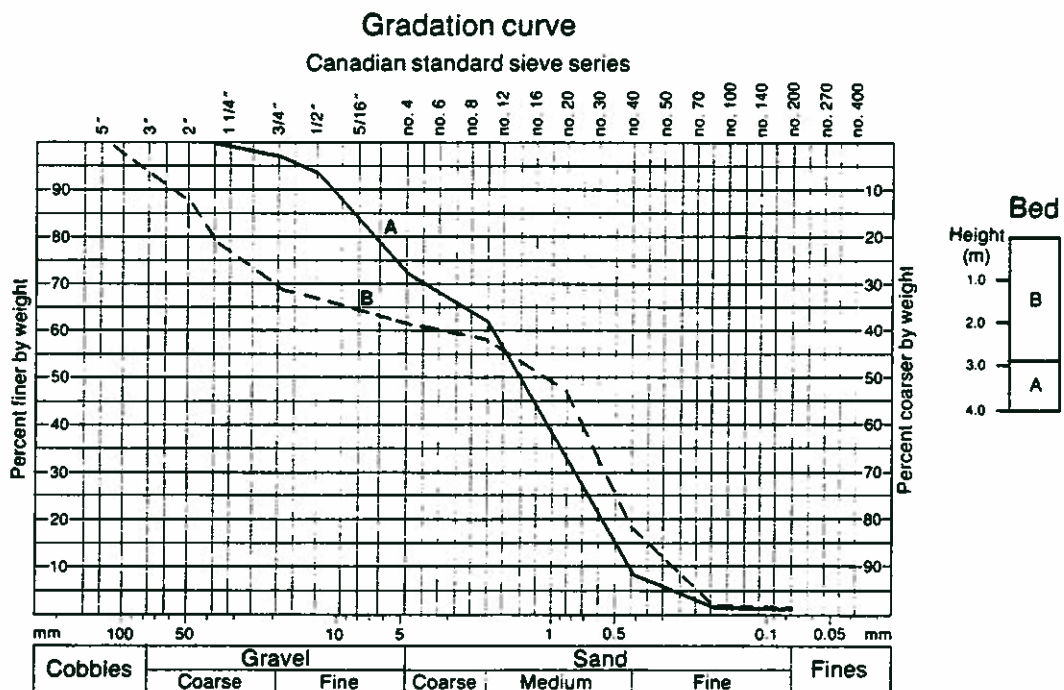
Deposit No. 5

Description: Field checked. Glaciofluvial highly extracted area. Very good access.

(A) -% cobbles 28% gravel
 71% sand 1% fines

(B) 7% cobbles 32% gravel
 60% sand 1% fines

Remarks: Samples were taken from NW corner of Deposit No. 5.

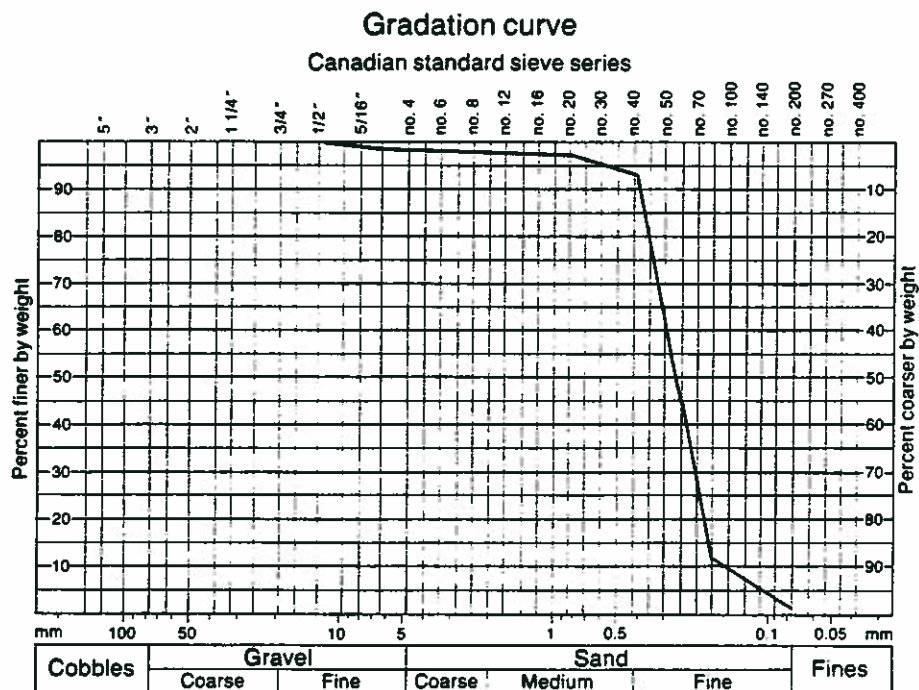
Deposit No. 18

Description: Field checked. Glaciofluvial, ice contact, esker. Over 97% medium-fine sand, with less than 2% small clasts, fairly good access, potential sand area.

Gradation: -% cobbles 2% gravel
 97% sand 1% fines

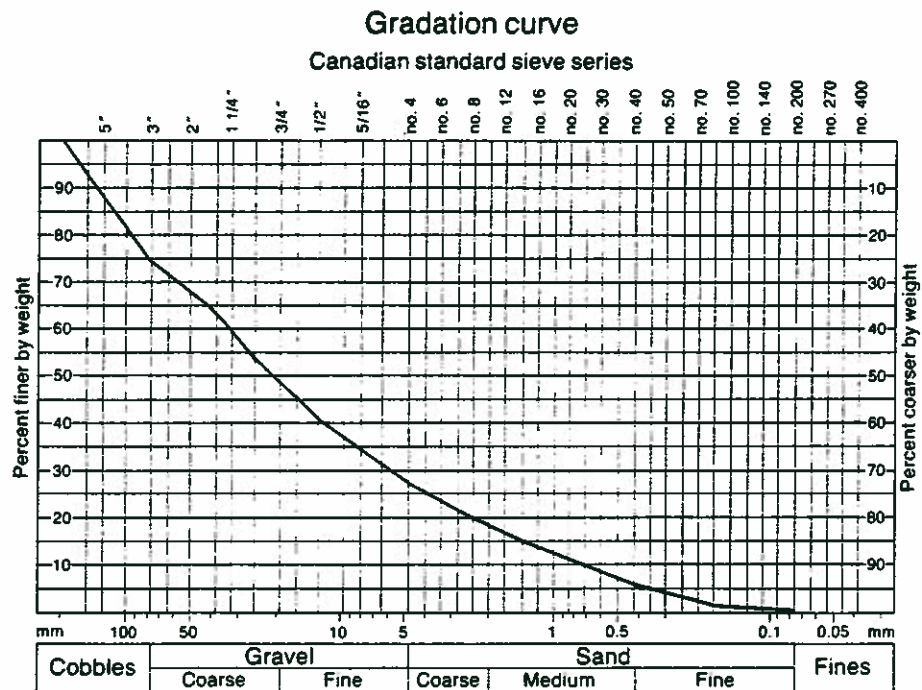
Deposit No. 19

Description: Field checked. Glaciofluvial, ice contact, kame.
 Variable material (mostly sandy gravel), crushing may be
 necessary, good potential sand and gravel area, good
 access.

Gradation: 26% cobbles 48% gravel
 25% sand 1% fines

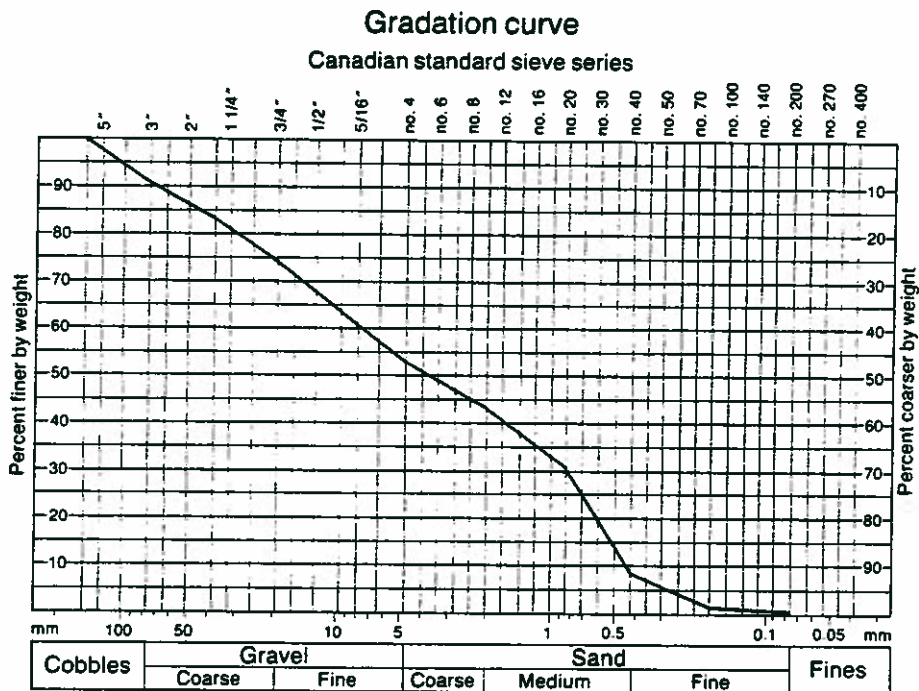
Deposit No. 20

Description: Field checked. Glaciofluvial, ice contact, probably kame delta deposit. Material varies, interbedded sand and pea gravel with till lenses as contaminants, up to 10 m thick, thin overburden, good potential sand and gravel area, fairly good access.

Gradation: 9% cobbles 38% gravel
52% sand 1% fines

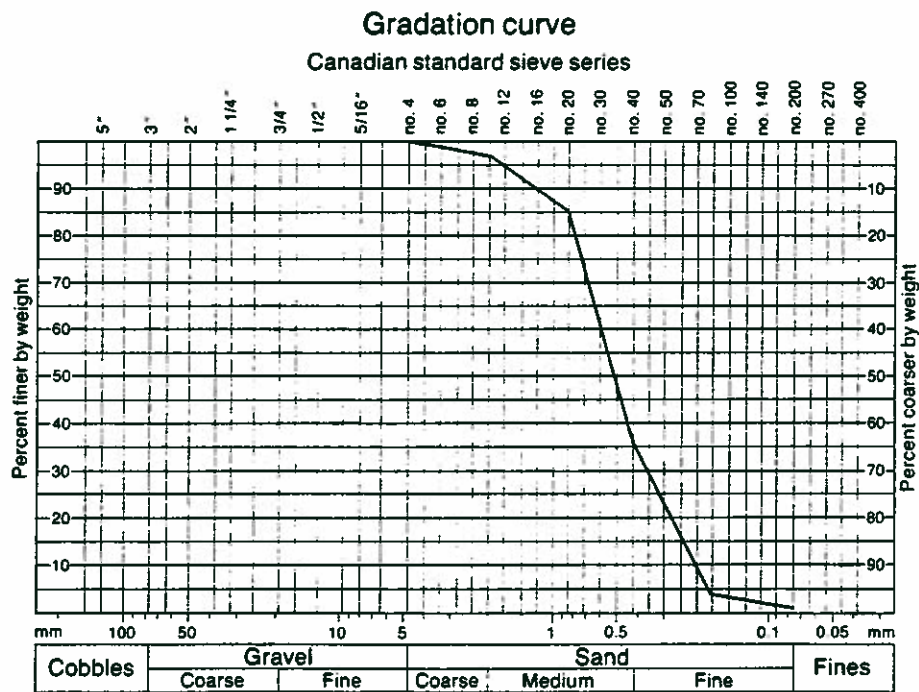
Deposit No. 28

Description: Field checked. Glaciofluvial. Highly extracted area, reclaimed, medium to fine sand, very good access.

Gradation: -% cobbles -% gravel
 99% sand 1% fines
